FIELD INSPECTION

Project Name:	Mountain Valley Pipeline	Inspector:	Matthew Grant
Inspection Date:	Wednesday, August 15, 2018	Project Contact:	Brian Clauto
Spread: Locations in Spread G inspected included MP 218.31-218.37, MP 222.04-222.90, MP 211.76, MP 209.86, MP 214.36	Spread G	Weather (Wet/Dry/Rain):	Dry

FIELD INSPECTION PHOTO LOG

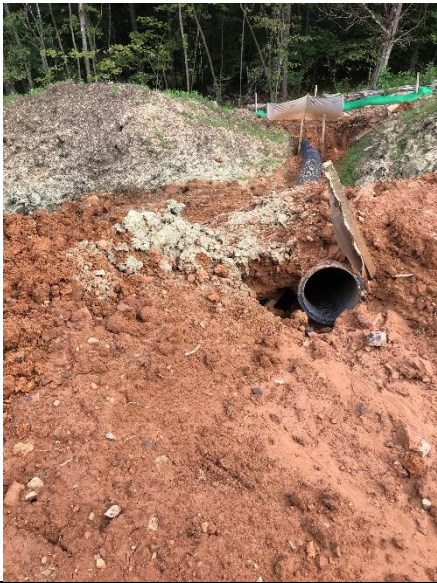
Area 1 - Spread G, near MP 218 station 11527+00 through 11530+00 slope drains observed were not built to spec.
Recommended Corrective Action: Build all slope drains with inlet protection per the spec

Area 2 - Spread G, near MP 218 near station 11529+00 the water bar observed required maintenance including the end treatment
Recommended Corrective Action: Repair all controls per the annual standard and specs.

Fig. 1
Near MP258 station 11529+00, slope drain observed was not built to spec and water bar required maintenance

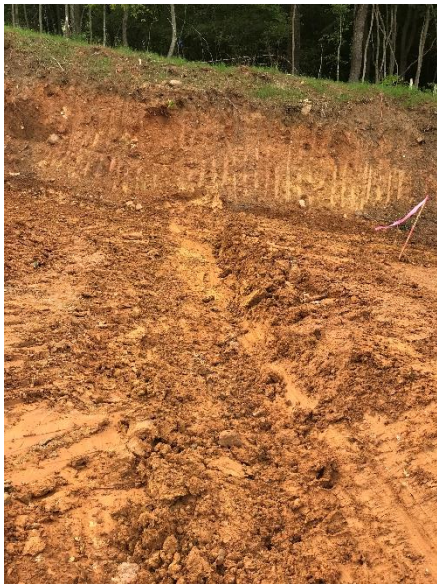
Fig. 3
Near station 11529+00 water bar observed required maintenance

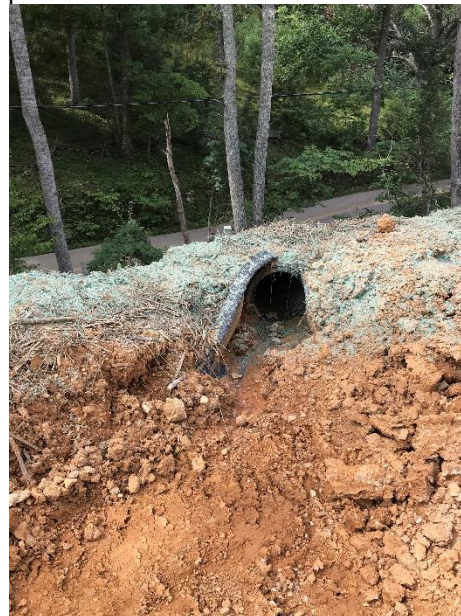
Area 3 – Spread G, near MP223 station 11776+80 through MP 222.9 station 11769+60, slope drains observed were not built to spec.
Recommended Corrective Action: Build all slope drain with inlet protection per the spec.

Fig.
Near station 11776+80 slope drain observed lacked inlet protection
