COMPLAINT INSPECTION REPORT

Project Name:	Mountain Valley Pipeline	Inspector:	John McCutcheon	
Inspection Date:	Thursday, August 9, 2018	Project Contact:	Brian Clauto, Tim Bowen	
Spread:	Spread G	Weather (Wet/Dry/Rain):	Dry	
STAGE OF CONSTRUCTION: (Check all that apply)				
TAGE OF CONSTRUCTION. (Check all that apply)

FIELD INSPECTION PHOTO LOG

Project Name: Mountain Valley Pipeline Date:Thursday, August 9, 2018

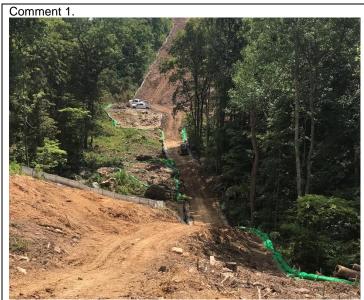
E&S controls in good condition.

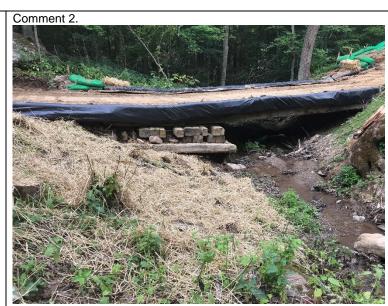
Stabilization applied to streambank.

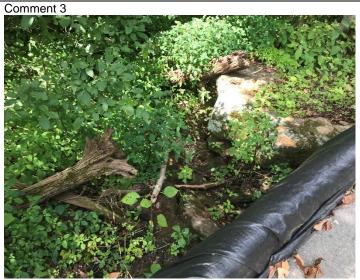
Sediment deposits not evident in channel. Water flowing clear.
