## **MVP INSPECTION REPORT**

Project Name:	Mountain Valley Pipeline	Inspector:	John McCutcheon
Inspection Date:	Wednesday, August 1, 2018	Project Contact:	Brian Clauto, Tracy Hilbun
Spread:	Spread I	Weather (Wet/Dry/Rain):	Dry

## PIPELINE SWPPP INSPECTION REPORT REQUEST FOR CORRECTIVE ACTION

## FIELD INSPECTION PHOTO LOG

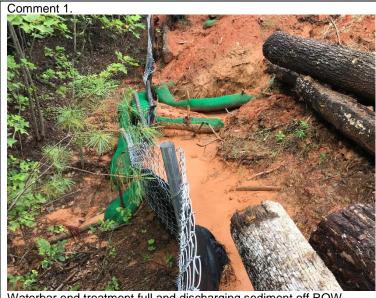
1. Waterbar end treatment at STA 134393+71 is full and discharging s	ediment off ROW.			
	2. Silt fence undermined and sediment escaping ROW at STA 13496+	·14.

Waterbar end treatment full and discharging sediment off ROW

Comment #	Regulatory Citation/Legal requirement <sup>1</sup>	Observation/Recommended Corrective Action		
1	(Va. Code §62.1- 44.15:31) (MVP Standards & Specifications for VA, p. 1) (9VAC 25-840- 60.A) (9VAC 25-880- 70.II.G.2.).	Observation Waterbar end treatment at STA 134393+71 is full and discharging sediment off ROW.  Recommended Corrective Action: Clean out and repair waterbar and end treatment. Remove deposited sediment and stabilize disturbed areas.		
2	(Va. Code §62.1- 44.15:31) (MVP Standards & Specifications for VA, p. 1) (9VAC 25-840- 60.A). (9VAC 25-880- 70.II.G.2.)	Observation: Silt fence undermined and sediment escaping ROW at STA 13496+14.  Recommended Corrective Action: Clean out and repair silt fence. Remove deposited sediment and stabilize disturbed areas.		
3	(Va. Code §62.1- 44.15:31) (MVP Standards & Specifications for VA, p. 1) (9VAC 25-880- 70.II.G.2.)	Observation: Sediment off ROW has entered a small channel paralleling ROW down to road.  Recommended Corrective Action: Remove sediment and stabilize denuded channel as needed.

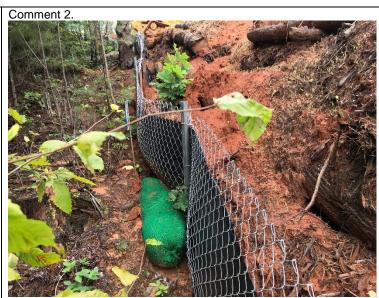
Silt fence undermined and discharging sediment off ROW.

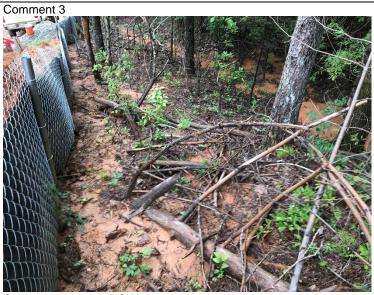
Sediment escaping ROW.

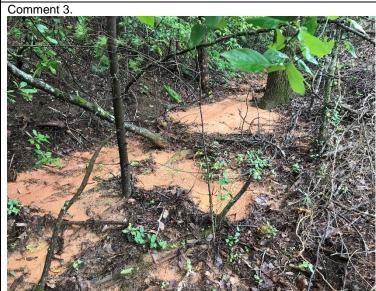
3. Sediment off ROW has entered a small channel paralleling ROW down to road.				
Deadl	ine: Within 24 hours of receipt or as noted				
constitu	commended corrective action deadline date applies to all conditions noted on this ate non-compliance and/or corrective actions are not completed by the deadline, or g compliance on the above project.				
Inspe	ctor Signature:		Date: <u>8-1-18</u>

Sediment in channel off of ROW.
