Complaint Investigation

1	
Project Name:	Mountain Valley Pipeline	Inspector:	Matthew Grant	
Inspection Date:	Wednesday, December 11, 2019	Project Contact:	Brian Clauto	
Spread: Giles Co. AR GI 234 AR GI 241.01 ATWS1331,1333,1332 ,1360 MP 202.4 MP 206.8	Spread G	Weather (Wet/Dry/Rain):	Dry	
STAGE OF CONSTRUCTION: (Check all that apply)				
_	Clearing			
Backfilling and Grade	e Restoration	3 & Stabilization	Other: <u>Dormant</u>	
Are all control meas condition in accorda applicable, manufac Areas of offsite sedi	d and implemented in accordance with the nt control plan and stormwater managementers properly maintained in effective opeince with good engineering practices and sturer specifications? ment deposition were observed?	nent plans? erating		
 Comments: Inspected designated stream included: S-Q14, S-G32, S-E20, S-Y2, S-Y3, S-A32 ECD's controls were in place and functioning at crossings. Access Roads inspected included GI 234, ditch line has recently been re blanketed and is stable. Recommend Corrective Action: N/A

FIELD INSPECTION PHOTO LOG

Project Name: Mountain Valley Pipeline Date: Wednesday, December 11, 2019

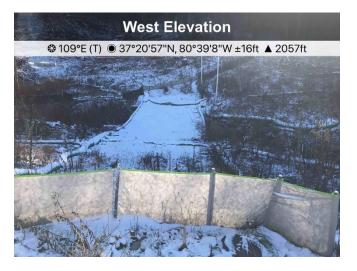
Fig. 1 Designated stream crossing S-G32, ECD's in place and functioning.

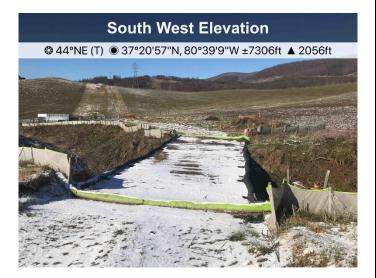
Fig. 2 Designated stream crossing S-E20, ECD's in place and functioning.

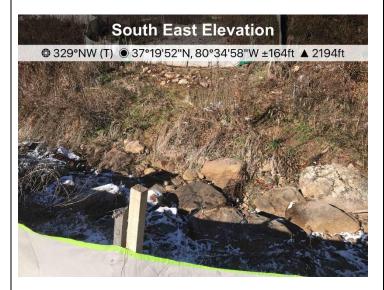
Fig. 3 Designated stream crossing S-Y3, ECD's in place and functioning.

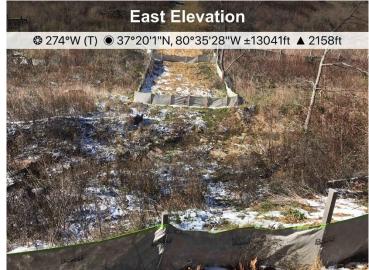
Fig. 4. Designated stream crossing S-A32, ECD's in place and functioning.
