## Complaint Investigation

<b>Project Name:</b>	Mountain Valley Pipeline	<b>Inspector:</b>	Matthew Grant
<b>Inspection Date:</b>	Tuesday, December 3, 2019	<b>Project Contact:</b>	Brian Clauto
<b>Spread: Montgomery Co.</b> AR MN 266 MP225.9-227.4 ATWS 1487 MP223.1-222.8 ATWS 1373 ATWS 1057 AR MN 258.03 MP219.6-219.8	<b>Spread G</b>	<b>Weather (Wet/Dry/Rain):</b>	<b>Dry</b>

## FIELD INSPECTION PHOTO LOG

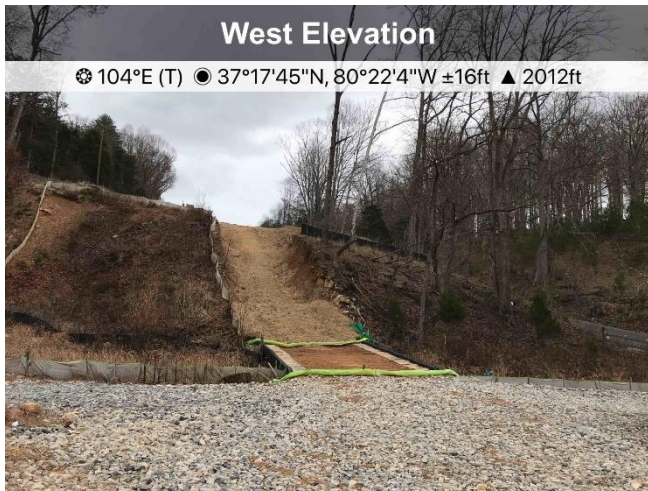
- Fig. 1 Designated stream MLV26, area near crossing is stabilized and ECD's are in place and functioning.

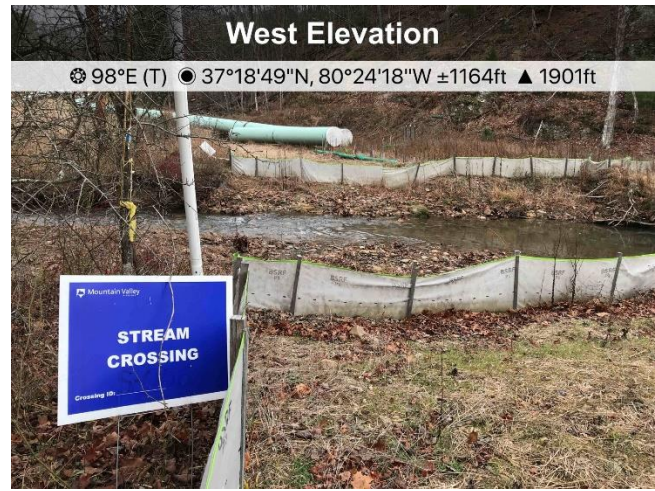
- Fig. 2 Designated stream S-006, area near crossing is stabilized and ECD's are in place and functioning.

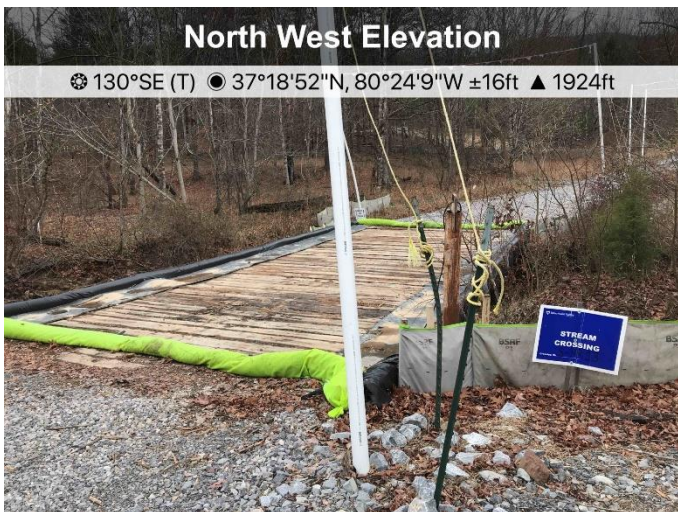
- Fig. 3 Designated stream S-RR13, area near crossing is stabilized and ECD's are in place and functioning.

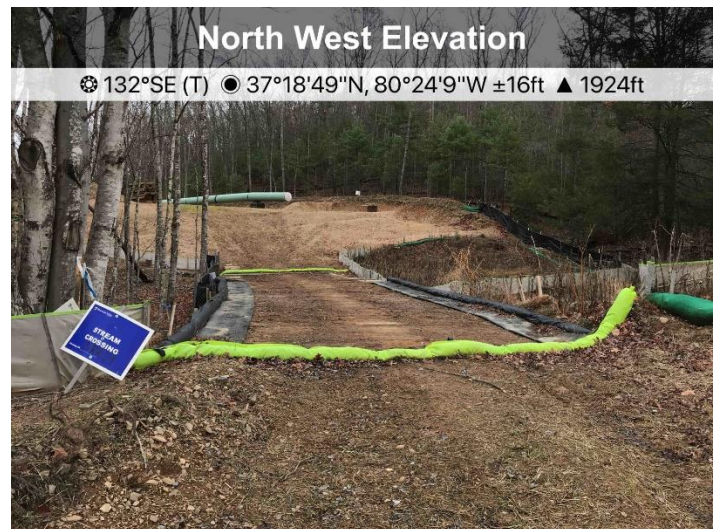
- Fig. 4 Designated stream S-RR14, area near crossing is stabilized and ECD's are in place and functioning.
