COMPLAINT INSPECTION REPORT

Project Name:	Mountain Valley Pipeline	Inspector:	Marshall Willis
Inspection Date:	Tuesday, December 3, 2019	Project Contact:	Brian Clauto, Cory Chalmers
Spread G: Montgomery County	STA 11929+47 – 12008+53 ATWS 473A, ATWS 473, ATWS 1157A & ATWS 1157 MVP-MN-266/268	Weather (Wet/Dry/Rain):	Wet

FIELD INSPECTION PHOTO LOG

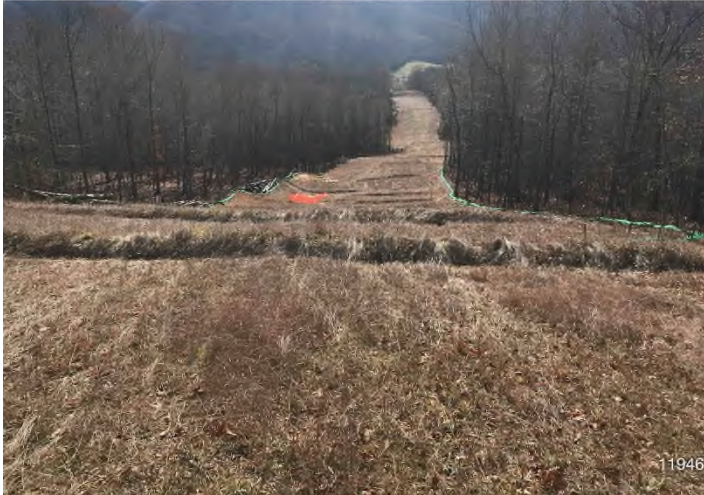
Fig. 1: **STA 11946+00** – Controls in place and functioning. Area stabilized with vegetative cover.

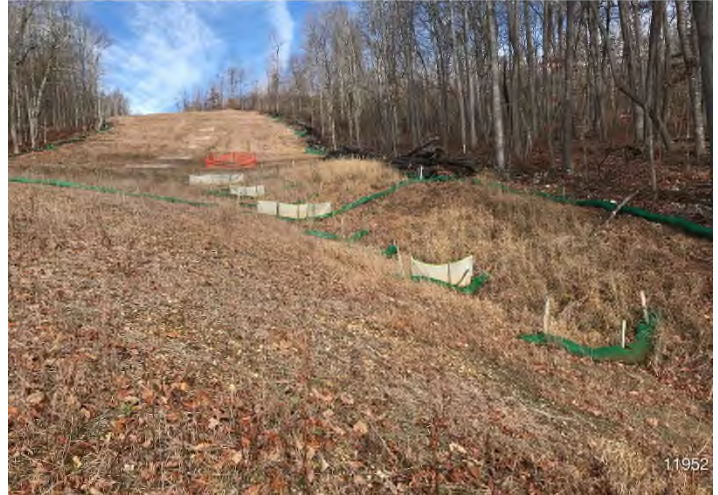
Fig. 2: **STA 11952+00** – Controls in place and functioning. Area stabilized with vegetative cover.

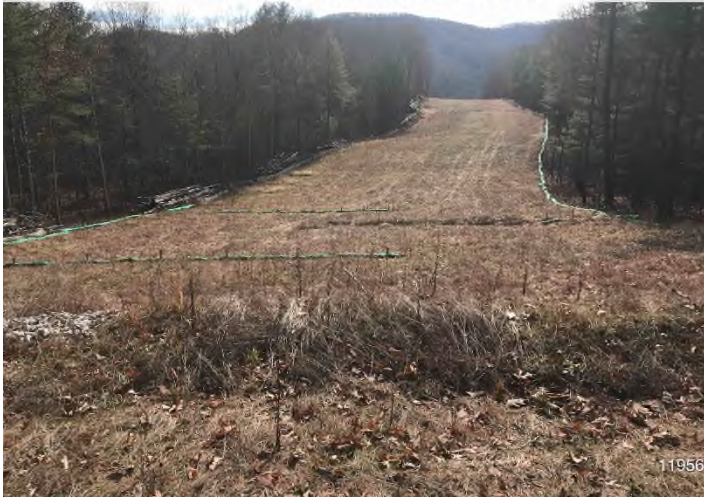
Fig. 3: **STA 11956+00** – Controls in place and functioning. Area stabilized with vegetative cover.

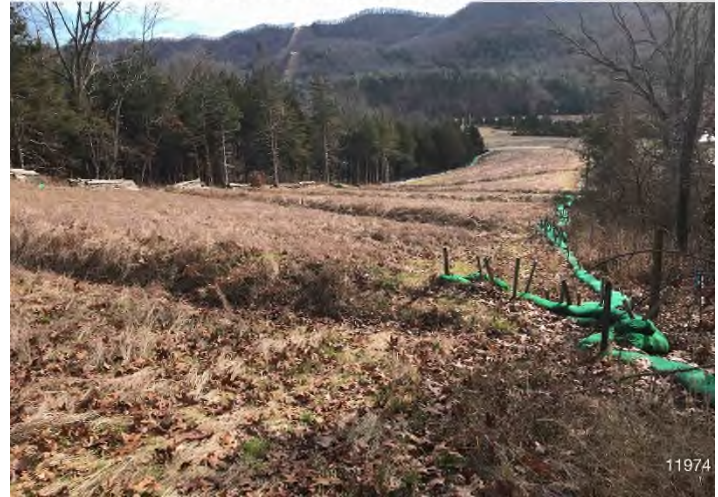
Fig. 4: **STA 11974+00** – Controls in place and functioning. Area stabilized with vegetative cover. No erosion evident.

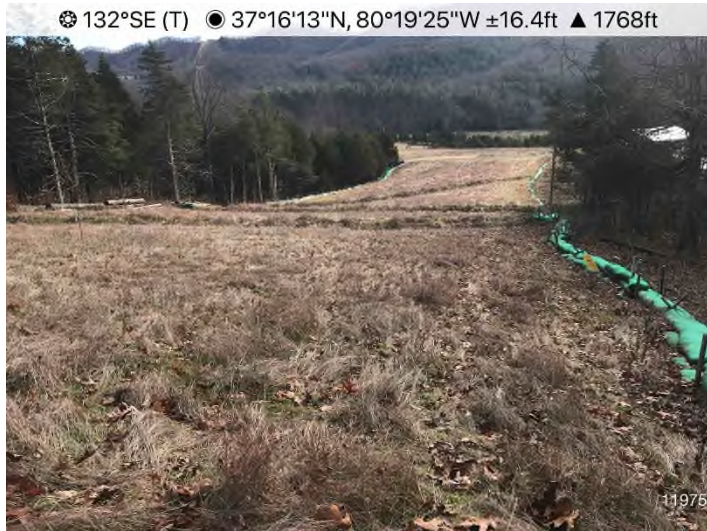
Fig. 5: **STA 11975+00** – Controls in place. Area stabilized with vegetative cover. No erosion evident.

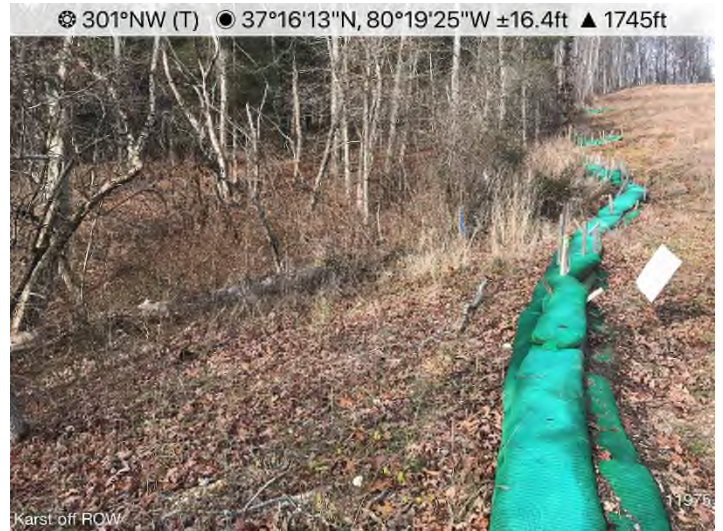
Fig. 6: **STA 11975+00** – Controls in place. Area stabilized with vegetative cover. No erosion evident.

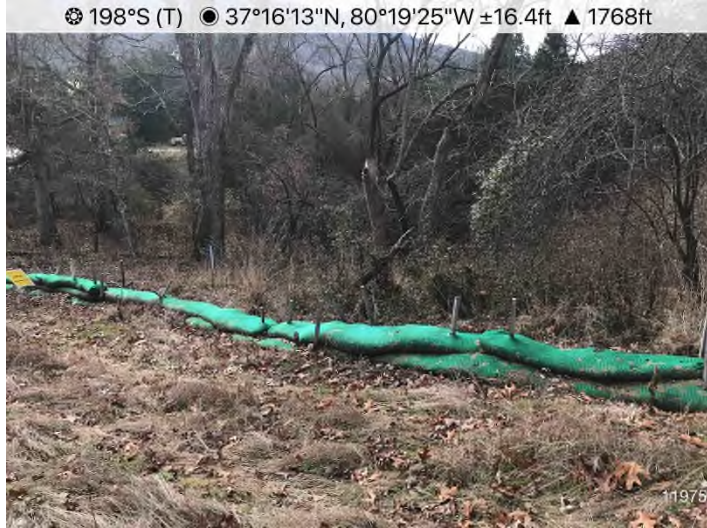
Fig. 7: **STA 11975+00** – Looking south towards offsite karst feature. Controls in place. Area stabilized with vegetative cover. No erosion evident.

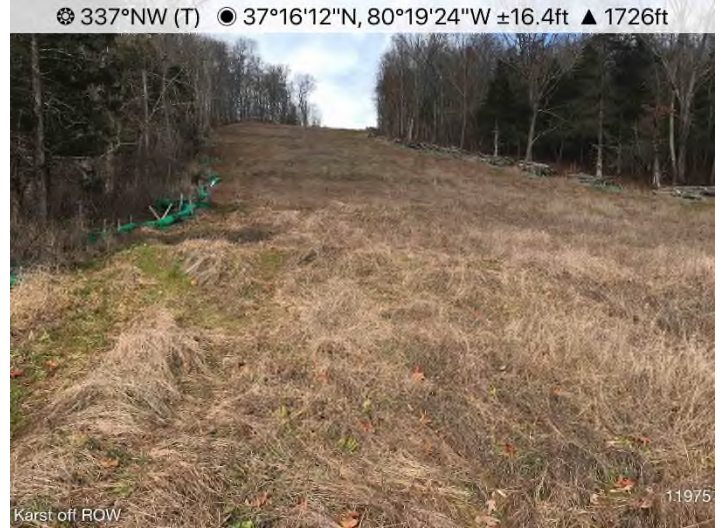
Fig. 8: **STA 11975+00** – Controls in place. Area stabilized with vegetative cover. No erosion evident.

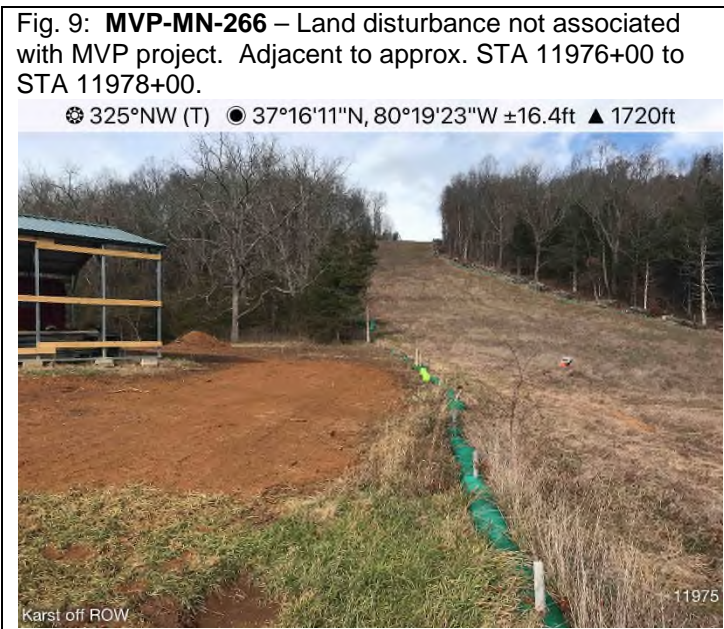
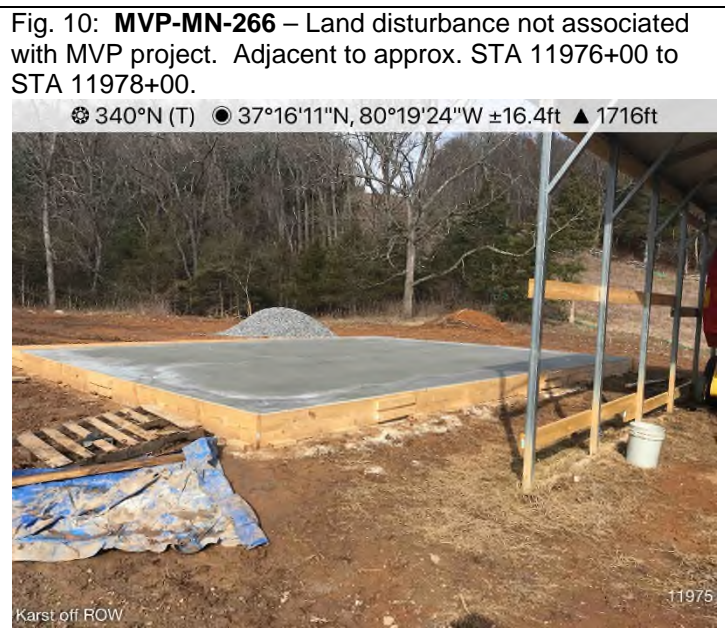
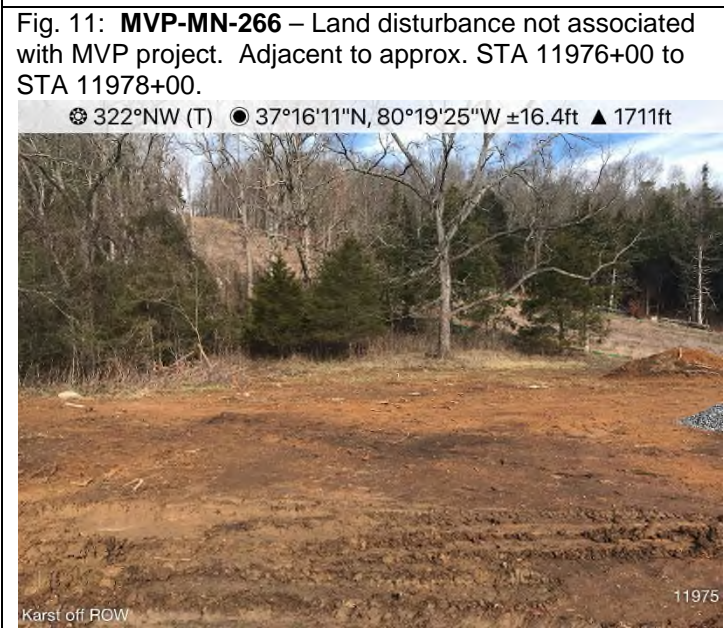
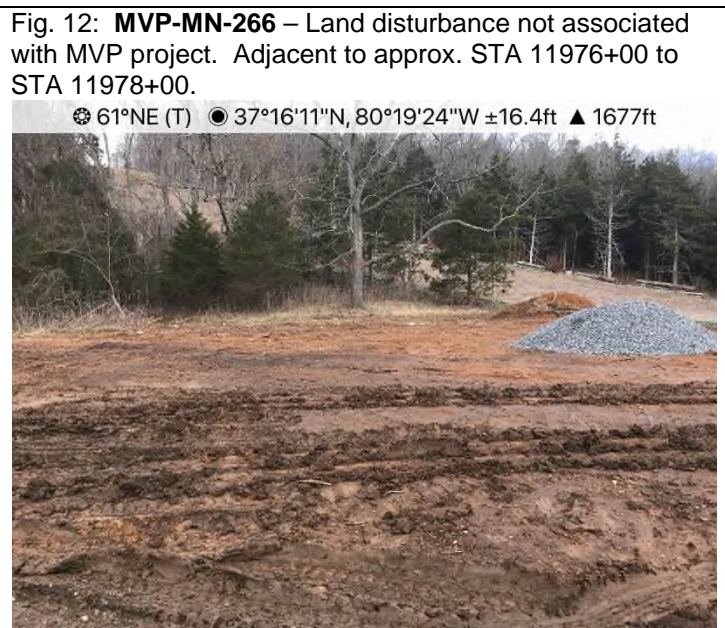
1. Underground gravel filter bed is located approximately at STA 11975+60. See Figures 4, 5, 6, 7 and 8.
2. At the time of inspection, there was no evidence of sediment discharge from MVP ROW.
3. ECDs within the MVP LOD were installed per the approved plans and appeared to be functioning as designed.
4. ROW in this area is currently stabilized with vegetative cover and no significant erosion was evident within the LOD.
5. Land disturbing activities not associated with the project were noted off-ROW during the inspection near STA 11976+00 along MVP-MN-266. See Figures 9-12.

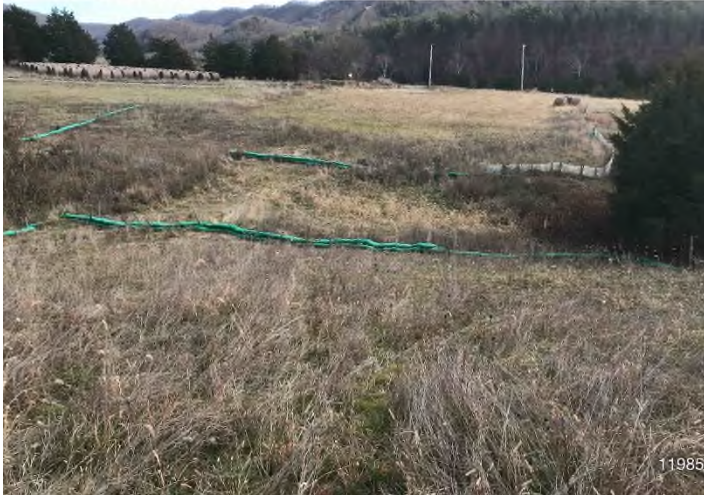
Fig. 13: **STA 11985+00** – Controls in place and functioning. Area stabilized with vegetative cover.

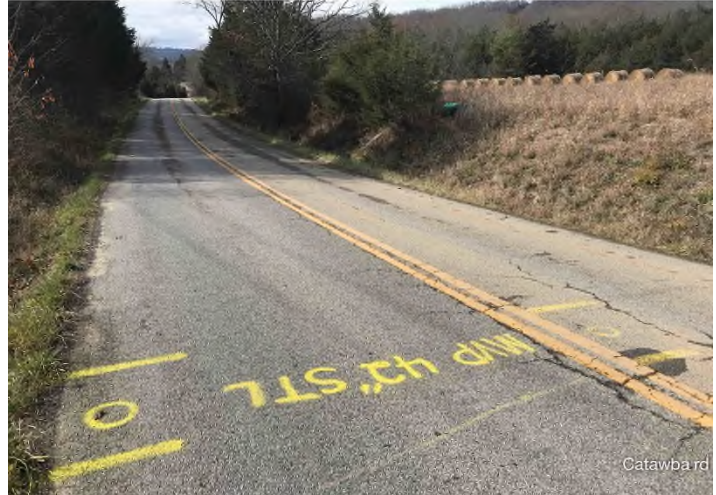
Fig. 14: **STA 11989+05** – Catawba Road crossing.

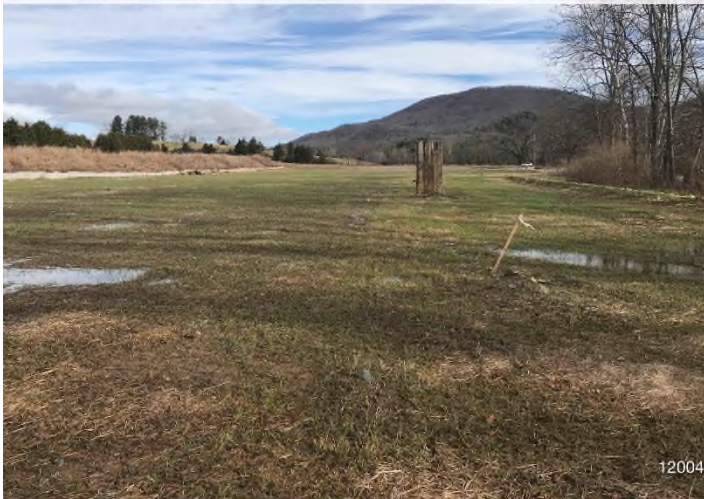
Fig. 15: **STA 12004+00** – Controls in place and functioning. Area stabilized.

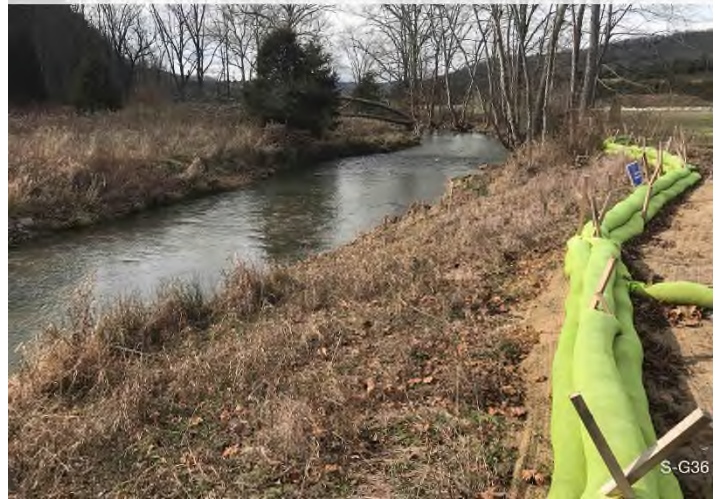
Fig. 16: **Stream S-G36** – Controls in place and functioning at North Fork Roanoke River crossing.
