## Complaint Investigation

<b>Project Name:</b>	Mountain Valley Pipeline	<b>Inspector:</b>	Matthew Grant
<b>Inspection Date:</b>	Tuesday, November 5, 2019	<b>Project Contact:</b>	Brian Clauto
<b>Spread: Montgomery Co. MN 266 MP225.9-226.8 Spread H MN268 ATWS473 , 473A ST12008+69</b>	Spread G	<b>Weather (Wet/Dry/Rain):</b>	Dry

## FIELD INSPECTION PHOTO LOG

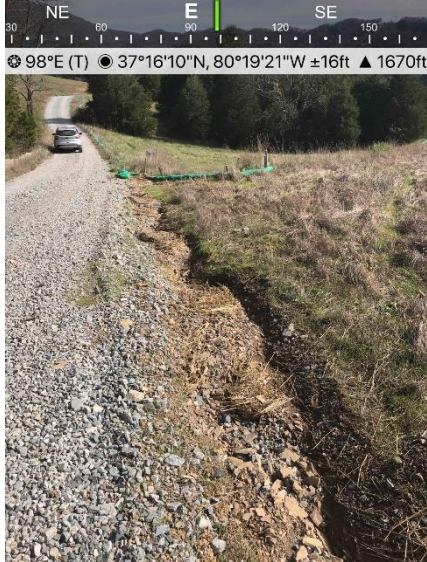
- Inspected designated stream included: S-G36 ECD's were in place and functioning at the designated crossing.
- All karsts features within this section of right of way are protected and the ECD's are functioning.
- MN 266 access road conveyance channel requires repair.

- Fig. 1 MN 266 access road conveyance channel requires repair.

**Recommend Corrective Action:** Maintain and install all controls per the approved plan and specs

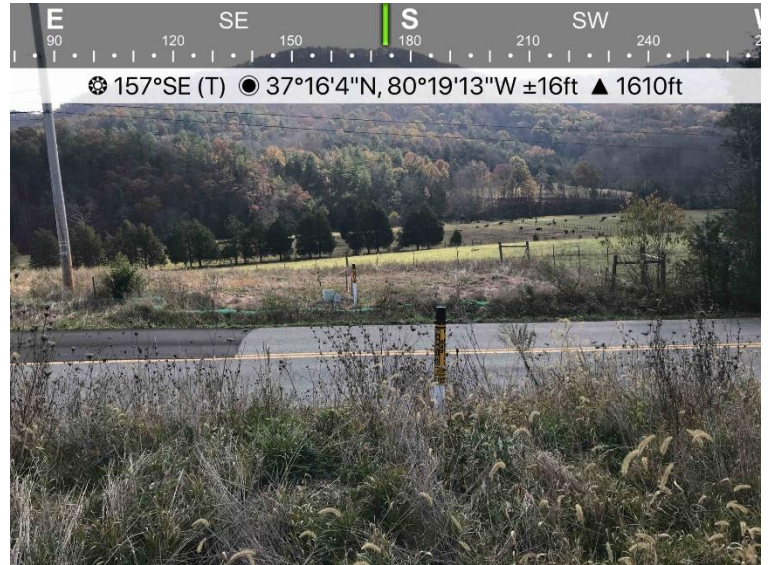
- Fig. 2 Catawba Rd crossing, ROW is stabilized and ECD's are in place and functioning.

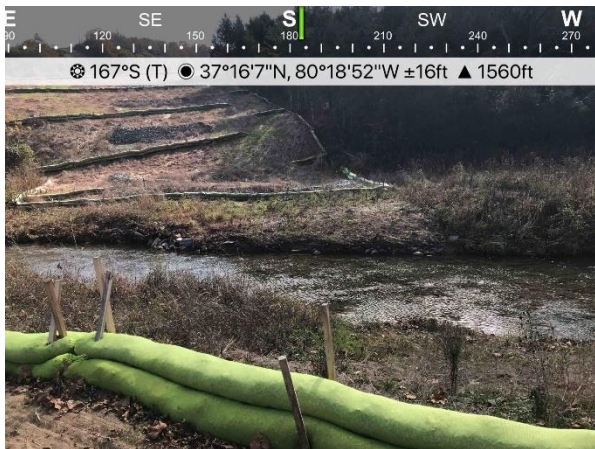
- Fig. 3 At designated crossing S-G36, area is stabilized and ECD's are functioning.

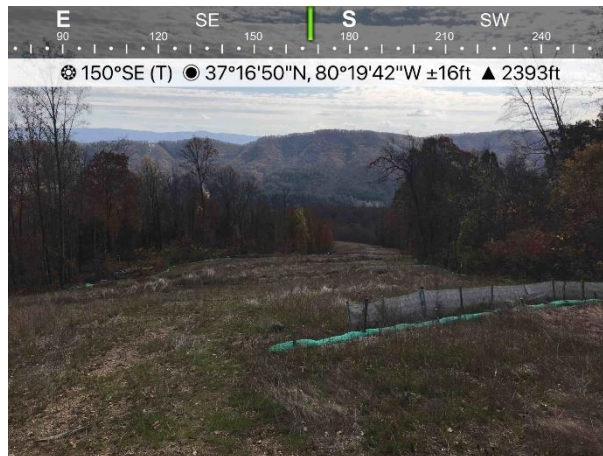
- Fig. 4 Near MP225.9 area is stabilized and ECD's are in place and functioning.
