## COMPLAINT INSPECTION REPORT

<b>Project Name:</b>	Mountain Valley Pipeline	<b>Inspector:</b>	Marshall Willis
<b>Inspection Date:</b>	Monday, October 28, 2019	<b>Project Contact:</b>	Brian Clauto
<b>Spread H: Montgomery County</b>	STA 12544+27 – 12540+00 MVP-MN-278.01	<b>Weather (Wet/Dry/Rain):</b>	Wet

## FIELD INSPECTION PHOTO LOG

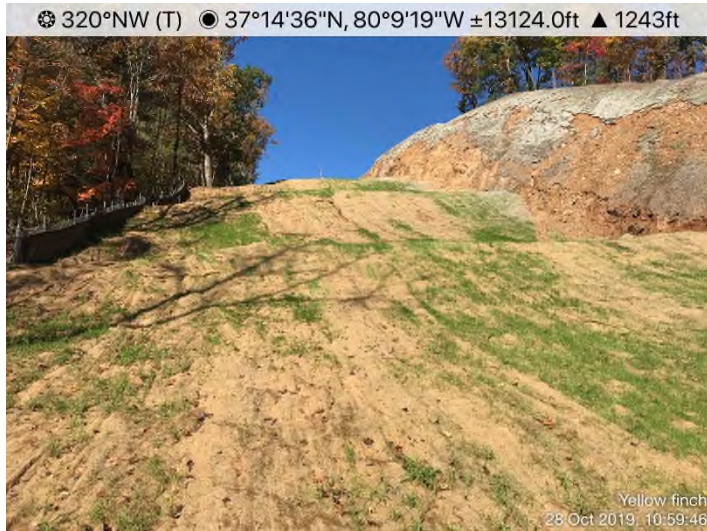
Fig. 1: **STA 12544+00** – Area stabilized with erosion matting. Controls in place and functioning at the time of inspection.

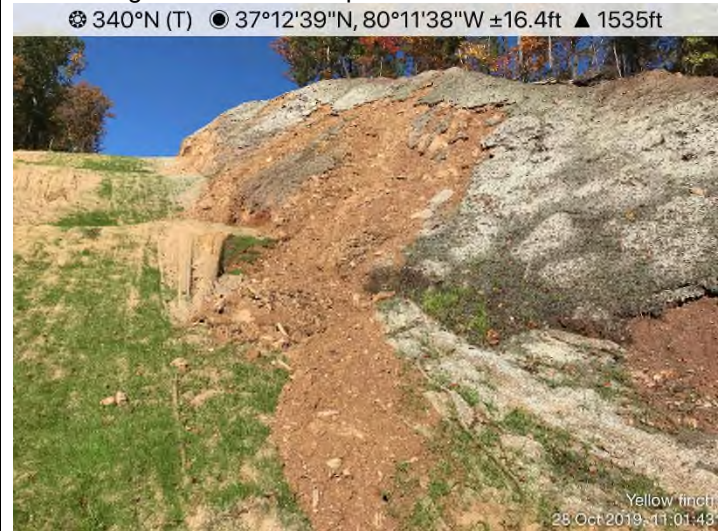
1. At the time of inspection, there was no evidence of sediment discharge from MVP ROW onto Yellow Finch Lane or into S-EF20a.
2. ECDs within the MVP LOD were installed per the approved plans and appeared to be functioning as designed.
3. Soil stockpile at STA 12541+00 – 12543+00 is eroding onto ROW and depositing sediment within waterbar throat. Item was identified by MVP inspectors on 10/20/2019 and is currently extended due to wet conditions on the ROW.

Fig. 2: **STA 12543+00** – Stockpile slipping onto ROW. Item identified by MVP on 10/20/2019. Repair extended due to wet ROW conditions. Controls in place and functioning at the time of inspection.

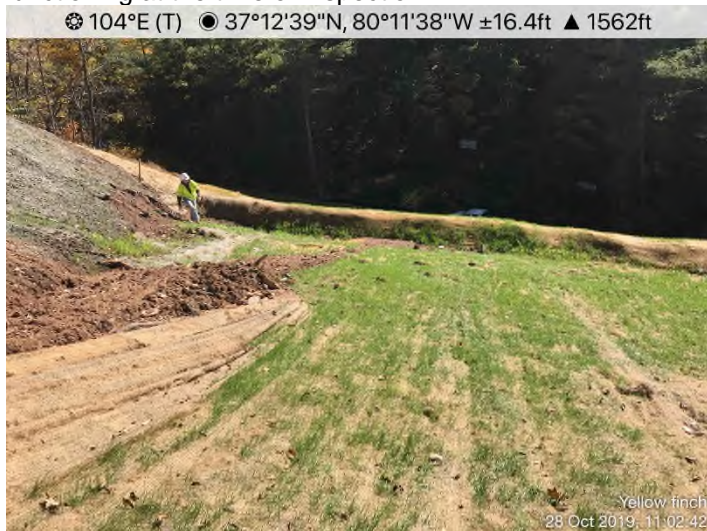
Fig. 3: **STA 12541+00** – Stockpile slipping onto ROW. Item identified by MVP on 10/20/2019. Repair extended due to wet ROW conditions. Controls in place and functioning at the time of inspection.

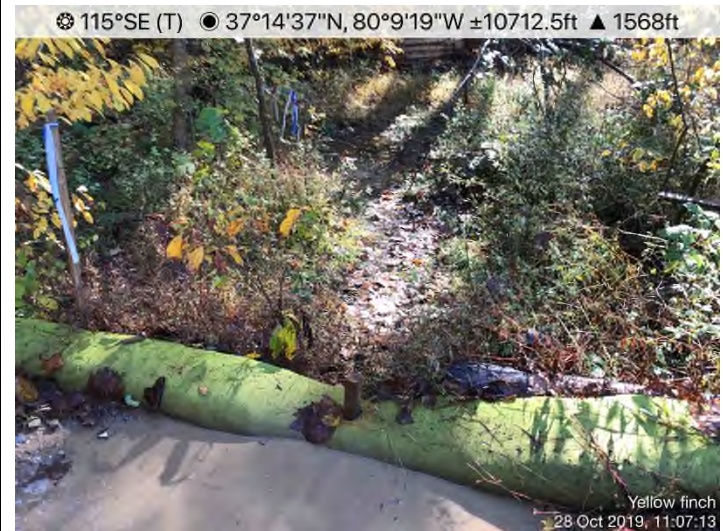
Fig. 4: **MVP-MN-278.01** – Yellow Finch Lane. CFS installed correctly and functioning properly at the time of inspection.
