## COMPLAINT INSPECTION REPORT

Project Name:	Mountain Valley Pipeline	Inspector:	Marshall Willis	
Inspection Date:	Monday, October 28, 2019	Project Contact:	Brian Clauto	
Spread H: Montgomery County	STA 12175+00 - 12200+00 ATWS 703, ATWS 704A, ATWS 1446 & ATWS 1375 MVP-MN-275/274	Weather (Wet/Dry/Rain):	Wet

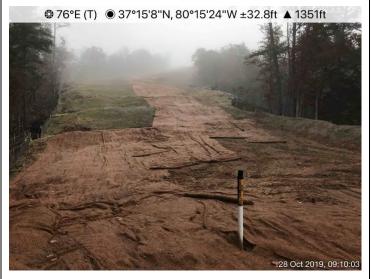
Fig. 1: **STA 12201+00** – Controls in place and functioning. Area stabilized with erosion fabric and seed.

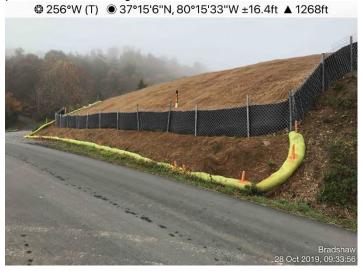
Fig. 2: **STA 12190+75** – Bradshaw Road crossing. No evidence of sediment discharge from ROW. Controls in place and functioning.

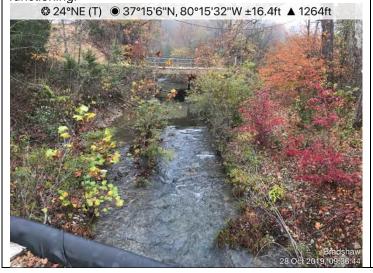
Fig. 3: **Stream S-C21** – Looking upstream at Bradshaw Creek crossing towards Bradshaw Road. No evidence of sediment discharge from ROW. Controls in place and functioning.

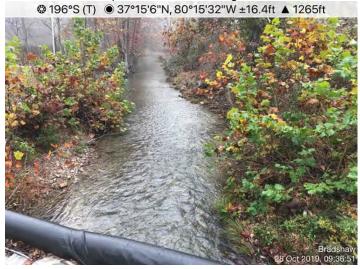
Fig. 4: **Stream S-C21** – Looking downstream at Bradshaw Creek crossing. No evidence of sediment discharge from ROW. Controls in place and functioning.

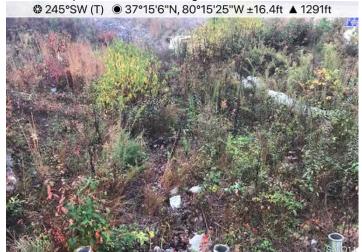
Fig. 5: **Stream S-OO11** – Looking downstream at stream S-OO11 from ROW. No sediment deposition observed. Controls in place and functioning.

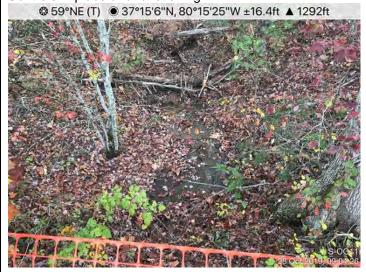
Fig. 6: **Stream S-OO11** – Looking upstream at stream S-OO11 from ROW. No sediment deposition observed. Controls in place and functioning.

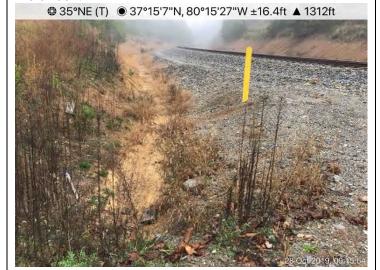
Erosion occurring along the Roanoke Valley Resource Authority (RVRA) spur line was documented during the inspection. Discharge from these channels flows through the MVP ROW and into S-OO11. See Figure 7.

Fig. 7: **STA 12197+40** – Looking NE towards RVRA spur line from ROW. Erosion along channel and banks of rail line evident.

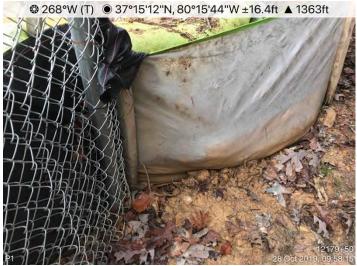
STA 12179+50: P1 maintenance needed.

Fig. 8: **STA 12179+50** – P1 undermined. Maintenance needed

Recommended Corrective Action: Maintain and install all controls per the approved plans and PSS&S.

**Deadline:** Within 24-hr notification
