FIELD INSPECTION

Project Name:	Mountain Valley Pipeline	Inspector:	Marshall Willis
Inspection Date:	Tuesday, November 5, 2019	Project Contact:	Brian Clauto, Cory Chalmers
Spread G: Montgomery County	STA 11788+43 – 11929+47 MVP-MN-266	Weather (Wet/Dry/Rain):	Dry

FIELD INSPECTION PHOTO LOG

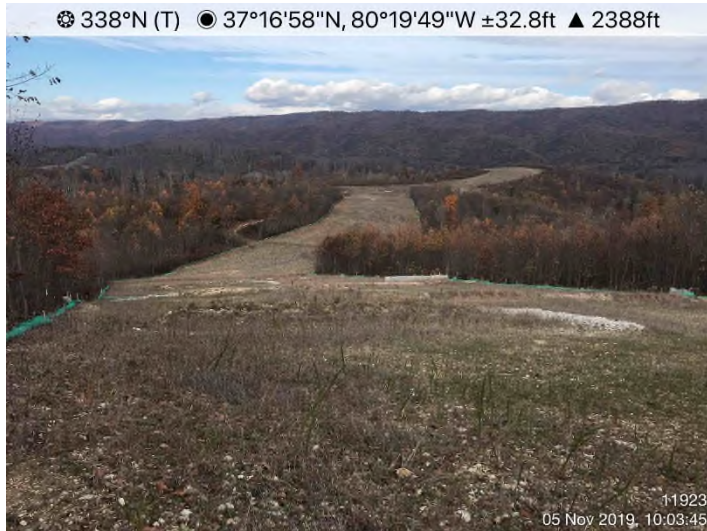
Fig. 1: **STA 11923+00** – Controls in place and functioning properly. Area adequately stabilized.

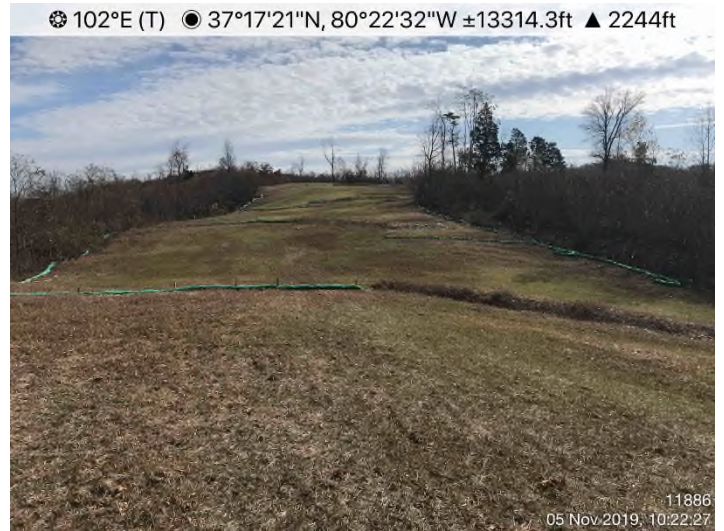
Fig. 2: **STA 11886+00** – Controls in place and functioning properly. Area adequately stabilized.

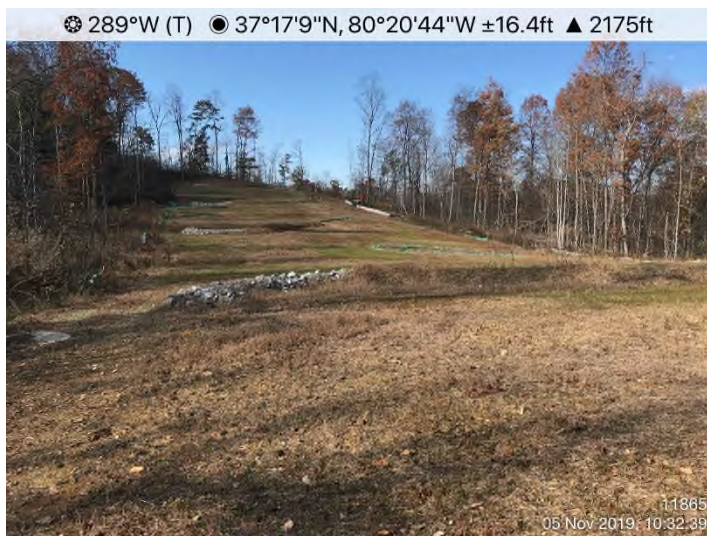
Fig. 3: **STA 11865+00** – Controls in place and functioning properly. Area adequately stabilized.

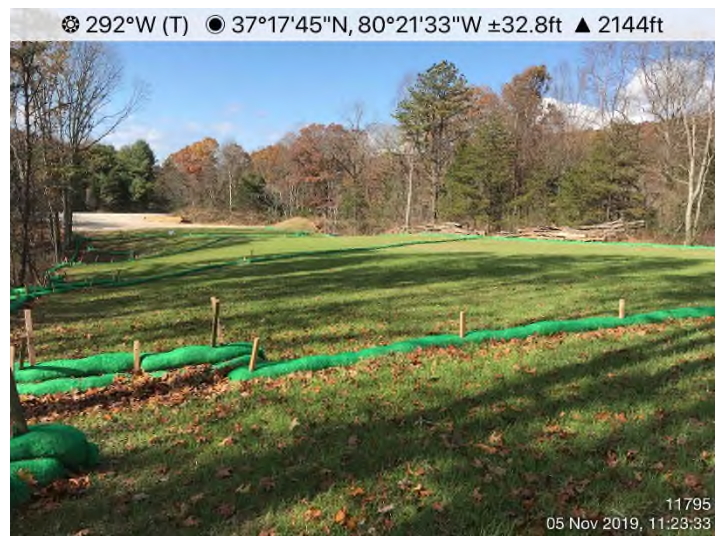
Fig. 4: **STA 11795+00** – Controls in place and functioning properly. Area adequately stabilized.
