## FIELD INSPECTION

<b>Project Name:</b>	Mountain Valley Pipeline	<b>Inspector:</b>	Matthew Grant
<b>Inspection Date:</b>	Tuesday, October 8, 2019	<b>Project Contact:</b>	Brian Clauto
<b>Spread: Giles County</b> <b>MLV26</b> <b>GI 256.02</b> <b>ATWS 1370</b> <b>MLV 249.02</b> <b>GI 249.01</b> <b>ATWS 1331</b>	<b>Spread G</b>	<b>Weather (Wet/Dry/Rain):</b>	<b>Rainy</b>

## FIELD INSPECTION PHOTO LOG

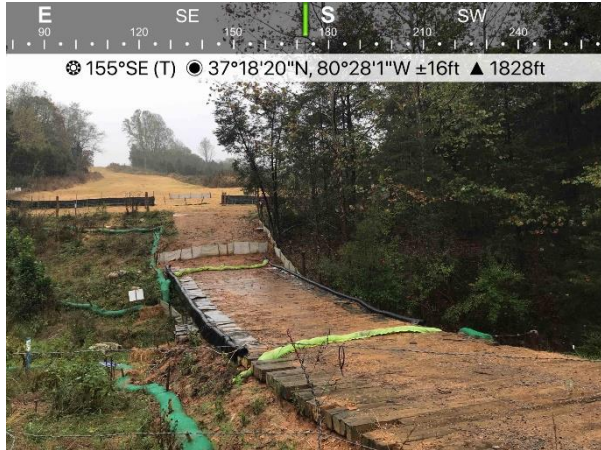
- Fig. 1 Designated stream S-N11, ECD's are in place and functioning.

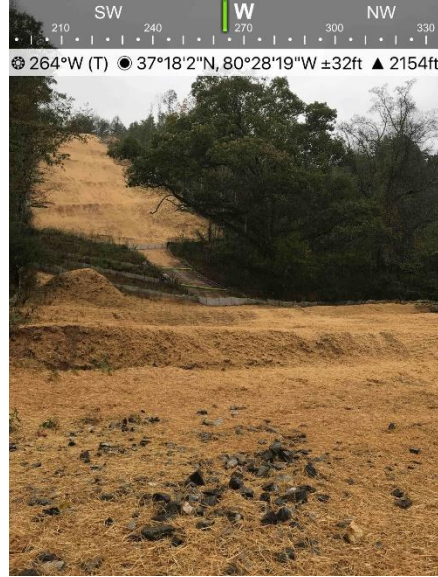
- Fig. 2 Near MP 214.4 stabilization has been applied and ECD's are in place and functioning.

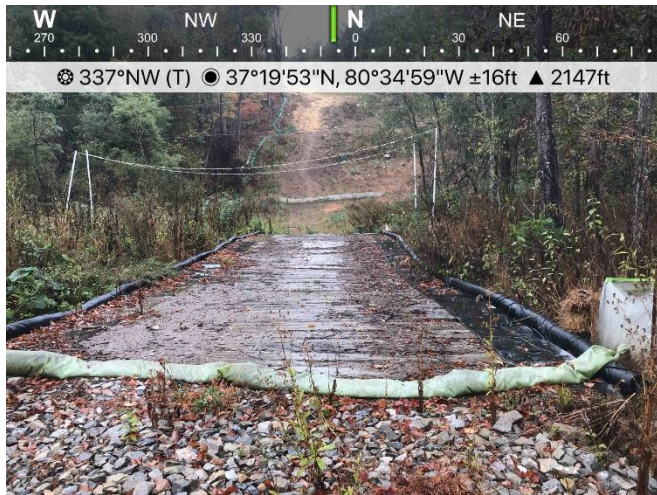
- Fig. 3 Designated stream S-Y2, ECD's are in place and functioning.

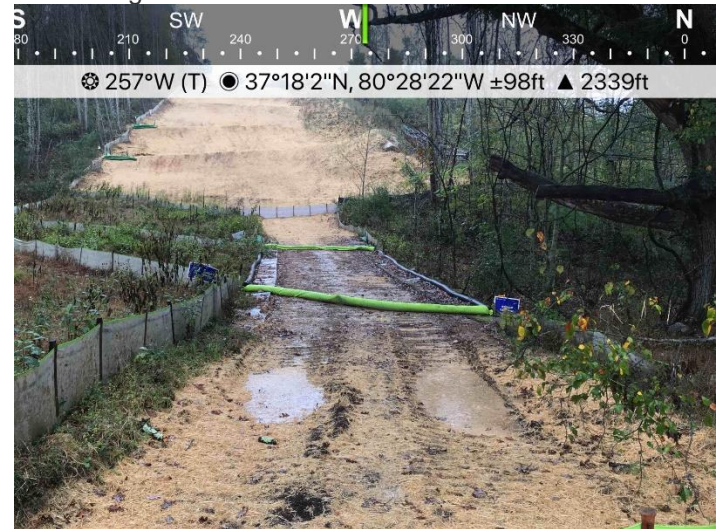
- Fig. 4 Designated stream S-N12, ECD's are in place and functioning.
