FIELD INSPECTION

Project Name:	Mountain Valley Pipeline	Inspector:	Matthew Grant
Inspection Date:	Tuesday, September 24, 2019	Project Contact:	Brian Clauto
Spread: Montgomery County MP 223.1-225.3 MLV266.03 MLV25 MP212	Spread G	Weather (Wet/Dry/Rain):	Dry

FIELD INSPECTION PHOTO LOG

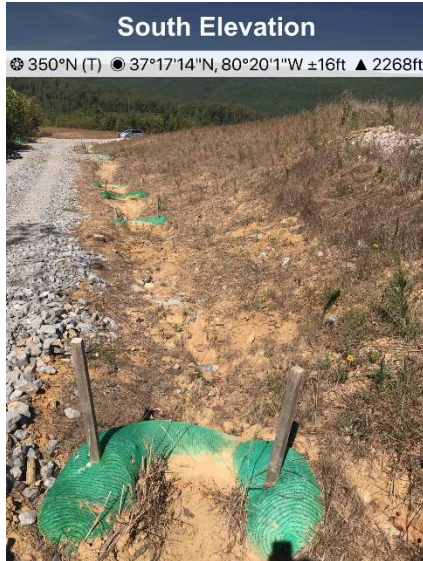
- Access Road MLV 266.03 ditch line requires stabilization and check dam repairs.

- Fig. 1 Access Rd MLV 266.03 ditch line requires repair/ stabilization.

Recommend Corrective Action: Maintain and install all controls per the approved plan and specs

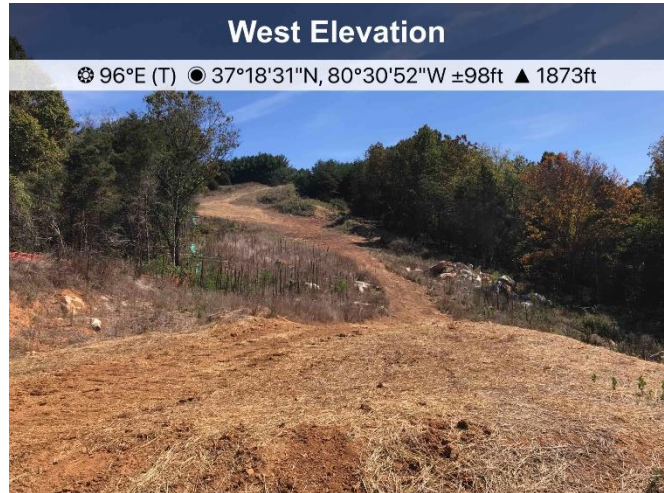
- Fig. 2 On going stabilization work was being conducted near MP 211.5

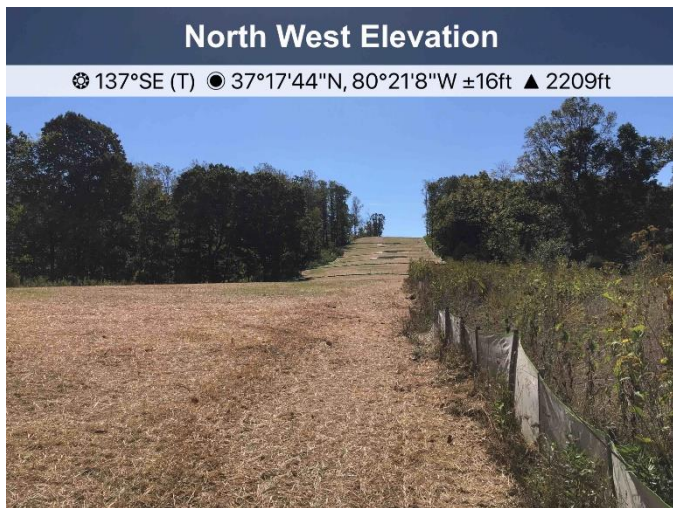
- Fig. 3 At St11816+00 stabilization has been applied with permanent style water bars with level spreaders.

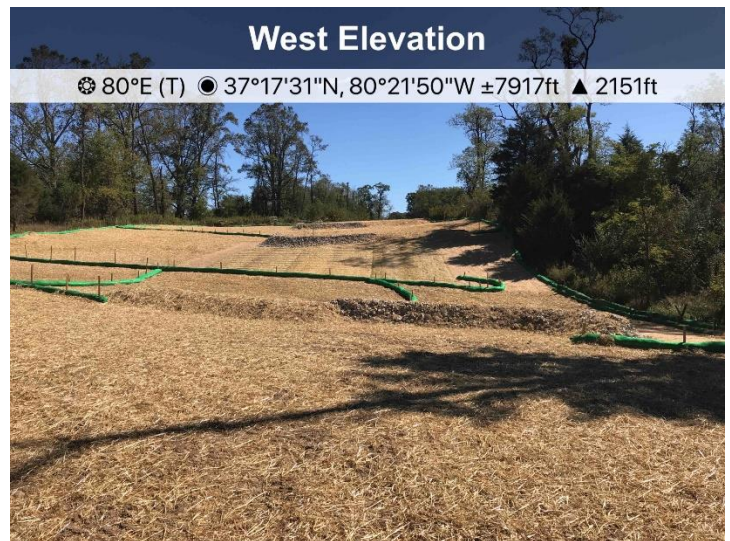
- Fig. 4 At St11798 stabilization has been applied with permanent style water bars with level spreaders.
