## **FIELD INSPECTION**

| Project Name: | Mountain Valley Pipeline | Inspector: | Matthew Grant |
| Inspection Date: | Tuesday, September 17, 2019 | Project Contact: | Brian Clauto |

## FIELD INSPECTION PHOTO LOG

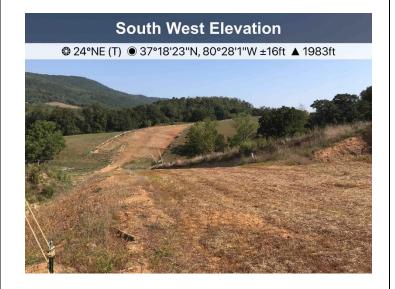
Fig. 2 Near ST11354+00 area has been stabilized with seed and mulch

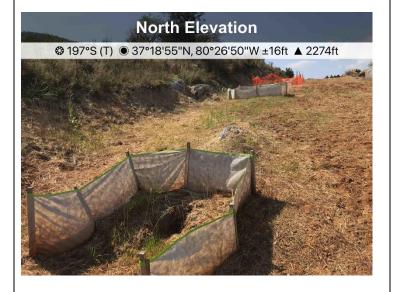
Fig. 3 Near MP 216.3 holes protected per DCR Will Orndorff.

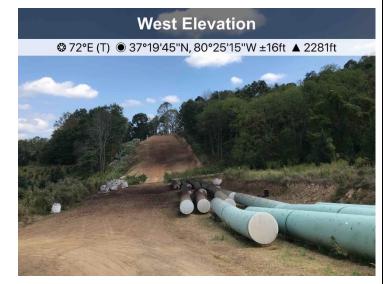
Fig. 4 Near St11524 stabilization has been applied by helicopter near the base Sinking Creek Mountain.
