## **FIELD INSPECTION**

Project Name:	Mountain Valley Pipeline	Inspector:	Marshall Willis
Inspection Date:	Thursday, August 29, 2019	Project Contact:	Brian Clauto, Cory Chalmers
Spread G: Giles County	STA 11023+80 - 11064+53 MVP-GI-244 MVP-GI-241.04	Weather (Wet/Dry/Rain):	Dry

## FIELD INSPECTION PHOTO LOG

Project Name: Mountain Valley Pipeline <u>Date</u>: Thursday, August 29, 2019

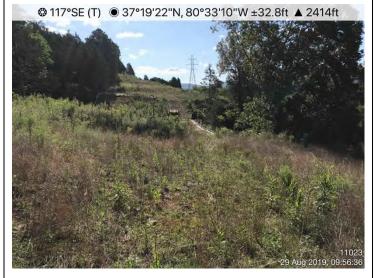
Fig. 1: **STA 11023+00** – Controls in place. Area stabilized with vegetation.

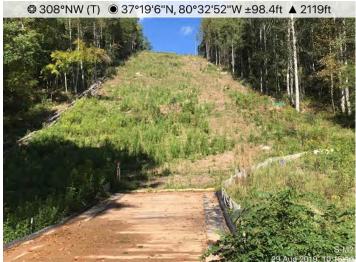
Fig. 2: **Stream S-IJ16B** – Controls in place. Area stabilized with vegetation.

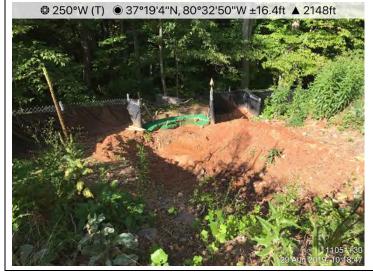
Fig. 3: STA 11051+30 – Sump needs maintenance.

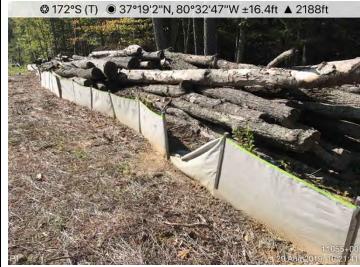
Fig. 4: **STA 11055+00** – P1 needs maintenance.
