## FIELD INSPECTION

<b>Project Name:</b>	Mountain Valley Pipeline	<b>Inspector:</b>	Matthew Grant
<b>Inspection Date:</b>	Tuesday, August 27, 2019	<b>Project Contact:</b>	Brian Clauto
<b>Spread: Montgomery County AR 258.02 MP218 11527-11550 Giles County GI-234 GI-240</b>	Spread G	<b>Weather (Wet/Dry/Rain):</b>	Rainy

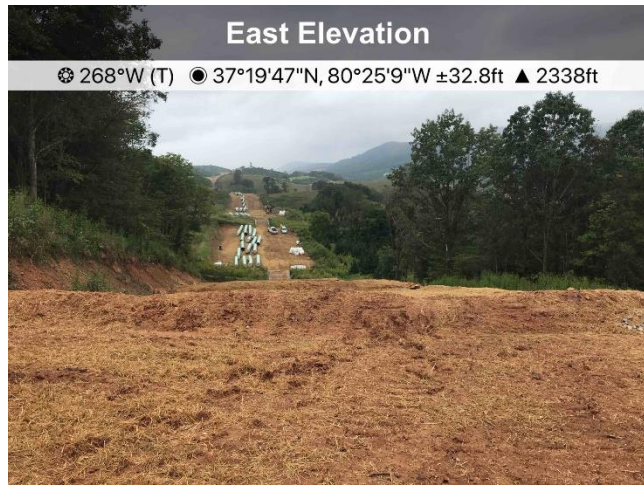
- Fig. 1 St11527+00 stabilization and ECD's are in place and functioning.

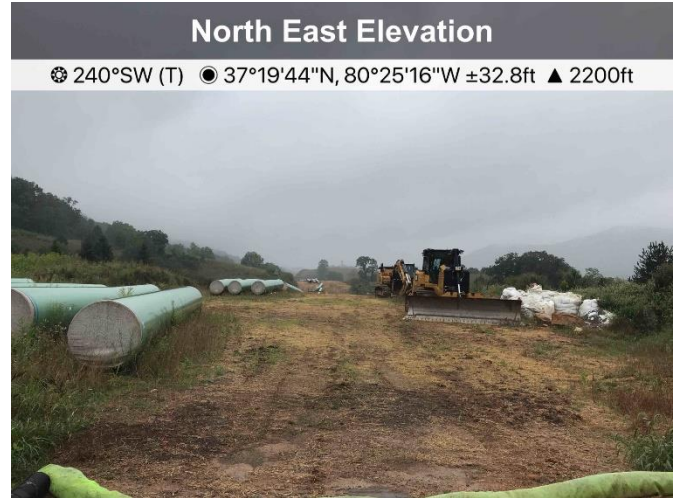
- Fig. 2 St11550+00 stabilization and ECD's are in place and functioning

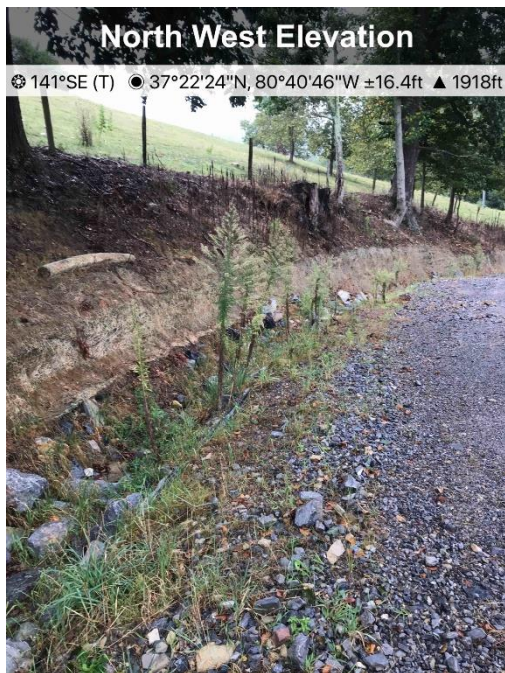
- Fig. 3 AR GI-234 rock lined channel

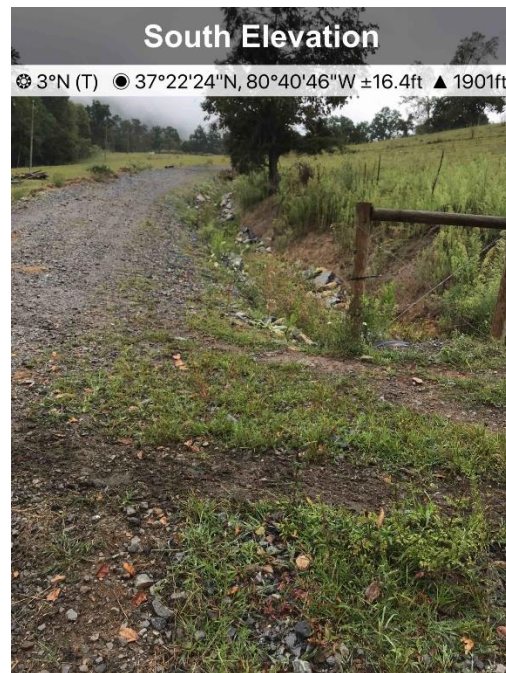
- Fig. 4 GI-234 rock lined channel
