FIELD INSPECTION

Project Name: Mountain Valley Pipeline Date: Wednesday, October 24, 2018

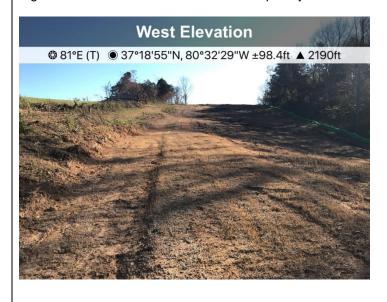
Fig. 3 St#11064+84-11073+00 is not adequately stabilized.
