VWP FIELD INSPECTION CHECKLIST

Project Name	Mountain Valley Pipeline Spread G, Giles County	VWP Permit #	N/A	Inspection Date	9/5/2018
Inspector Name	Nathan Hughes; Matt Grant	Phone # & Email Address	(804) 698-4026; Nathan.Hughes@deq.virginia.gov (804) 418-9874; Matthew.Grant@deq.virginia.gov		
Address or lat/long (if no permit no.)	Stream Crossing Q-14	Others Present During Inspection	N/A		
Project Phase	Land Clearing; Grading	Reason for Inspection	Construction		
PERMIT / REGULATORY REQUIREMENT		Yes/ No/ NA	Location, Description and Other Notes		
Unauthorized impacts to surface waters, including wetlands, or upland preservation areas have occurred . <i>(This includes sedimentation impacts due to inadequate or failed erosion controls.)</i>		Yes	Approximately 630 linear feet of stream channel has been impacted by sedimentation		
Non-impacted wetlands, streams and preservation areas within 50 feet of construction are clearly marked to prevent unpermitted impacts.		Yes

Site Name: Mountain Valley Pipeline_Spread G; Stream Q-14

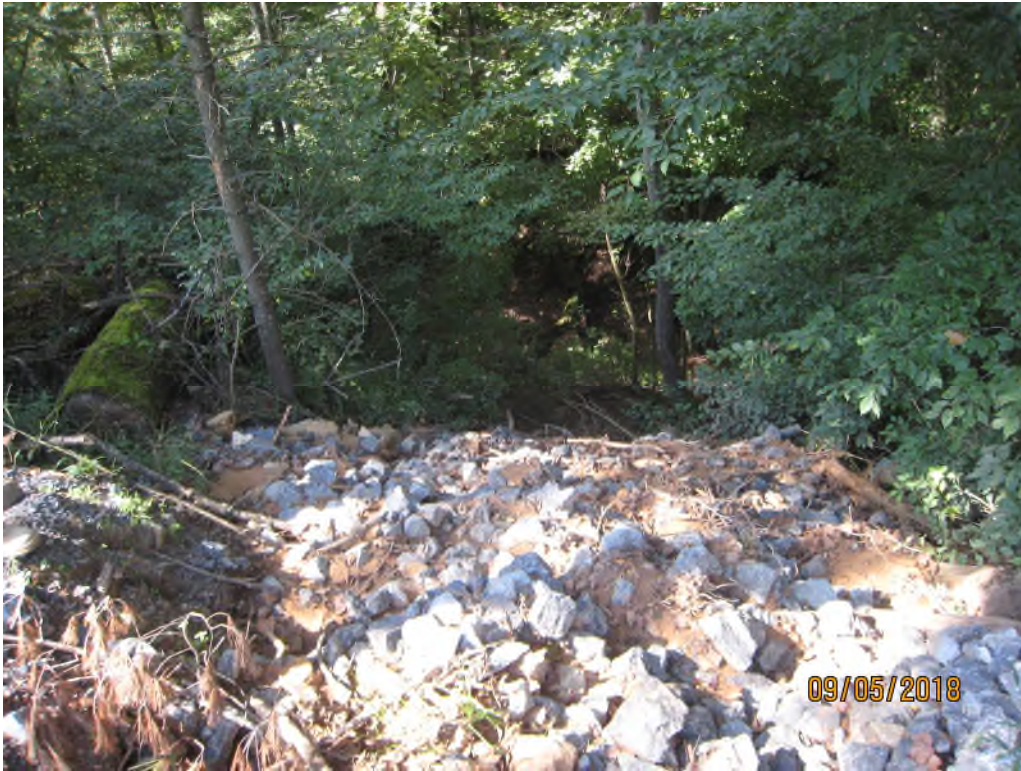
Photo 1: View from Access Road G/I 234 toward Kimballton Branch downslope of ESC failure
Orientation: N/A

1. Repair erosion and sediment controls in areas where needed;
2. Stabilize all slopes above and below perimeter controls;
3. Remove sediment from impacted stream channel using hand removal methods (buckets and shovels) and stabilize with appropriate seed mix where applicable.

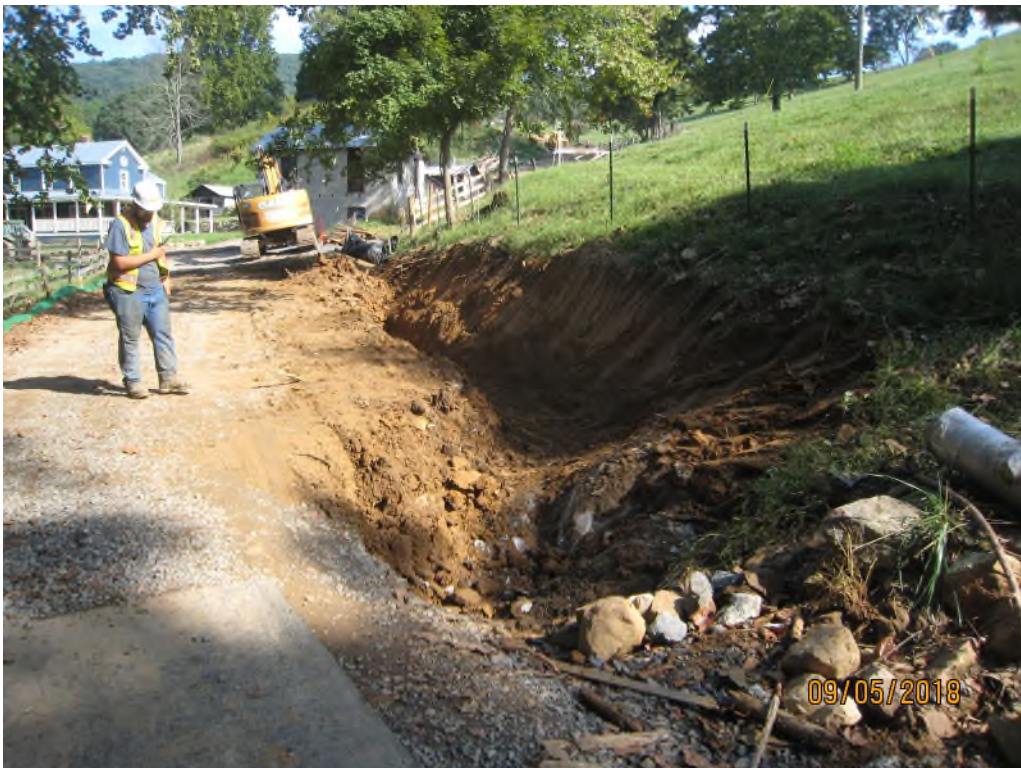
Photo 2: Access Road construction/maintenance near Photo 1
Orientation: Upslope

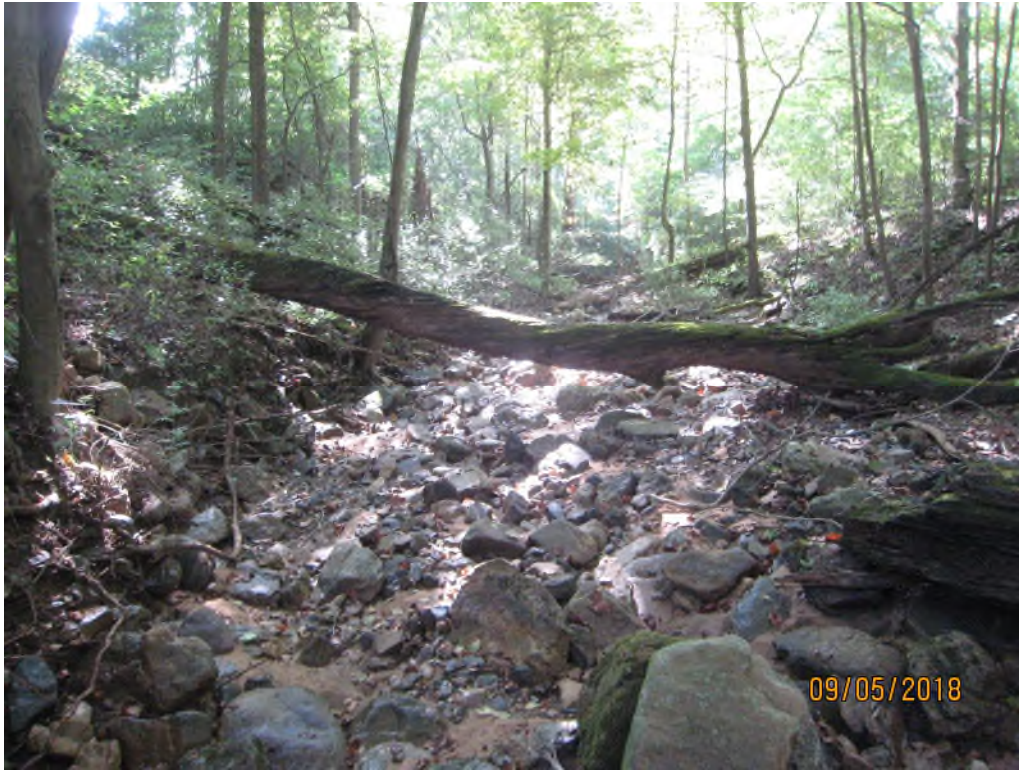
Approximately 630 linear feet of stream channel contained sediment ranging from <0.5-inch to a maximum depth of 9-inches was observed. No flow was present in the 10-12' wide channel at time of inspection. Sediment within the stream's thalweg was generally 3-inches in depth; sediment bars and pool deposition was generally >6-inches in depth. Landowner permission was not granted for Kimballton Branch downstream of Rogers Road culverts.

Photo 3: Sediment in stream approximately 50' downslope of Access Road G/I 234 Depth = 3"
Orientation: Downstream

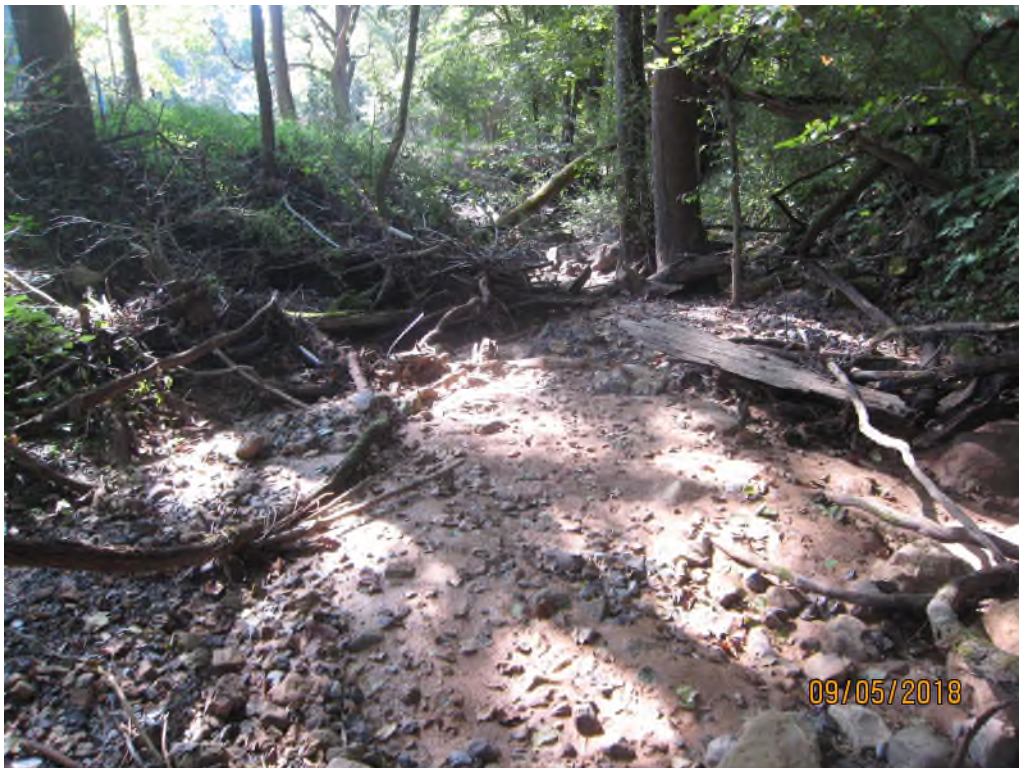
Photo 4: Sediment at debris dam approximately 400' downstream of Photo 1; Depth = 4"
Orientation: Downstream

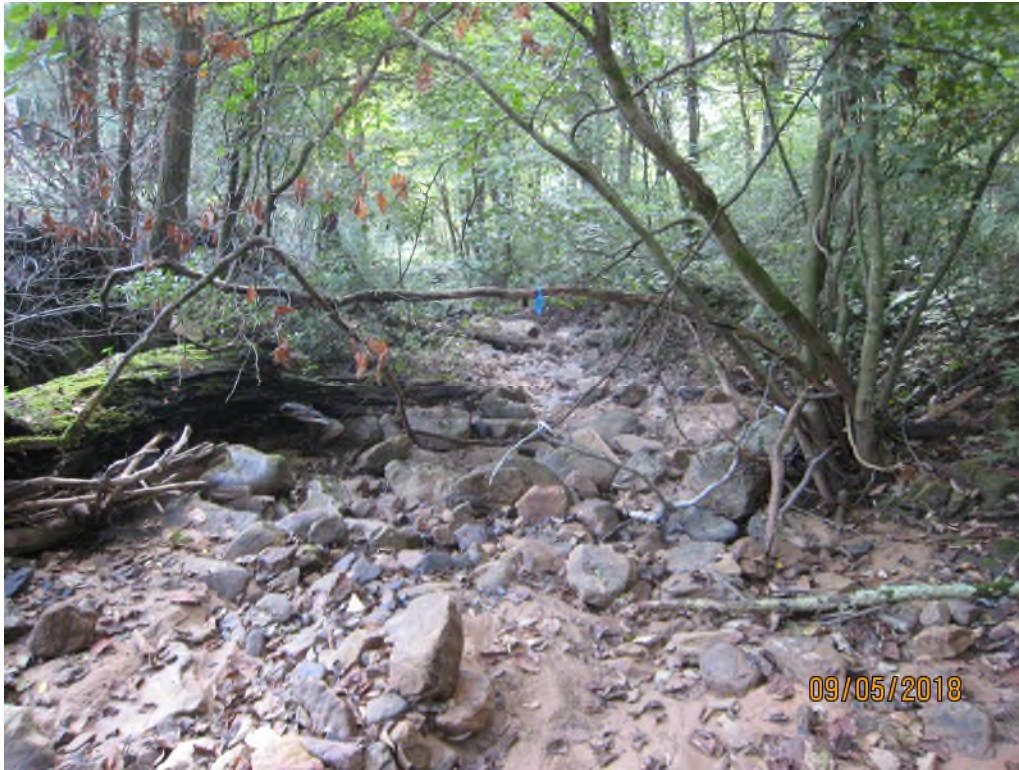
Photo 5: Sedimentation in channel 100' upstream of Rogers Road culverts; Depth = 8"
Orientation: Upstream

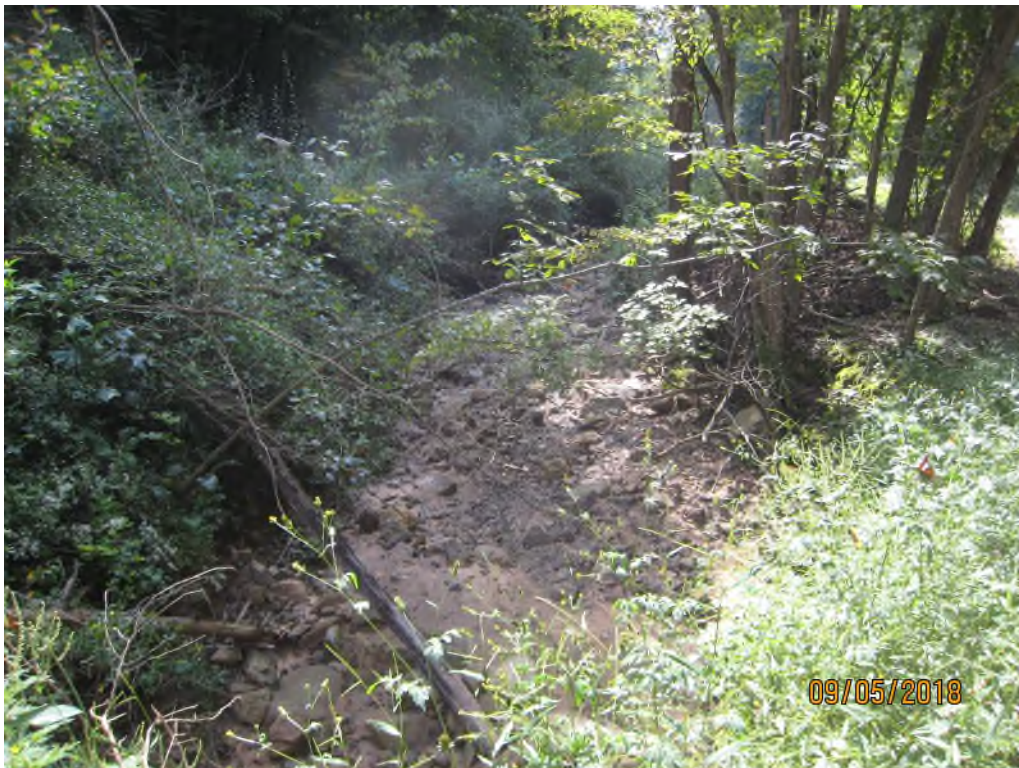
Photo 6: Sedimentation in channel downstream of Rogers Road culverts; no landowner permission
Orientation: Downstream
