VWP FIELD INSPECTION CHECKLIST

Project Name	Mountain Valley Pipeline Spread G, Giles County	VWP Permit #	N/A	Inspection Date	8/29/2018
Inspector Name	Nathan Hughes; Matt Grant	Phone # & Email Address	(804) 698-4026; Nathan.Hughes@deq.virginia.gov (804) 418-9874; Matthew.Grant@deq.virginia.gov		
Address or lat/long (if no permit no.)	Stream Crossing NN-12	Others Present During Inspection	N/A		
Project Phase	Land Clearing; Grading	Reason for Inspection	Construction		
PERMIT / REGULATORY REQUIREMENT		Yes/ No/ NA	Location, Description and Other Notes		
Unauthorized impacts to surface waters, including wetlands, or upland preservation areas have occurred .* <i>(This includes sedimentation impacts due to inadequate or failed erosion controls.)</i>		Yes	Approximately 600 linear feet of stream channel has been impacted by sedimentation		
Non-impacted wetlands, streams and preservation areas within 50 feet of construction are clearly marked to prevent unpermitted impacts.		Yes

Site Name: Mountain Valley Pipeline_Spread G; Stream NN-12

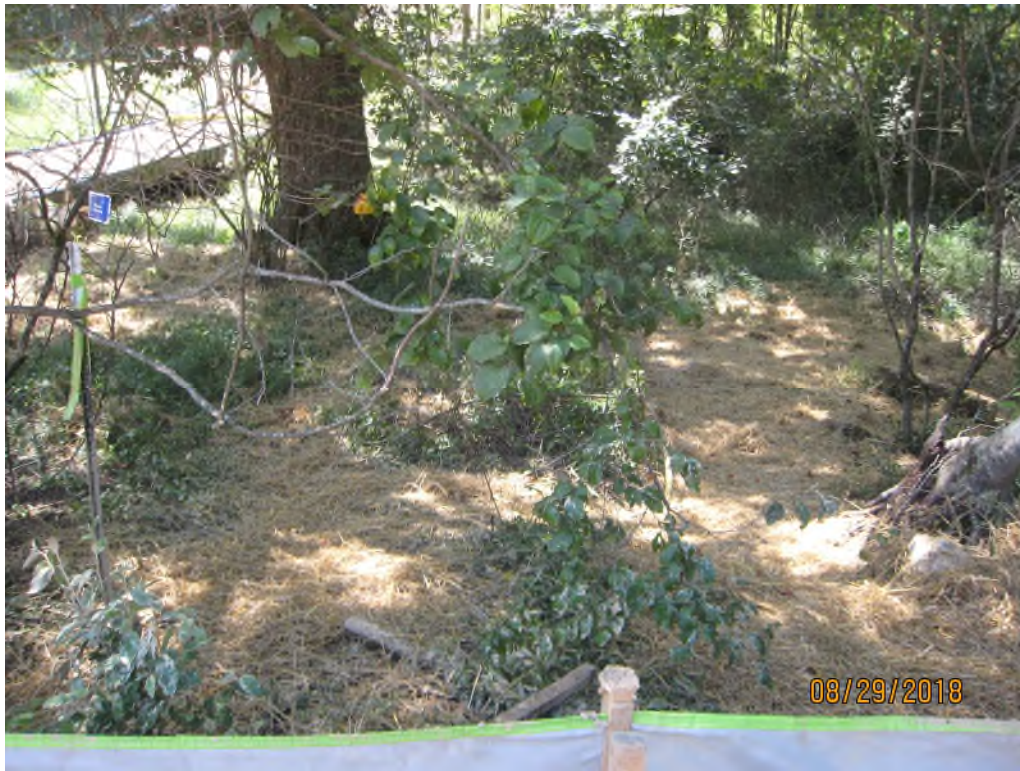
Photo 1: Seed/straw area within forested stream buffer downslope of ESC failure

1. Repair erosion and sediment controls in areas where needed;
2. Stabilize all slopes above and below perimeter controls;
3. Remove sediment from impacted stream channel using hand removal methods (buckets and shovels) and stabilize with appropriate seed mix where applicable.

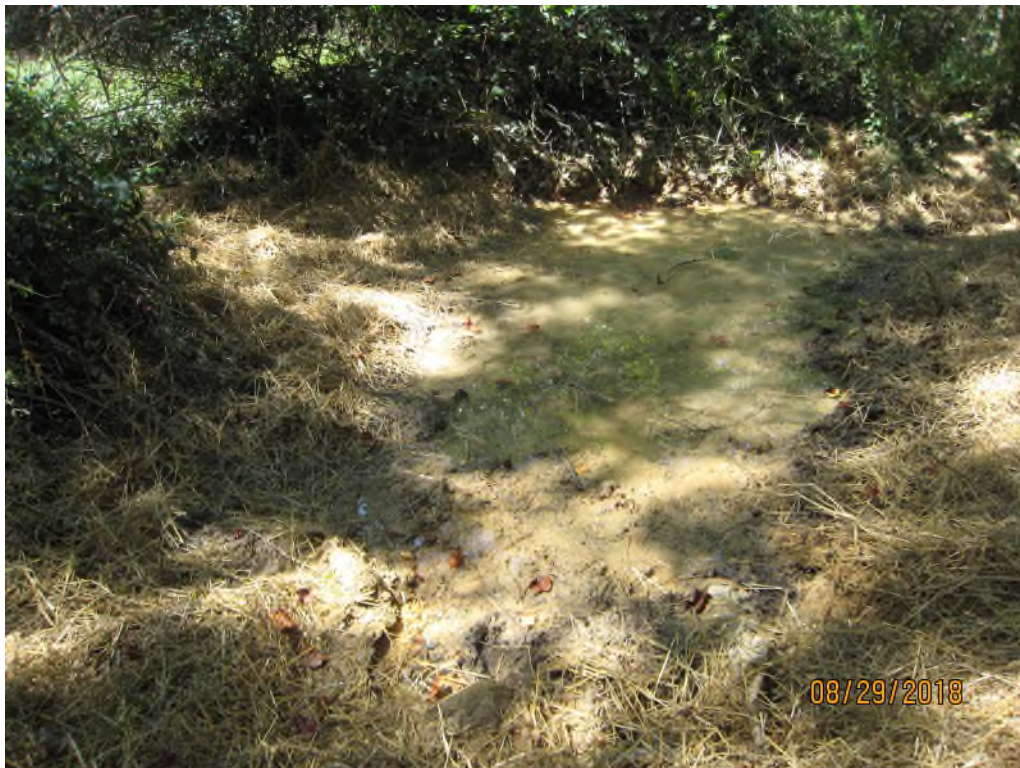
Photo 2: Sedimentation and seed/straw in small pool downslope of ESC failure
