COMPLAINT INSPECTION REPORT

Project Name:	Mountain Valley Pipeline	Inspector:	Marshall Willis
Inspection Date:	Wednesday, July 17, 2019	Project Contact:	Brian Clauto
Spread G: Giles County	STA 11353+67 – 11471+52	Weather (Wet/Dry/Rain):	Dry

FIELD INSPECTION PHOTO LOG

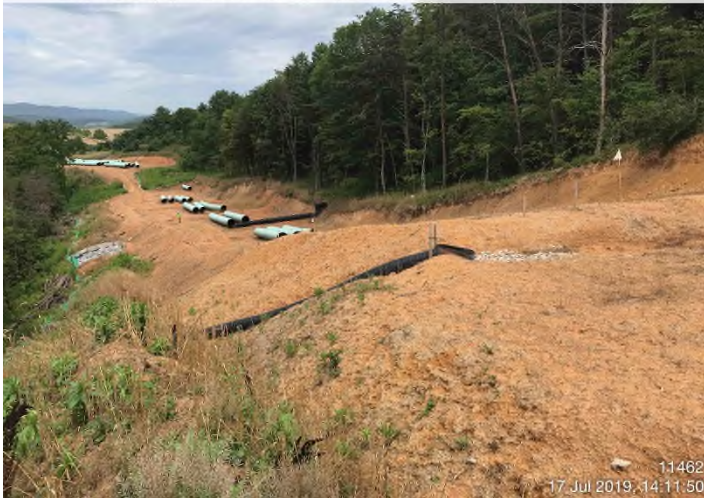
Fig. 1: **STA 11462+00** – Controls in place and functioning properly. Mobilization for re-stabilization occurring in the area.

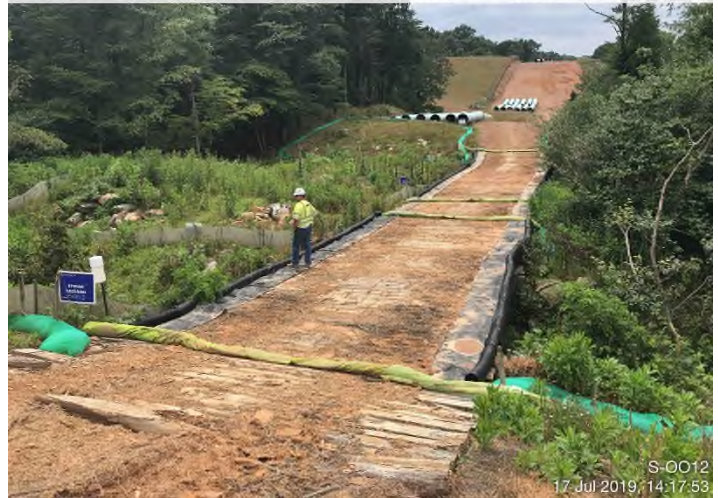
Fig. 2: **Stream S-0012** – Controls in place. Bridge clean with functioning sideboards and waddles.

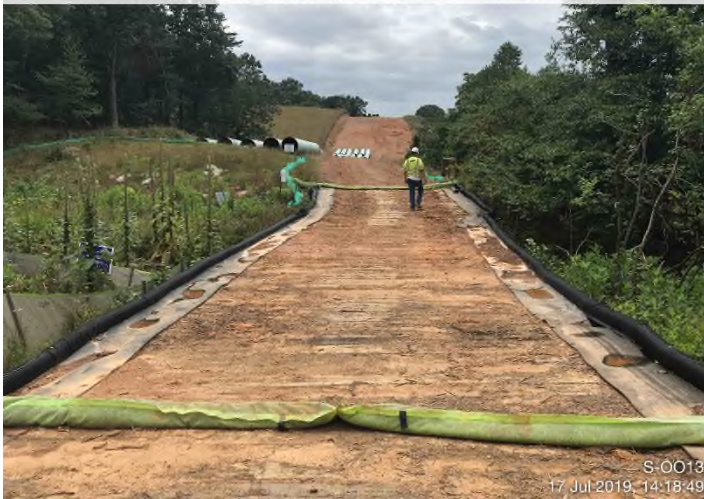
Fig. 3: **Stream S-0011** – Controls in place. Bridge clean with functioning sideboards and waddles.

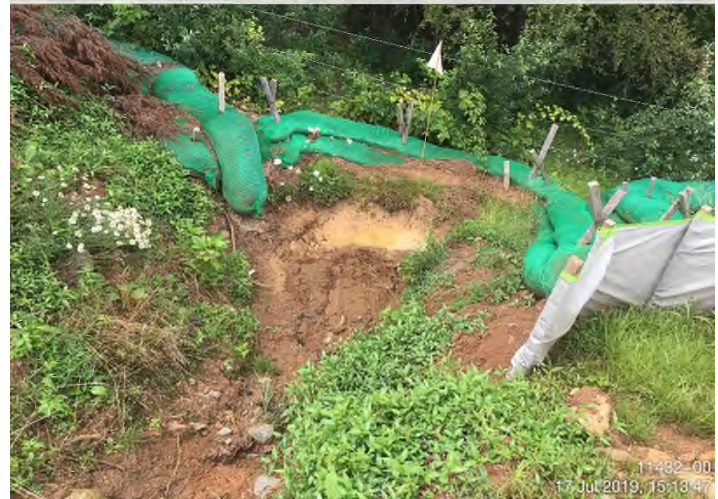
Fig. 4: **STA 11432+00** – Sump maintenance needed.

Recommended Corrective Action: Adequately re-stabilize ROW. Maintain and install all controls per the approved plan and specs.
