COMPLAINT INSPECTION REPORT

Project Name:	Mountain Valley Pipeline	Inspector:	Marshall Willis
Inspection Date:	Wednesday, July 31, 2019	Project Contact:	Brian Clauto
Spread H: Montgomery County	STA 12180+00 – 12200+00 ATWS 703, ATWS 704A, ATWS 1446 & ATWS 1375 MVP-MN-275/274	Weather (Wet/Dry/Rain):	Wet

Background: This investigation was conducted in response to a complaint (IR#: 291656) received on July 30, 2019 for the Bradshaw Creek area. The complaint describes sediment runoff below MVP ROW on Bradshaw Road and into Bradshaw Creek. The complainant also described the condition of Bradshaw Creek as “clear upstream but has high turbidity near pipeline ROW.”

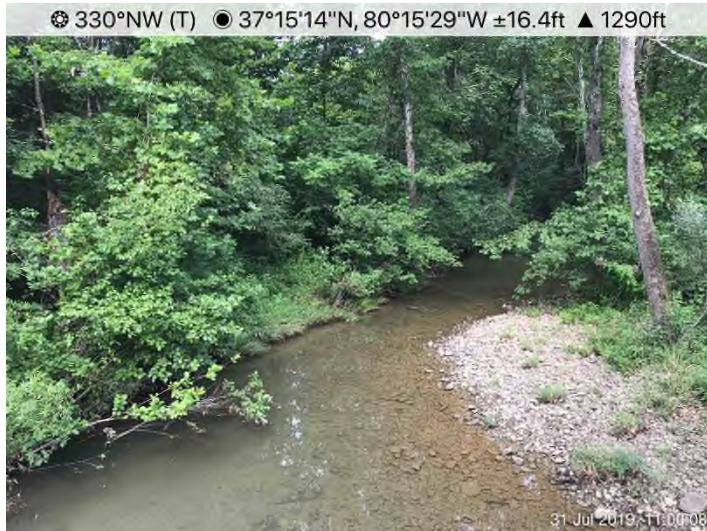
4. There was no evidence of high turbidity upstream or downstream of the MVP crossing of Bradshaw Creek (S-C21). See Figures 1, 5, 7, 8 and 12.
5. Minor sedimentation was observed deposited in the riprap channel of Stream S-OO11 starting at STA 12197+73. Source of the sediment is likely a combination of turbid water discharged through MVP ECDs during high intensity rainfall events and previous runoff from the Roanoke Valley Resource Authority (RVRA) property (See Figures 13, 14, 15, 16 & 17).

Fig. 1: Upstream Bradshaw Creek – 0.2 miles north of MVP ROW on Bradshaw Road.

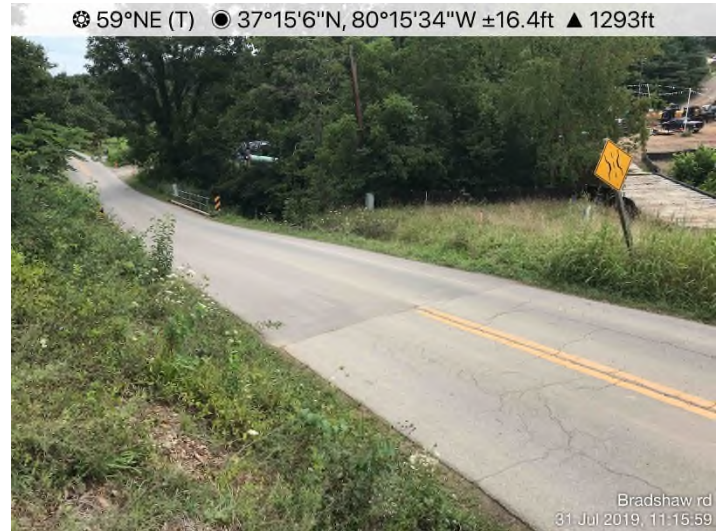
1. At the time of inspection, there was no evidence of sediment discharge from MVP ROW onto Bradshaw Road or into Bradshaw Creek. See Figures 2, 3, 4 & 5.

Fig. 2: STA 12190+75 – Bradshaw Road crossing. No evidence of sediment discharge from ROW.

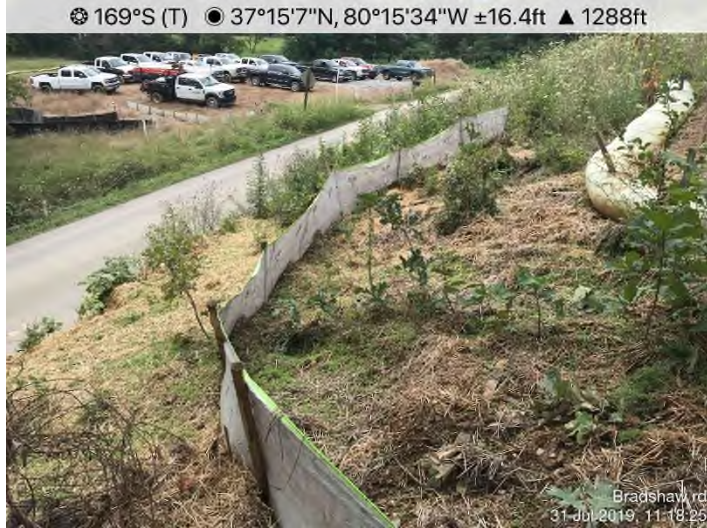
Fig. 3: STA 12190+75 – Bradshaw Road crossing. No evidence of sediment discharge from ROW. Controls functioning and area stabilized.

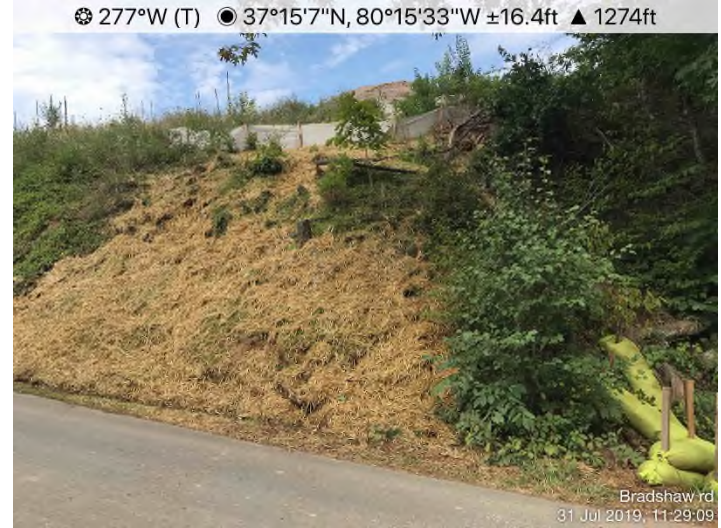
Fig. 4: STA 12190+95 – Bradshaw Road crossing. No evidence of sediment discharge from ROW. Slope stabilized.

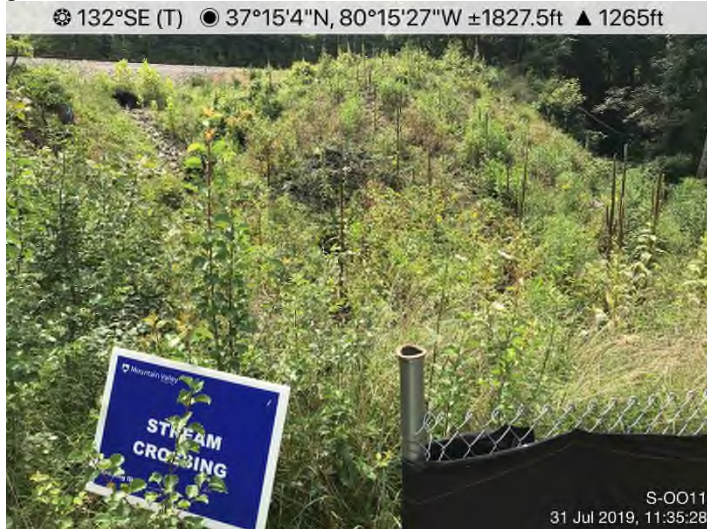
Fig. 9: **STA 12195+50** – Stream S-OO11 on the west side of Roanoke Valley Resource Authority (RVRA) tracks. No ground disturbance.

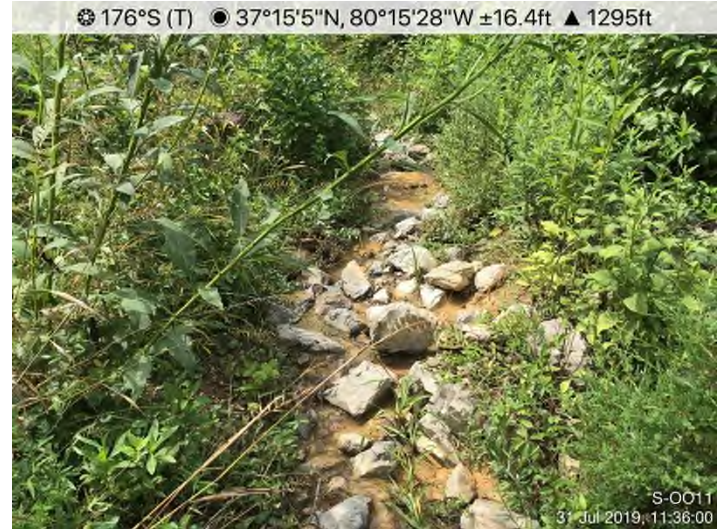
Fig. 10: **Stream S-OO11** – Sediment deposition in riprap channel of S-OO11 on west side of RVRA tracks at approx. STA 12196+24.

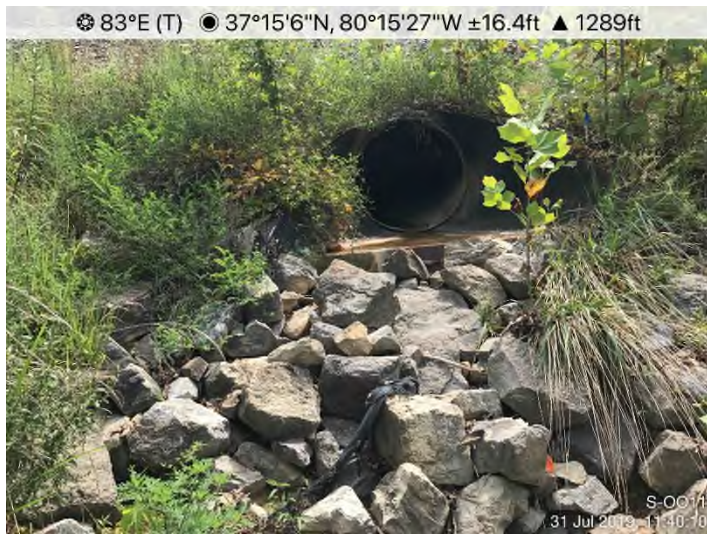
Fig. 11: **Stream S-OO11** – Outfall of S-OO11 on west side of RVRA tracks at approx. STA 12497+00

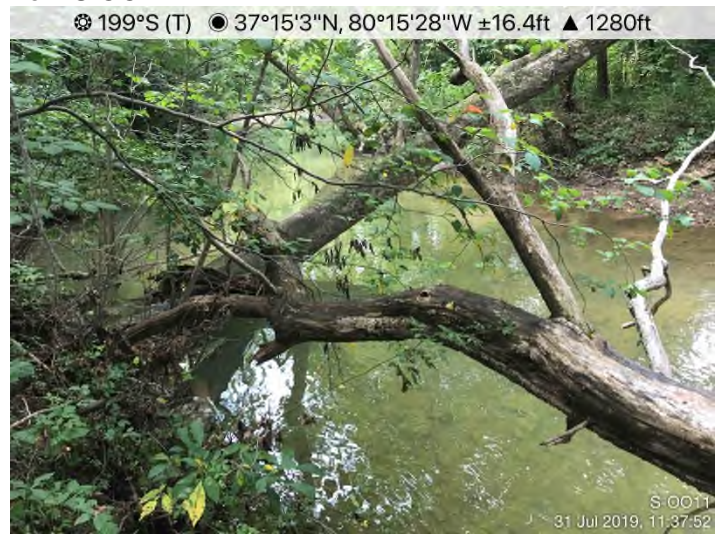
Fig. 12: **Bradshaw Creek** – Downstream of the confluence of S-OO11 and Bradshaw Creek. No increased turbidity from S-OO11.

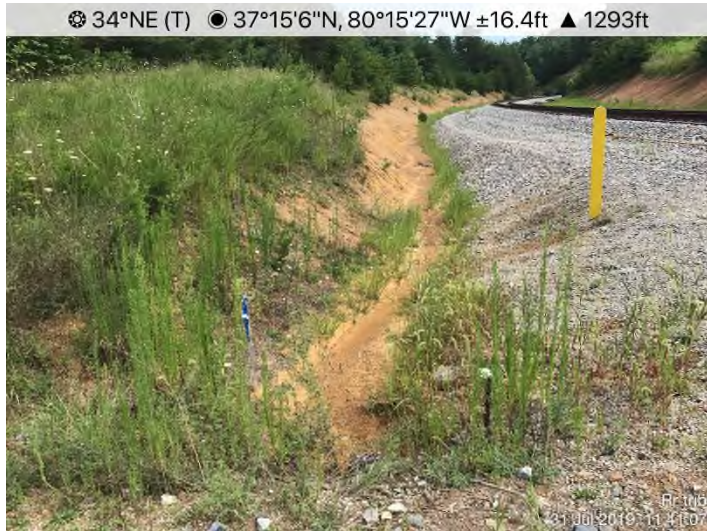
Fig. 13: MVP-MN-275 – RVRA west track swale leading to S-OO11 north side of access road MVP-MN-275.

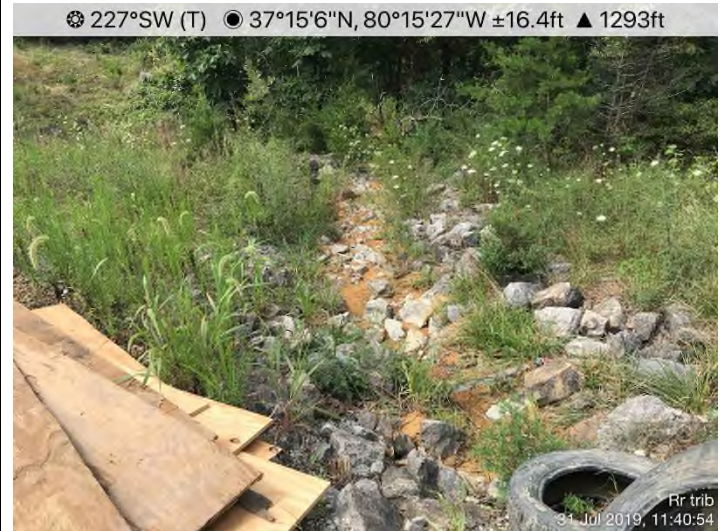
Fig. 14: MVP-MN-275 – Minor sediment accumulation in RVRA west track swale leading to S-OO11 south side of access road MVP-MN-275.

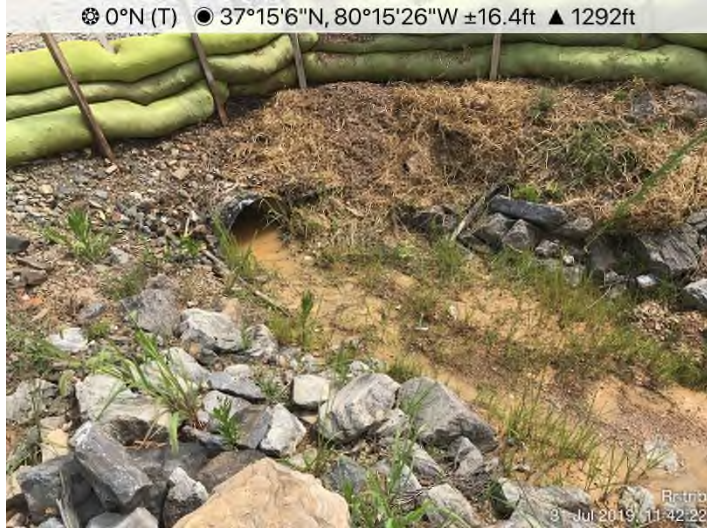
Fig. 15: MVP-MN-275 – RVRA east track swale leading to S-OO11 south side of access road MVP-MN-275. Sediment accumulation evident in culvert and swale.

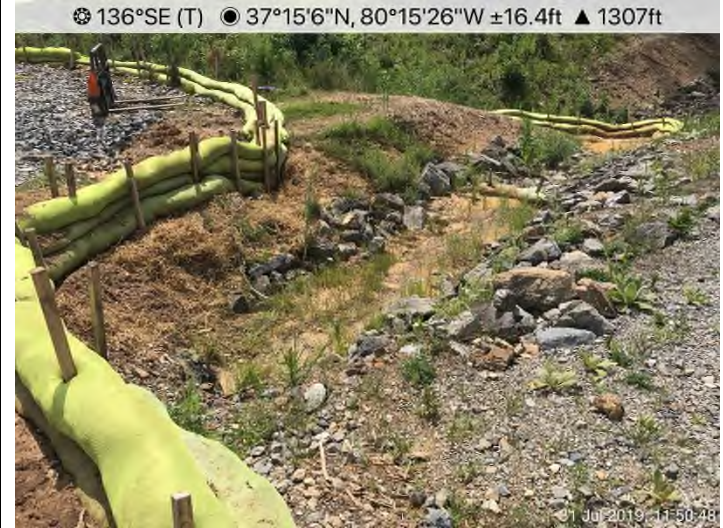
Fig. 16: MVP-MN-275 – Sediment accumulation in RVRA east track swale leading to S-OO11 south side of access road MVP-MN-275.

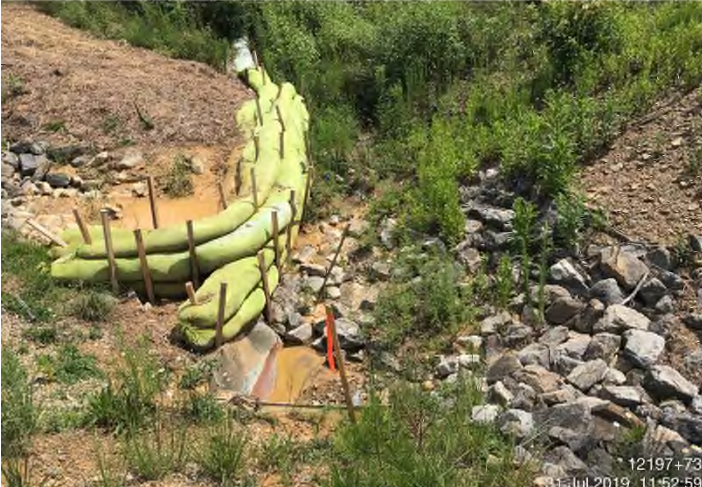
Fig. 17: **S-0011** – RVRA east track swale confluence with S-0011 south side of access road MVP-MN-275 at STA 12197+73. MVP controls in place and functioning. Minor sediment passing through ECDs into riprap of S-0011.

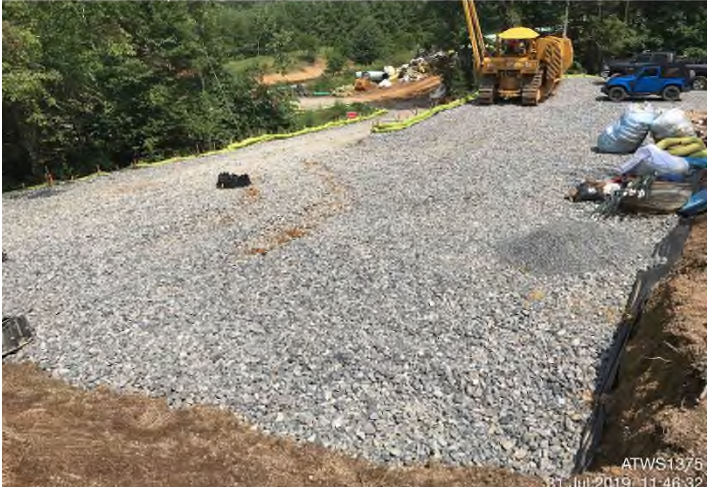
Fig. 18: **ATWS 1375** – Workspace stabilized with clean stone. Controls in place and functioning properly.

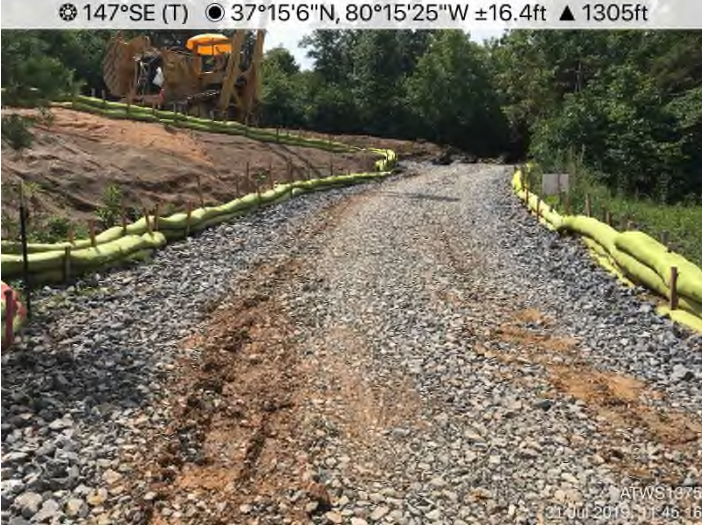
Fig. 19: **ATWS 1375** – Controls in place above S-0011 in ATWS 1375. Stone is clean and perimeter controls in place and functioning.

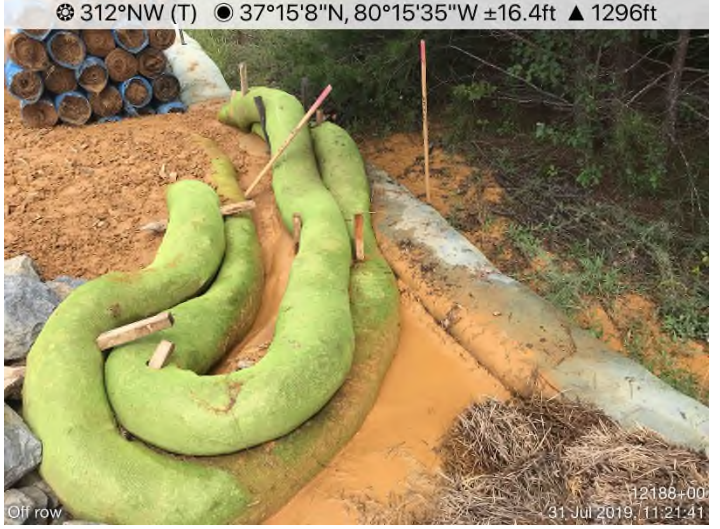
2. ECDs within the MVP LOD and along the resources were installed per the approved plans and appeared to be functioning as designed.
3. Sediment off ROW was found at STA 12188+00 (see Figure 20), however there were no impacts to Bradshaw Creek as a result.

STA 12188+00: Sediment off ROW.

Fig. 20: **STA 12188+00** – Sediment off ROW.

Recommended Corrective Action: Retrieve/stabilize sediment loss at STA 12188+00.
