COMPLAINT INSPECTION REPORT

Project Name:	Mountain Valley Pipeline	Inspector:	Marshall Willis
Inspection Date:	Tuesday, July 23, 2019	Project Contact:	Brian Clauto
Spread H: Montgomery County	STA 12180+00 – 12200+00 ATWS 703, ATWS 704A, ATWS 1446 & ATWS 1375 MVP-MN-275/274	Weather (Wet/Dry/Rain):	Rainy

FIELD INSPECTION PHOTO LOG

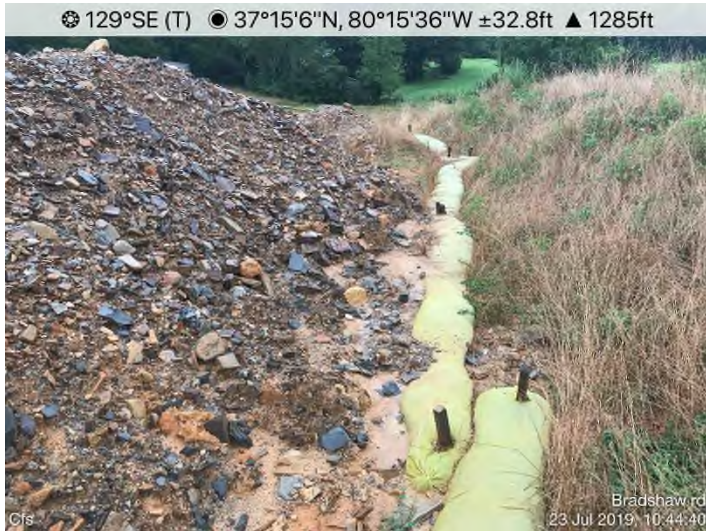
Fig. 1: **STA 12190+00** – CFS maintenance needed.

- STA 12190+00: Maintain CFS.
- STA 12190+00: Maintain CFS.
- STA 12188+00: Add ECDs at AEP Access from LOD.
- STA 12182+44: Maintain CFS.
- STA 12199+21: Repair Secondary Containment Structure.
- ATWS 1375: Clean/Top-Dress Access Road to ATWS 1375.
- ATWS 1375: Stabilize ATWS 1375. Use clean stone and fabric underlayment if area is needed for active construction.

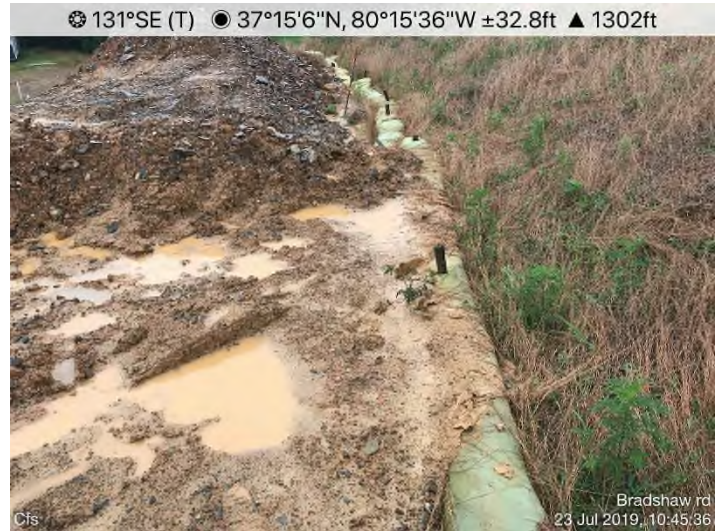
Fig. 2: **STA 12190+00** – CFS maintenance needed.

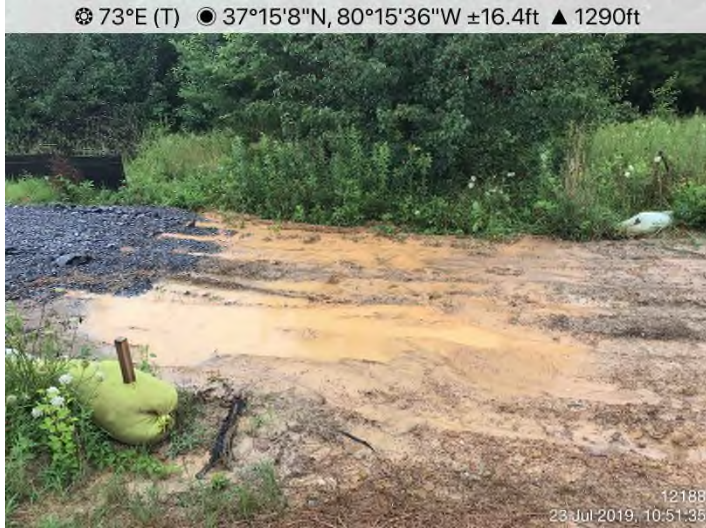
Fig. 3: **STA 12188+00** – ECDs needed between AEP entrance and MVP ROW.

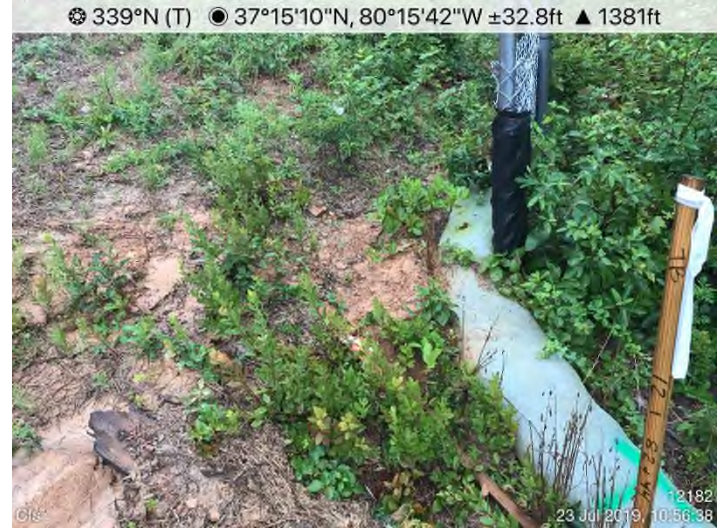
Fig. 4: **STA 12182+44** – CFS maintenance needed.

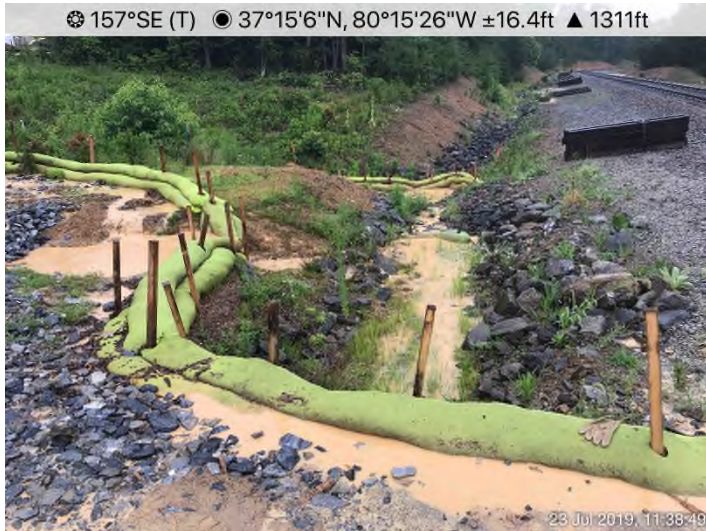
Fig. 9: **MVP-MN-275** – Sediment laden water from ATWS 1375 going through ECDs and into stream S-OO11.

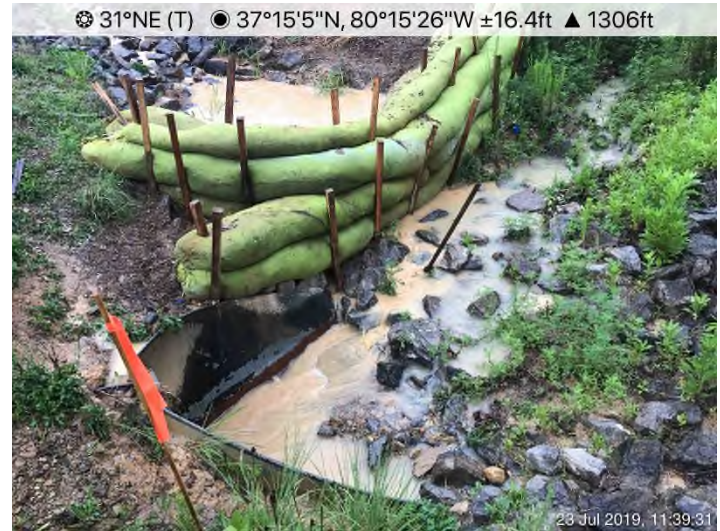
Fig. 10: **MVP-MN-275** – Sediment laden water from ATWS 1375 going through ECDs and into stream S-OO11.

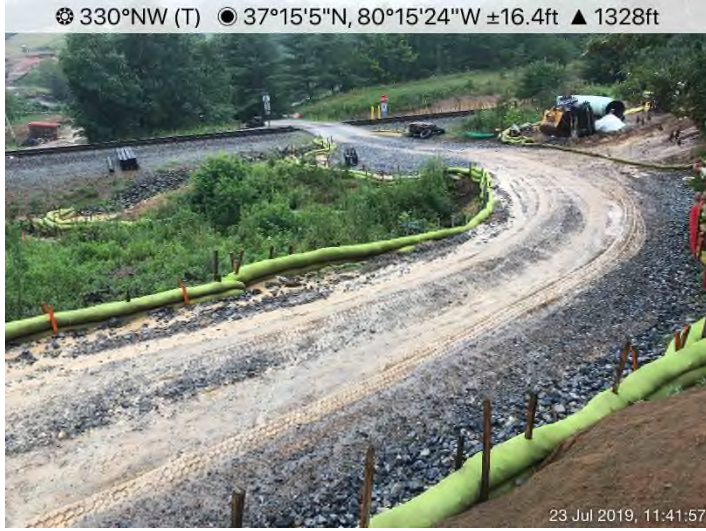
Fig. 11: **ATWS 1375** – Looking NW from ATWS 1375 towards stream S-OO11. Stone needs refreshing/top-dressing.

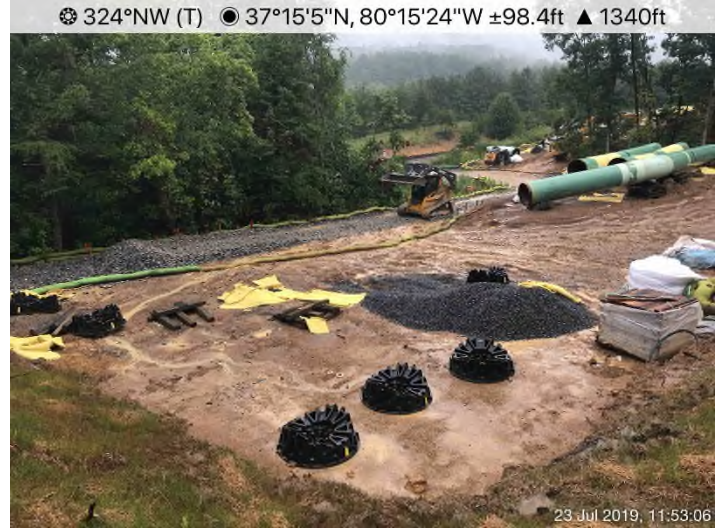
Fig. 12: **ATWS 1375** – Stabilize ATWS 1375.
