FIELD INSPECTION

Project Name:	Mountain Valley Pipeline	Inspector:	Marshall Willis
Inspection Date:	Monday, August 5, 2019	Project Contact:	Brian Clauto, Cory Chalmers
Spread G: Giles County	STA 11420+00 – 11471+52 MVP-CR-258.01	Weather (Wet/Dry/Rain):	Dry

FIELD INSPECTION PHOTO LOG

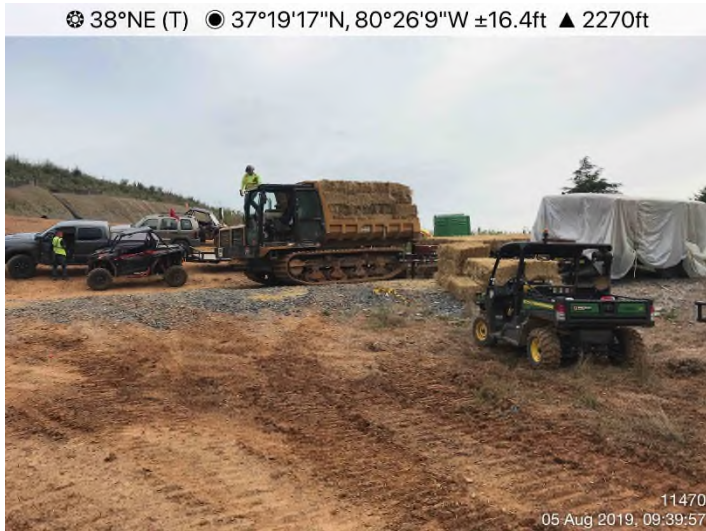
Fig. 1: **STA 11470+00** – Staging area for re-stabilization efforts at MVP-CR-258.01.

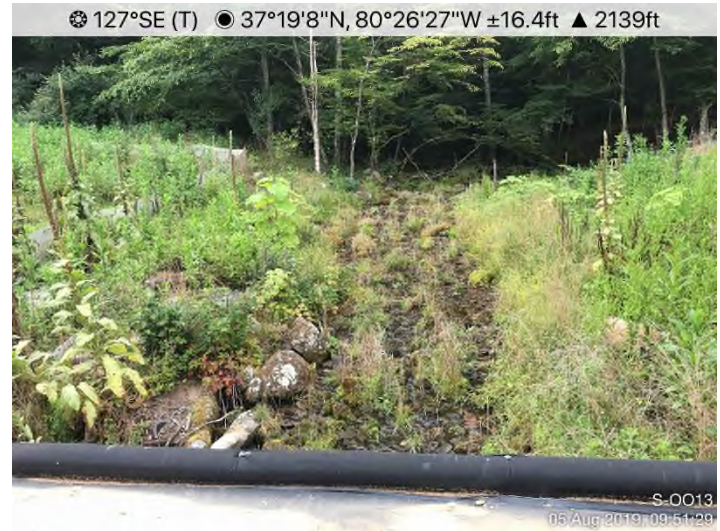
Fig. 2: **Stream S-0013** – Perimeter controls in place. Sideboards installed and functioning properly.

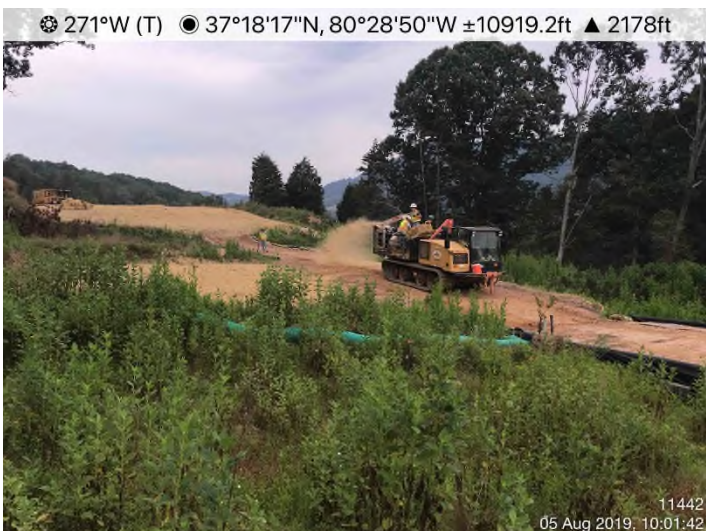
Fig. 3: **STA 11442+00** – Controls in place. Active re-stabilization efforts of straw and millet.

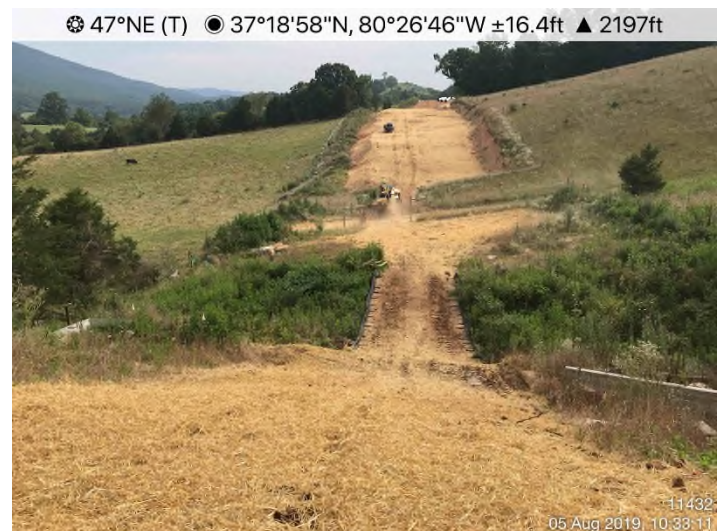
Fig. 4: **STA 11432+00** – Controls in place. Area re-stabilized with millet and straw.
