## FIELD INSPECTION

<b>Project Name:</b>	Mountain Valley Pipeline	<b>Inspector:</b>	Matthew Grant
<b>Inspection Date:</b>	Tuesday, July 30, 2019	<b>Project Contact:</b>	Cory Chalmers
<b>Spread: Giles County MP215 AR GI256 St11354-11385 Montgomery Co. MP223-225 St11788-11900</b>	<b>Spread G</b>	<b>Weather (Wet/Dry/Rain):</b>	<b>Dry</b>

# FIELD INSPECTION PHOTO LOG

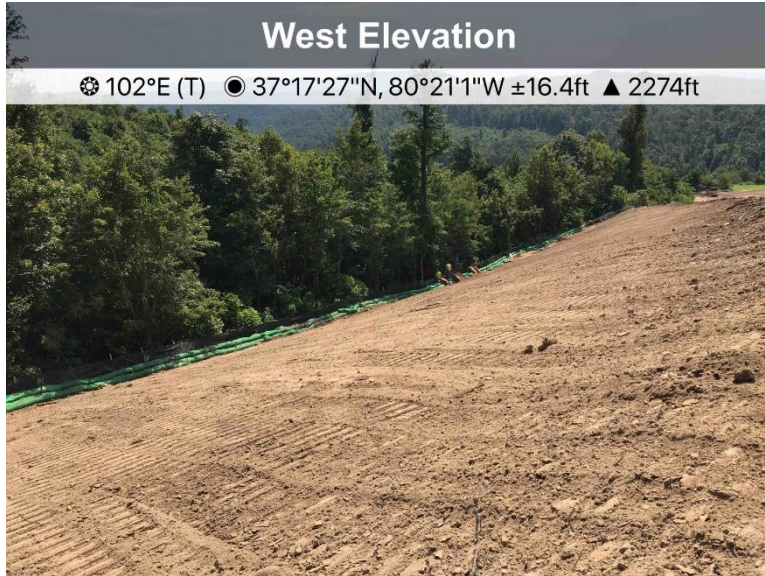
- Designated stream inspected included: SKL-43, S-NN12, S-NN13. ECD controls were in place and functioning at crossings.
- Stabilization completed from St11354+00 through 11385+00 at the time of inspection, remaining stabilization required to 11472. Stabilization issue was noted for corrective action on 7-17-19, with a current deadline date of 8-8-19. MVP staff was on site during the inspection conducting stabilization methods.
- Sediment was being removed off the ROW at St117833, at the time of the inspection.

Fig. 1. Sediment was being removed at the time of the inspection at St 117833.

**Recommended Corrective Action:** Maintain all controls per the approved plan and specs, remove escaped sediment per DEQ approval.

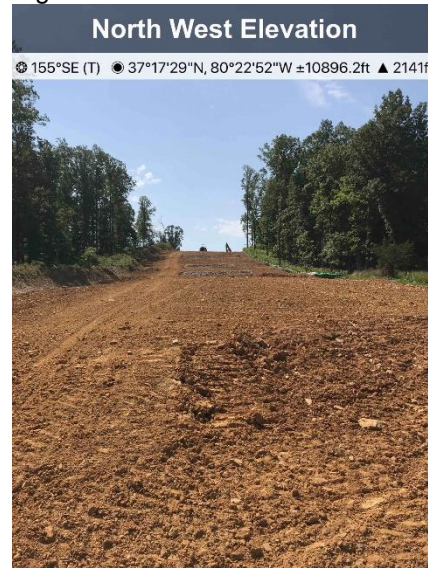
Fig. 2. Final stabilization efforts at St117818.

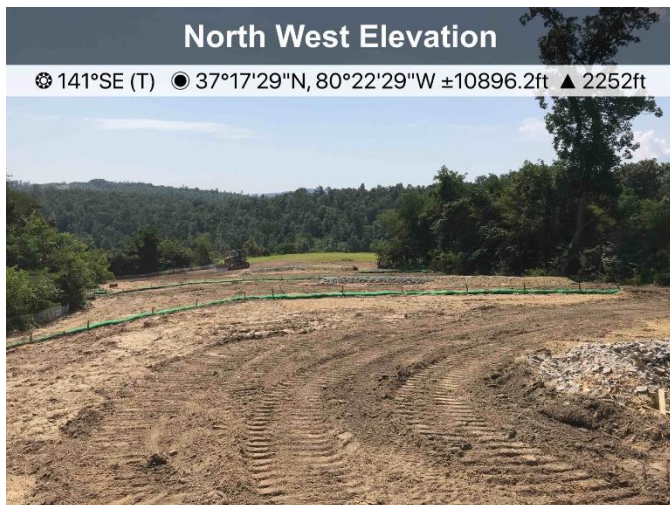
Fig. 3. Final stabilization efforts at St117838.

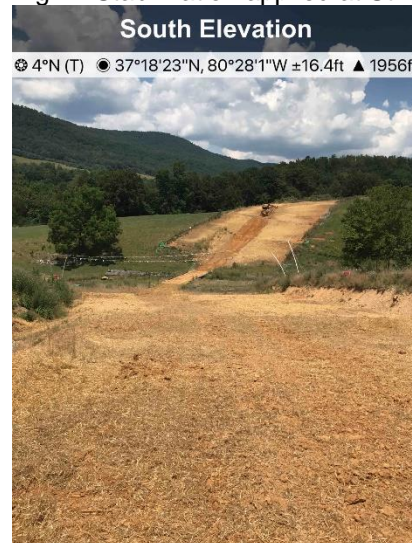
Fig. 4. Stabilization applied at St11354
