FIELD INSPECTION

Project Name:	Mountain Valley Pipeline	Inspector:	Matthew Grant
Inspection Date:	Thursday, June 27, 2019	Project Contact:	Brian Clauto
Spread: Giles County MP207-208 AR244 St11023-10964	Spread G	Weather (Wet/Dry/Rain):	Dry

FIELD INSPECTION PHOTO LOG

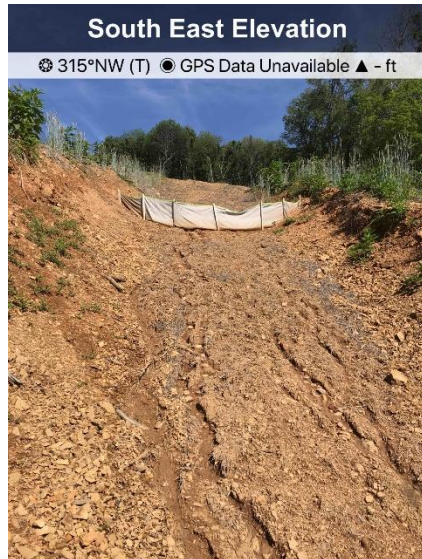
- Designated streams inspected included: S-R5, S-IJ18. ECD controls were in place at crossings.
- St11014+00 rill erosion has occurred and waterbar has sediment build up in flow path.
- St11014+00 waterbar flow path requires maintenance
- MP207.9 waddle at bridge requires maintenance
- St10964 sump requires maintenance

- Fig. 1. St11014+00 rill erosion has occurred

Recommended Corrective Action: Maintain all controls per the approved plan and specs

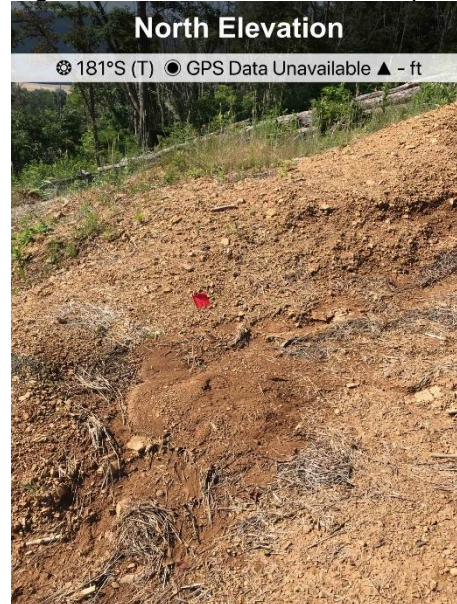
- Fig. 2. St11014+00 waterbar flow path requires maintenance

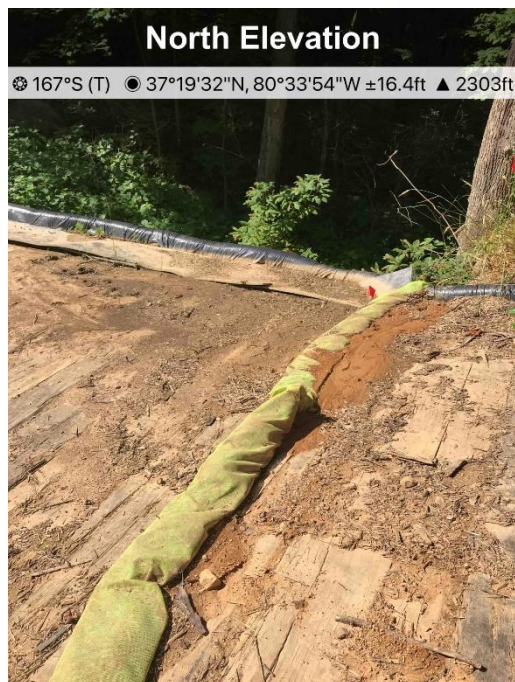
- Fig. 3. MP207.9 waddle at bridge requires maintenance.

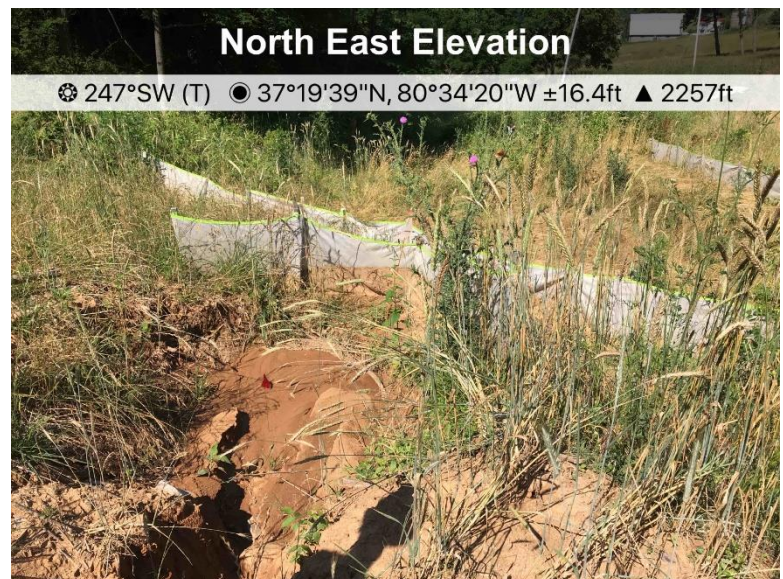
- Fig. 4. St10964 sump requires maintenance
