FIELD INSPECTION

FIELD INSPECTION PHOTO LOG

Project Name: Mountain Valley Pipeline Date: Wednesday, May 22, 2019

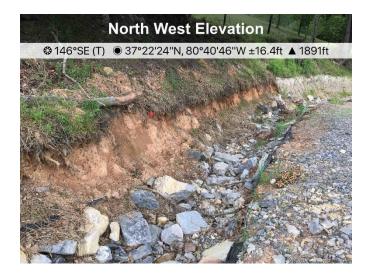
FIELD INSPECTION			
Project Name:	Mountain Valley Pipeline	Inspector:	Matthew Grant
Inspection Date:	Wednesday, May 22, 2019	Project Contact:	Brian Clauto
Spread: Giles County AR GI-234 Montgomery County MP221-222 St11669-11766	Spread G	Weather (Wet/Dry/Rain):	Dry
STAGE OF CONSTRUCT	ION: (Check all that apply)		
Clearing	Rough Grading	Trench Excavation	Pipe Assembly, Testing & Installation
Backfilling and Grade	e Restoration	& Stabilization	Other: Dormant
		Yes No N/A	
	d and implemented in accordance with that control plan and stormwater management		
2 condition in accorda	sures properly maintained in effective oper ance with good engineering practices and, aturer specifications?		
	ment deposition were observed?		
Comments: Streams inspected included: MN-21, MN-22, EF65, EF-62. ECD's were in place at all streams inspected and no impacts were observed.			
AR GI-234 ditch slope requires stabilization.

Fig. 1 AR GI-234 ditch slope requires stabilization.

St#11704+14 Sump and waterbar requires maintenance.			
Recommended Corrective Action: Maintain all controls per the approved plan and specs.			
Deadline: _Within 24hr notification			
The recommended corrective action deadline date applies to all conditions noted on this report unless otherwise noted. If listed condition(s) currently constitute non-compliance and/or corrective actions are not completed by the deadline, other enforcement actions may be issued to the entity responsible for ensuring compliance on the above project.			
Inspector Signature: Date: _6-17-19

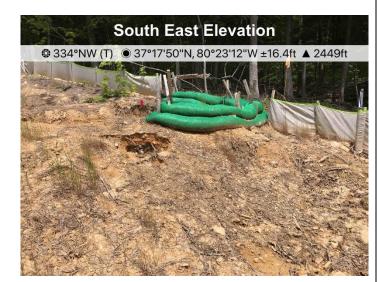
Fig. 2 St11704+14 sump and waterbar requires maintenance.
