FIELD INSPECTION

Project Name:	Mountain Valley Pipeline	Inspector:	Marshall Willis
Inspection Date:	Thursday, May 2, 2019	Project Contact:	Brian Clauto
Spread G: Giles County	STA 10929+62 – 11151+27	Weather (Wet/Dry/Rain):	Dry

FIELD INSPECTION PHOTO LOG

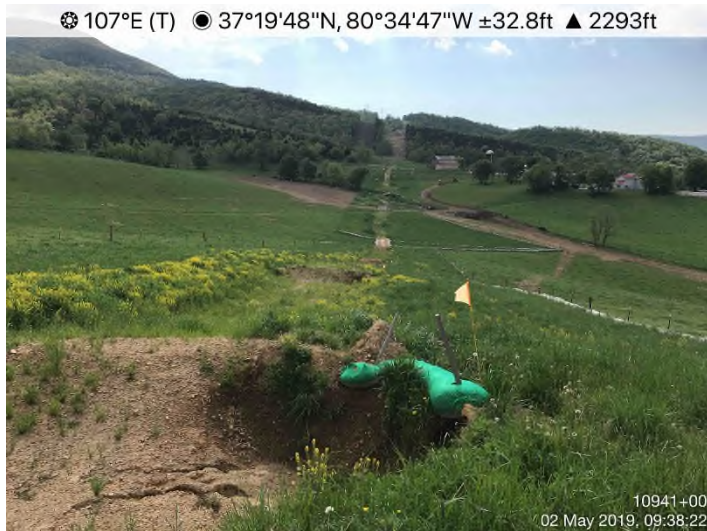
Fig. 1: STA 10941+00 – Controls in place. Area stabilized.

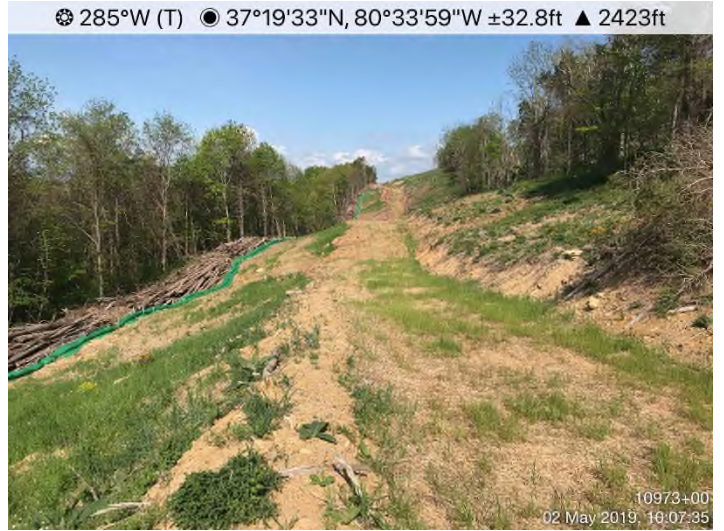
Fig. 2: STA 10973+00 – Controls in place. Area stabilized.

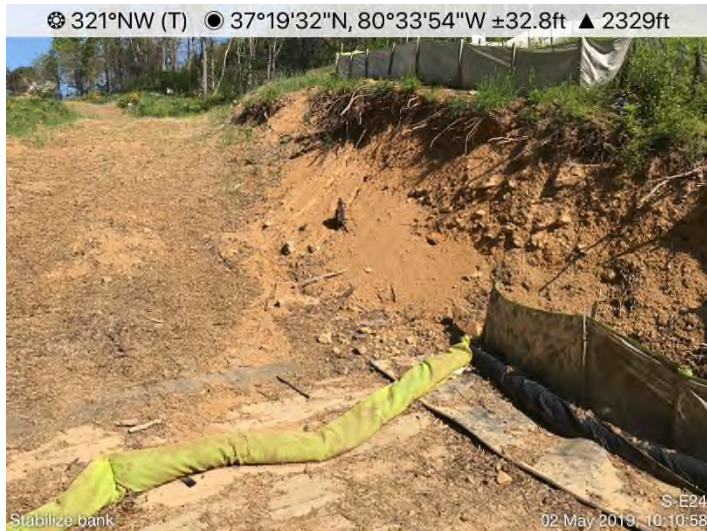
Fig. 3: STA 10985+50 – Stabilize erosion CIS stream S-E24.

- STA 10985+50 – Stabilize bank on CIS of S-E24.
- STA 11046+00 to 11049+00 – Install end treatments per PSS&S.
- STA 11119+00 – Clean out sump, install end treatment per PSS&S.
- STA 11120+00 – Repair waterbar.

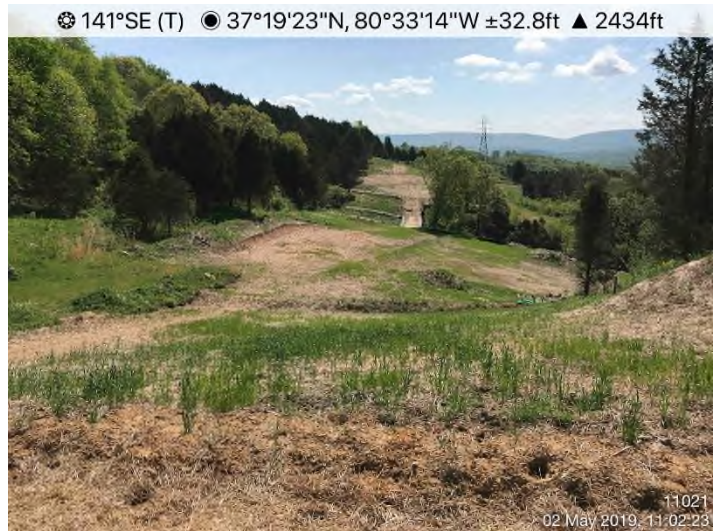
Fig. 4: STA 11021+00 – Controls in place. Area stabilized.

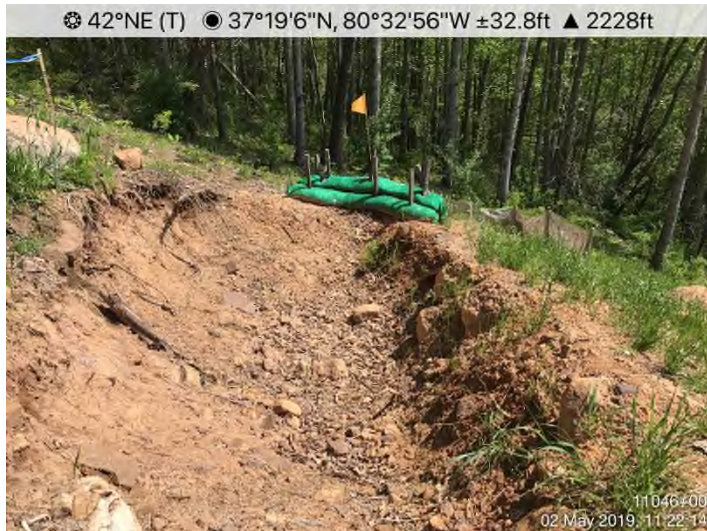
Fig. 5: STA 11046+00 to 11049+00 – End treatments not installed per PSS&S.

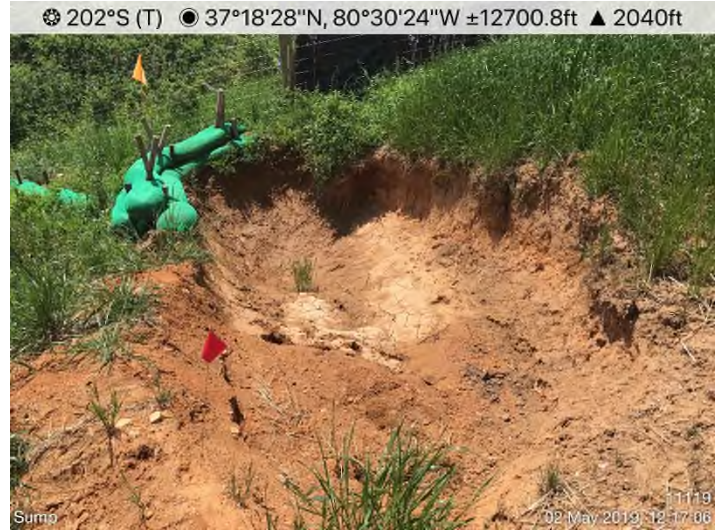
Fig. 6: STA 11119+00 – Sump maintenance needed. End treatment not installed per PSS&S.

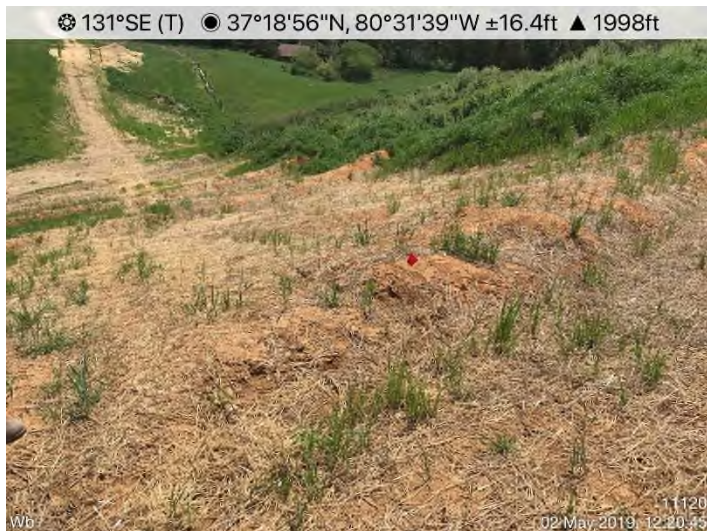
Fig. 7: STA 11120+00 – Waterbar maintenance needed.

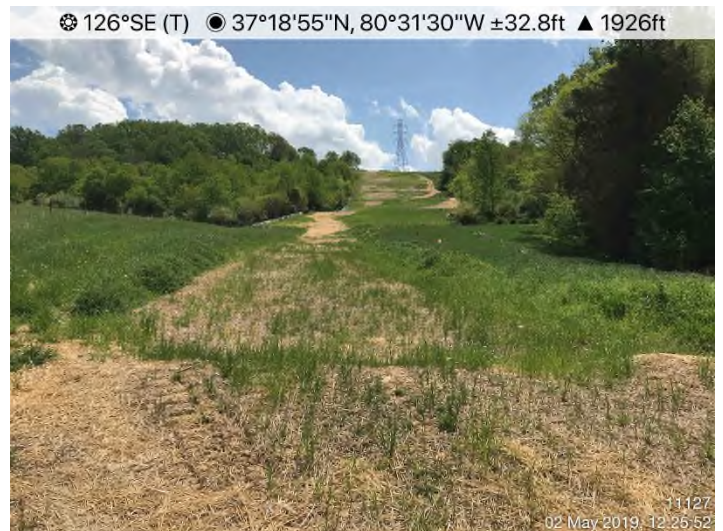
Fig. 8: STA 11127+00 – Controls in place. Area stabilized.
