FIELD INSPECTION

Project Name:	Mountain Valley Pipeline	Inspector:	Matthew Grant
Inspection Date:	Tuesday, April 9, 2019	Project Contact:	Brian Clauto
Spread: Giles County MP202 St#10697+00 MP219 St#11600+13- 11607+34 GI-234 GI-240 GI-241.01	Spread G	Weather (Wet/Dry/Rain):	Dry
STAGE OF CONSTRUCT	ION: (Check all that apply)		
Clearing	Rough Grading	Trench Excavation	Pipe Assembly, Testing & Installation
Backfilling and Grade	e Restoration	& Stabilization	Other: Dormant
		Yes No N/A	
	d and implemented in accordance with th nt control plan and stormwater managem		
2 condition in accorda	sures properly maintained in effective ope ance with good engineering practices and cturer specifications?		
3 Areas of offsite sedi	ment deposition were observed?		
Comments: Streams inspected included: S-G32, S-A32, S-006 ECD's and stabilization are functioning between St#11600+13-11607+34 Access Rd GI-234 matting has slipped on conveyance channel slope and requires re-install. Recommended Corrective Action: Maintain all controls per the approved plan and specs.

FIELD INSPECTION PHOTO LOG

Project Name: Mountain Valley Pipeline Date: Tuesday, April 9, 2019

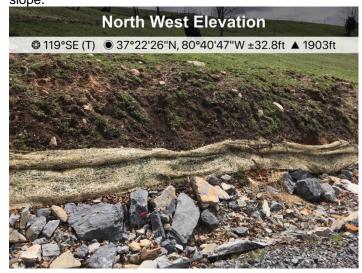
Fig. 1 Access Rd GI-234 matting has slipped off channel slope.

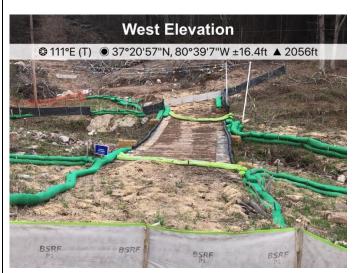
Fig. 2 Designated stream S-G32, ECD's in place

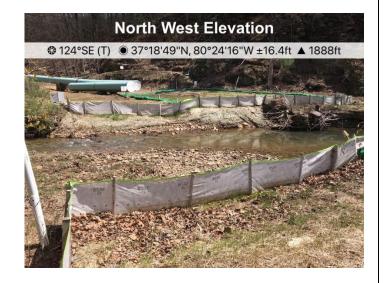
Fig. 4 Designated stream S-006, ECD's in place
