FIELD INSPECTION

Project Name:	Mountain Valley Pipeline	Inspector:	Marshall Willis
Inspection Date:	Monday, March 18, 2019	Project Contact:	Brian Clauto
Spread G: Montgomery County Craig County	STA 11596+94 – 11618+91 STA 11492+71 – 11530+00	Weather (Wet/Dry/Rain):	Dry

FIELD INSPECTION PHOTO LOG

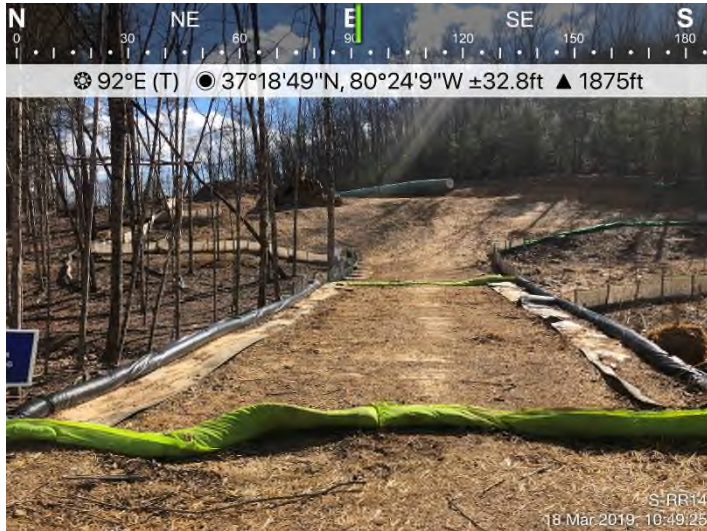
Fig. 1: **S-RR14** – Controls in place.

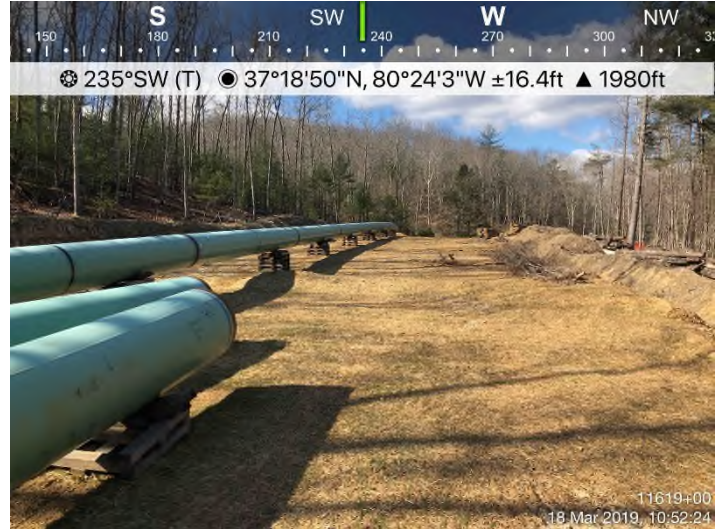
Fig. 2: **STA 11619+00** – Area adequately stabilized. Controls in place.

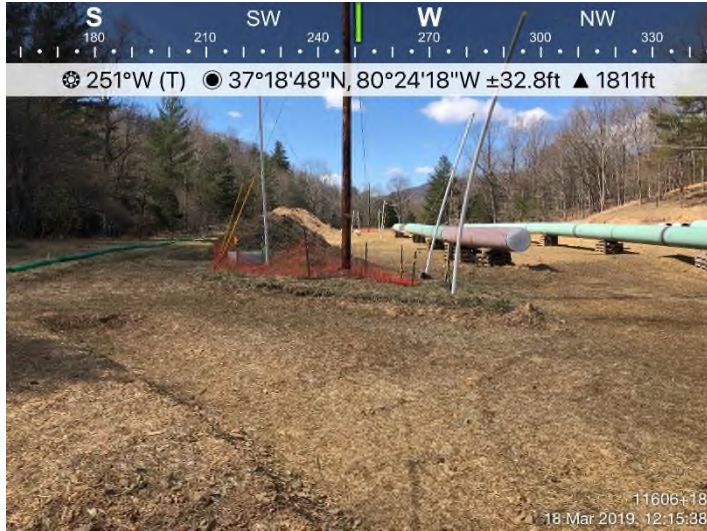
Fig. 3: **STA 11606+00** – Area adequately stabilized. Controls in place.

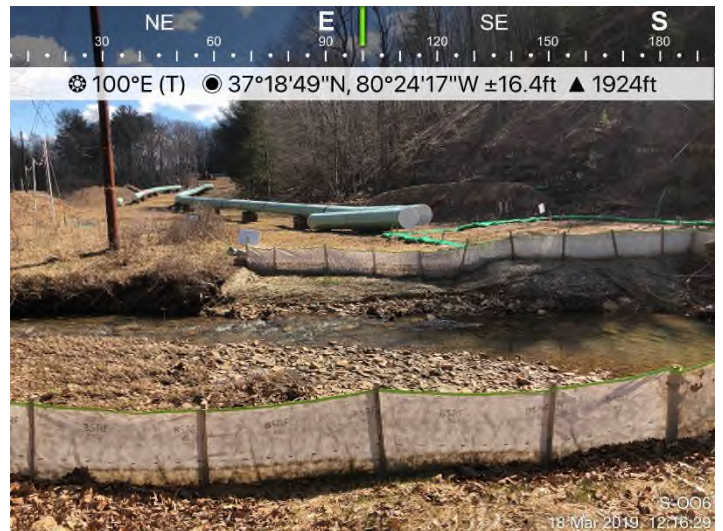
Fig. 4: **S-006** – Controls in place.

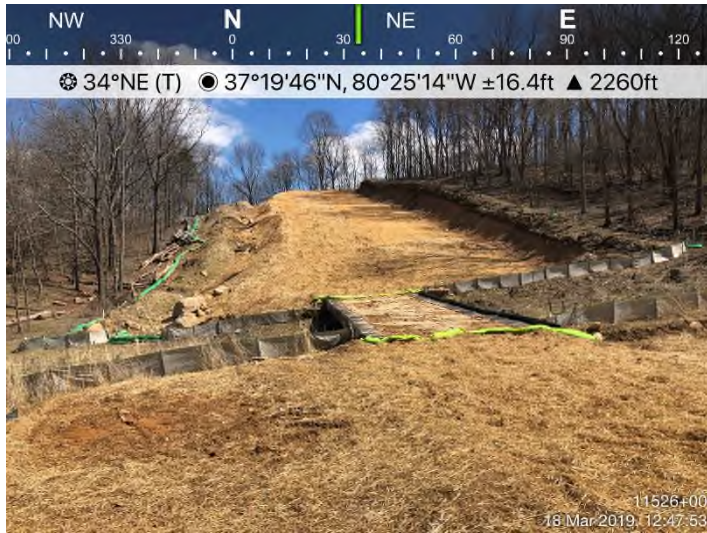
Fig. 5: **STA 11526+00** – Area adequately stabilized. Controls in place.

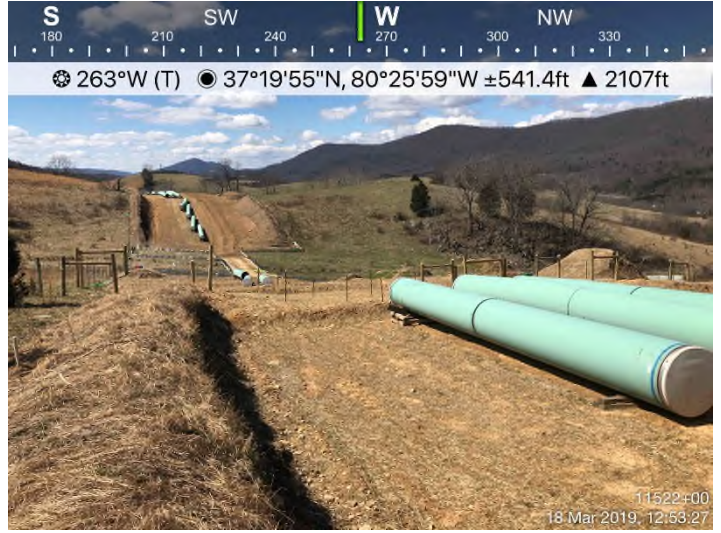
Fig. 6: **STA 11522+00** – Area adequately stabilized. Controls in place.

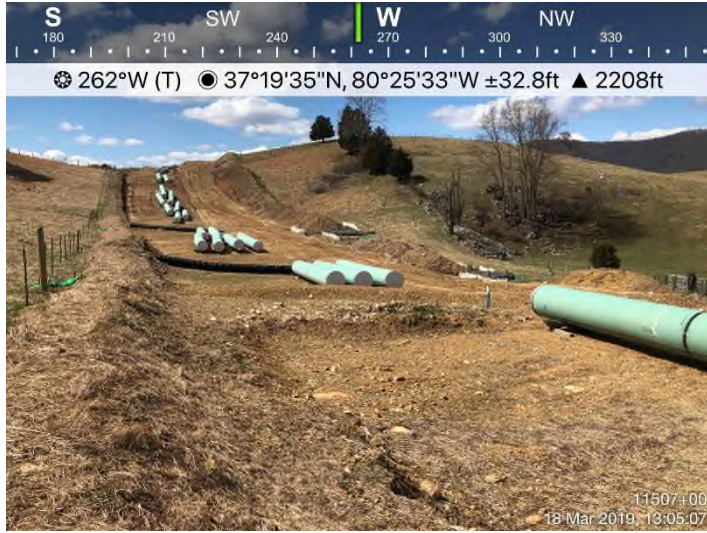
Fig. 7: **STA 11507+00** – Area adequately stabilized. Controls in place.

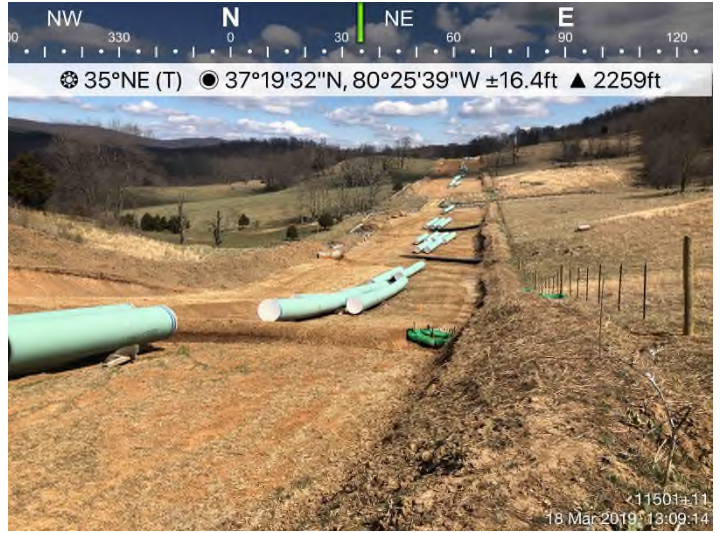
Fig. 8: **STA 11501+11** – Area adequately stabilized. Controls in place.
