FIELD INSPECTION

Project Name: Mountain Valley Pipeline Date: Tuesday, March 12, 2019

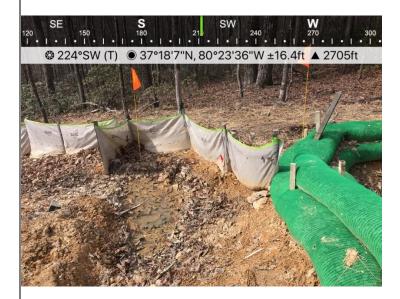
Fig. 1 St#11675+30 P1 fence is undermined

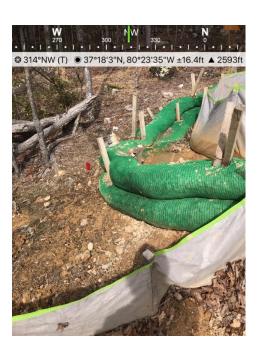
Fig. 3 St#11679+40 sump triple stack is undermined

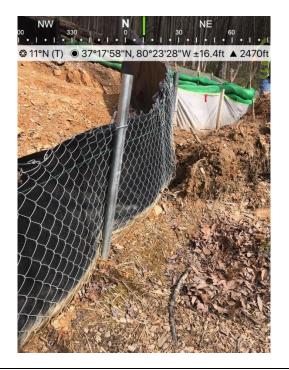
Fig. 4 St#11686+81 SS fence is undermined
