FIELD INSPECTION

Project Name:	Mountain Valley Pipeline	Inspector:				M	Matthew Grant		
Inspection Date:	Wednesday, March 6, 2019	Project Contact:				Bı	ian Clauto		
Spread: Giles County MP216-MP215 St#11451-11361	Spread G	Weather (Wet/Dry/Rain):			Rain):	Di	у		
STAGE OF CONSTRUCT	ION: (Check all that apply)								
Clearing	Rough Grading Trench Excavation						Pipe Assembly, Testing & Installation		
Backfilling and Grade	e Restoration	& Stabilization	on			\boxtimes	Other: Dormant		
	d and implemented in accordance with the nt control plan and stormwater management		Yes ⊠	No	N/A				
Are all control meas condition in accorda applicable, manufac									
3 Areas of offsite sedi	ment deposition were observed?			\boxtimes					
St#1421+50 sumSt#11361+75 surSt#11361+00 surSt#11428+00 sm	ds inspected included: S-0013, S-0 p end treatment is undermined np end treatment is undermined np end treatment is undermined all hole, 11427+50 small hole, 114 aper Aden and DEQ personnel W	127+00 soi	il pip	e fe	ature

FIELD INSPECTION PHOTO LOG

Project Name: Mountain Valley Pipeline Date: Wednesday, March 6, 2019

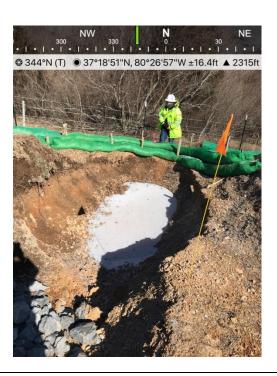
Fig. 3 St#1421+50 sump end treatment is undermined

Recommended Corrective Action: Maintain all controls per the approved plan.

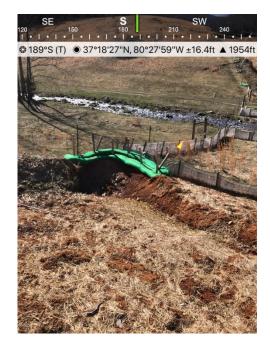
Fig. 4 St#11361+00 sump end treatment is undermined
