## FIELD INSPECTION

<b>Project Name:</b>	Mountain Valley Pipeline	<b>Inspector:</b>	Matthew Grant
<b>Inspection Date:</b>	Thursday, February 28, 2019	<b>Project Contact:</b>	Brian Clauto
<b>Spread: Giles County</b> AR GI-234 AR GI-249.01 MP 211.6 ST#11172+48--+70 AR GI-249.02 ST#11184+00-11193+85 <b>Craig County</b> MP218 ST#11530+00-11529+50 MP216 ST#11487+00	<b>Spread G</b>	<b>Weather (Wet/Dry/Rain):</b>	<b>Dry</b>

## FIELD INSPECTION PHOTO LOG

Project Name: Mountain Valley Pipeline

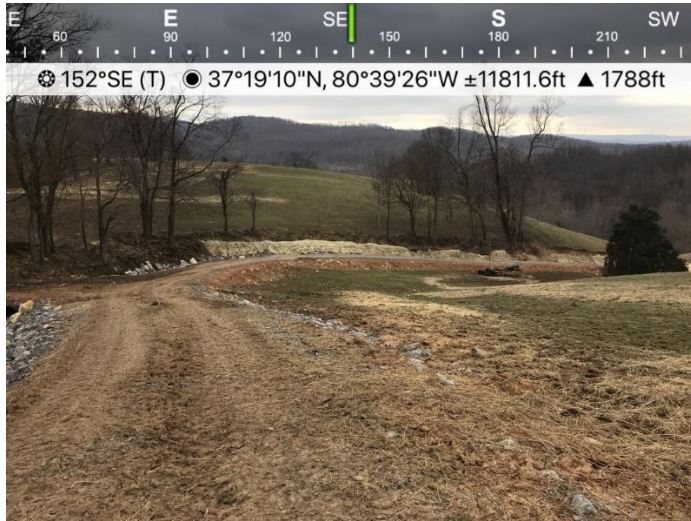
- Access Rd GI-234 Rodgers Road, ECD's in place and functioning.
- Access Rd GI-249.01 ECD's in place and functioning.
- Access Rd GI-249.02 ECD's in place and functioning
- At St#11529+50 slope has slipped and lacks stabilization.

Fig. 1 Access Road GI-234, controls in place.

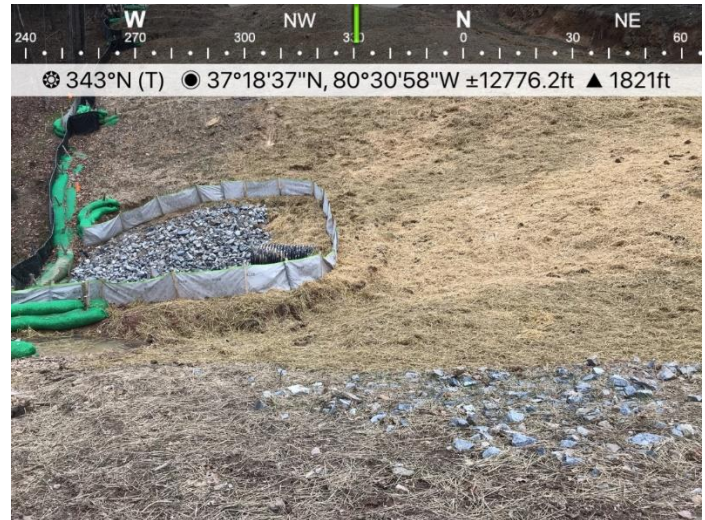
Fig. 2 ST#11184+00 plunge pool area has been repaired

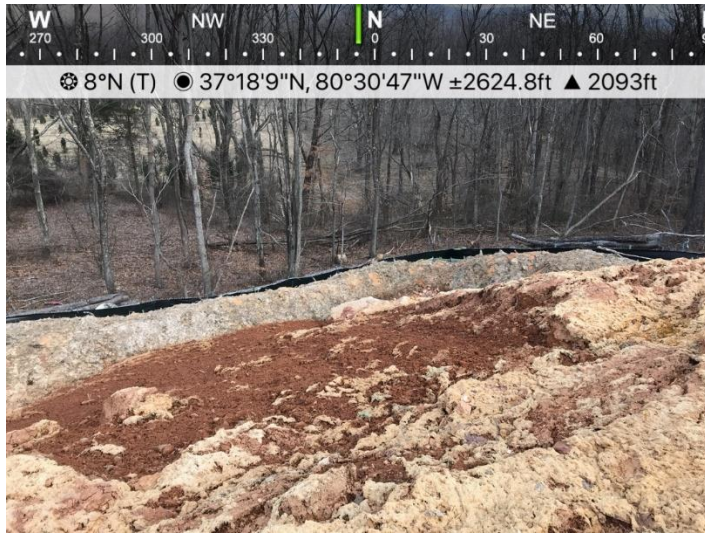
Fig. 3 At St#11529+50 slope has slipped and lacks stabilization.

**Recommended Corrective Action:** Maintain all controls per the approved plan.

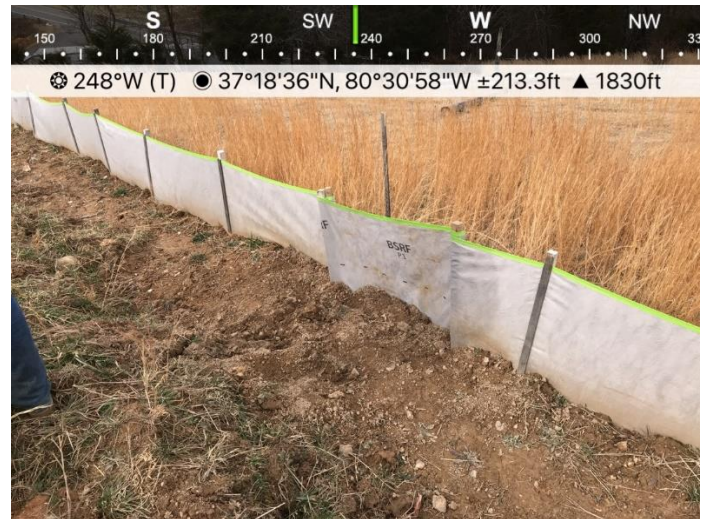
Fig. 4 At St#11172+48 P1 control has been repaired.
