FIELD INSPECTION

Project Name:	Mountain Valley Pipeline	Inspector:	Matthew Grant
Inspection Date:	Tuesday, February 26, 2019	Project Contact:	Brian Clauto
Spread: Montgomery County MN 266 MP 225 11932+54 MP226 11979+30	Spread G	Weather (Wet/Dry/Rain):	Dry

FIELD INSPECTION PHOTO LOG

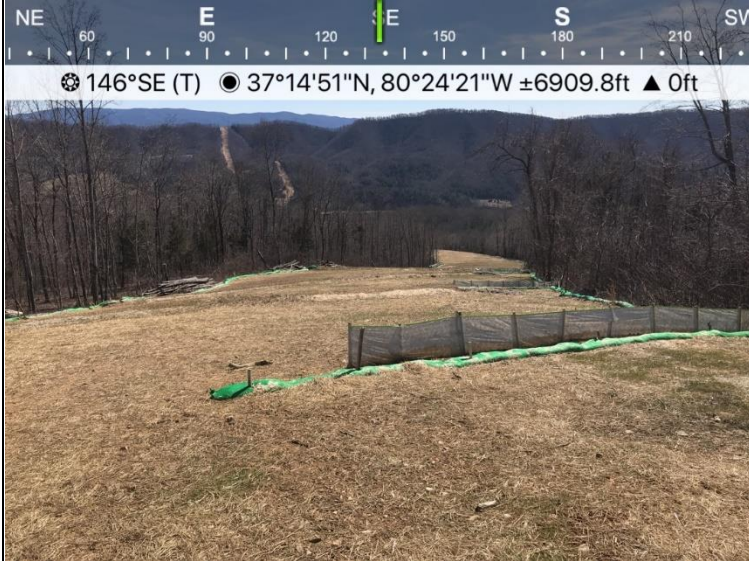
- Fig. 1 St#11934+71 near the top of Catawba Mtn. controls were in place and functioning, area has been stabilized.

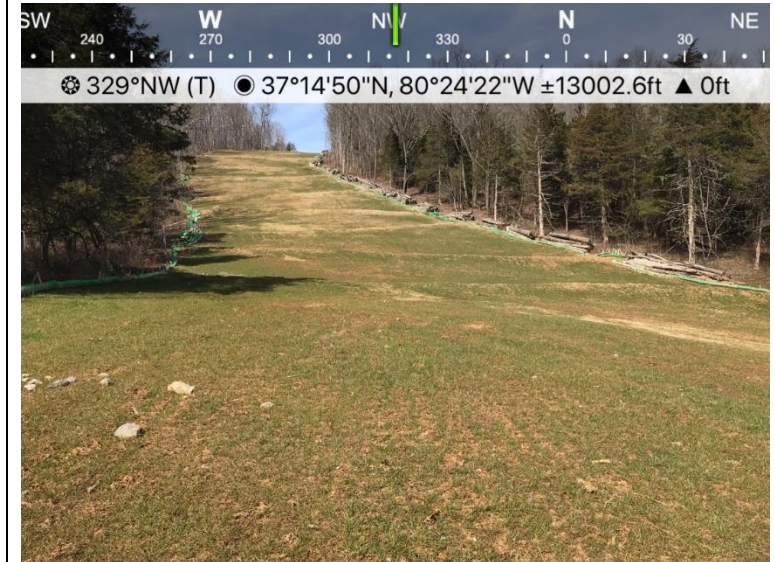
- Fig. 2 St#11979+30 near the base of Catawba Mtn. controls were in place and functioning, area has been stabilized
