FIELD INSPECTION

Project Name:	Mountain Valley Pipeline	Inspector:	Matthew Grant
Inspection Date:	Wednesday, February 6, 2019	Project Contact:	Brian Clauto
Spread: Craig County MP218 MP226-225 MN266 ARGI234	Spread G	Weather (Wet/Dry/Rain):	Wet

FIELD INSPECTION PHOTO LOG

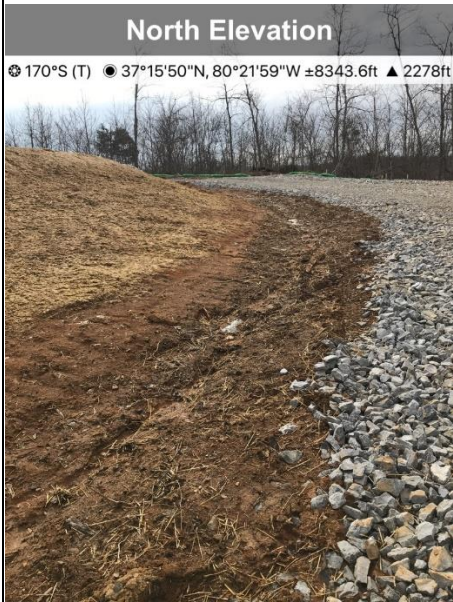
- St#11900+00 area lacks stabilization near access road and CFS requires maintenance.
- AR GI-234 rock lined channel requires matting re installed and sediment cleaned out of channel.

Fig. 1 St#11900 area requires additional stabilization

Recommended Corrective Action: Maintain all controls per the approved plan.

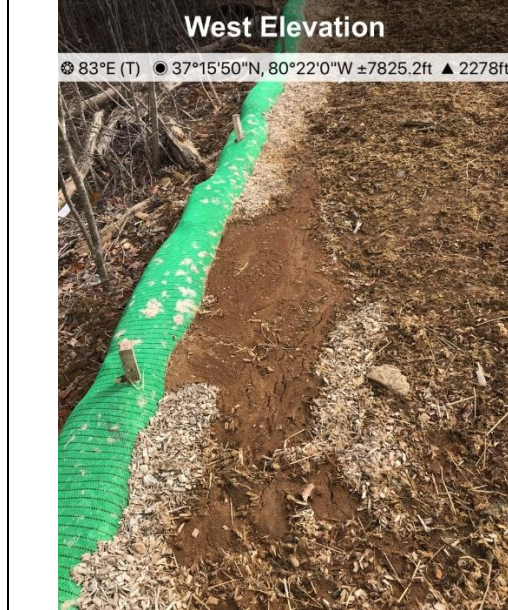
Fig. 2 St#11900 CFS requires maintenance

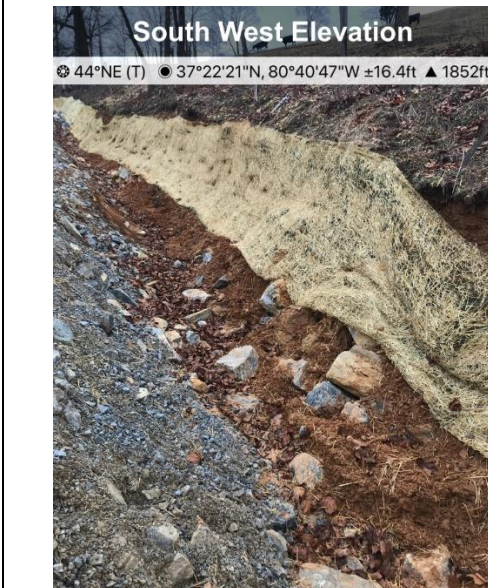
Fig. 3 AR GI234 rock lined channel requires maintenance

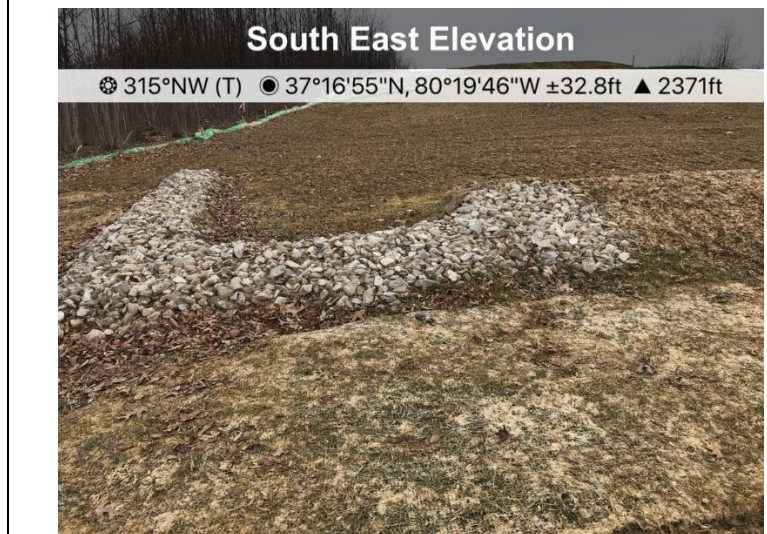
Fig. 4 Near St#11940+00 permanent waterbars have been installed
