FIELD INSPECTION

Project Name:	Mountain Valley Pipeline	Inspector:	Matthew Grant
Inspection Date:	Thursday, January 24, 2019	Project Contact:	Brian Clauto
Spread: Giles County AR GI-234 Montgomery County MP225-226	Spread G	Weather (Wet/Dry/Rain):	Dry

FIELD INSPECTION PHOTO LOG

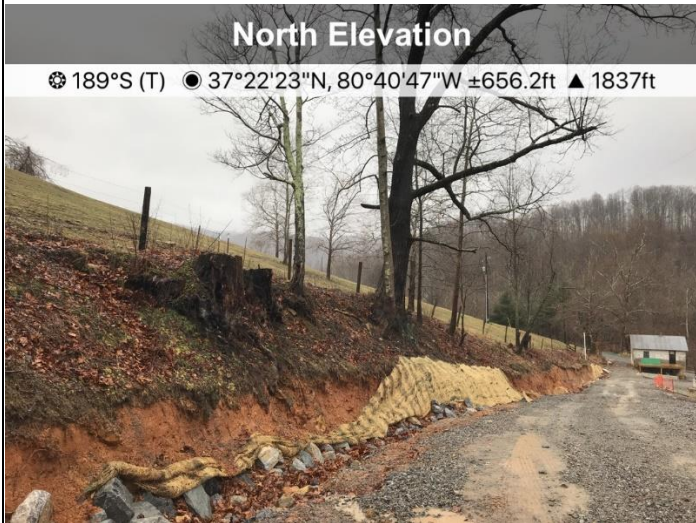
- Access Rd GI 234 matting of ditch line is no longer adequately installed
- ECD's and stabilization are functioning between St#11932+54 and 11961+00

- Fig. 1 Access Rd GI 234 matting of ditch line is no longer adequately installed

Recommended Corrective Action: Maintain all controls per the approved plan.

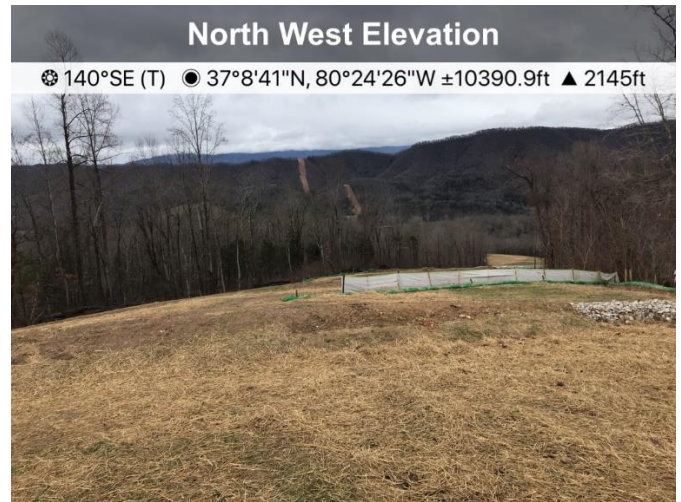
- Fig. 2 Near St#11932+54 ECD's in place and functioning

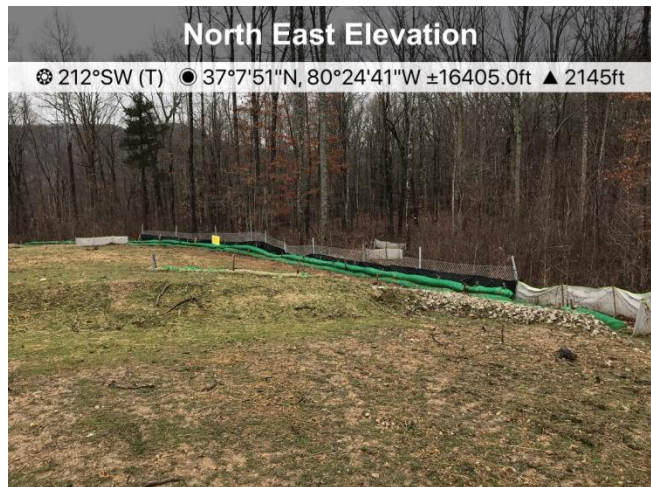
- Fig. 3 St#11943+60 ECD's in place and functioning

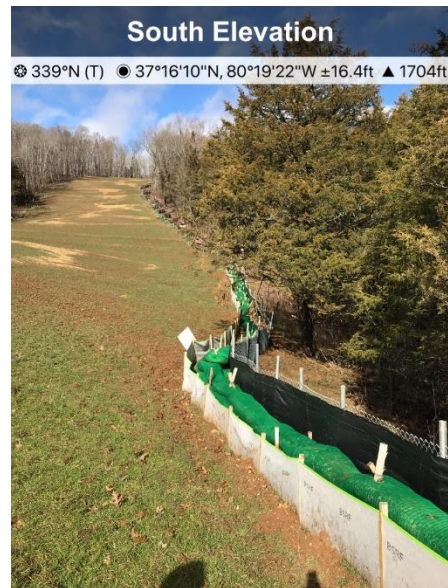
- Fig. 4 St#11961+00 ECD's in place and functioning
