FIELD INSPECTION

Project Name:	Mountain Valley Pipeline	Inspector:	Matthew Grant
Inspection Date:	Tuesday, January 8, 2019	Project Contact:	Brian Clauto
Spread: Montgomery County MP225-226 MP222-223	Spread G	Weather (Wet/Dry/Rain):	Wet

FIELD INSPECTION PHOTO LOG

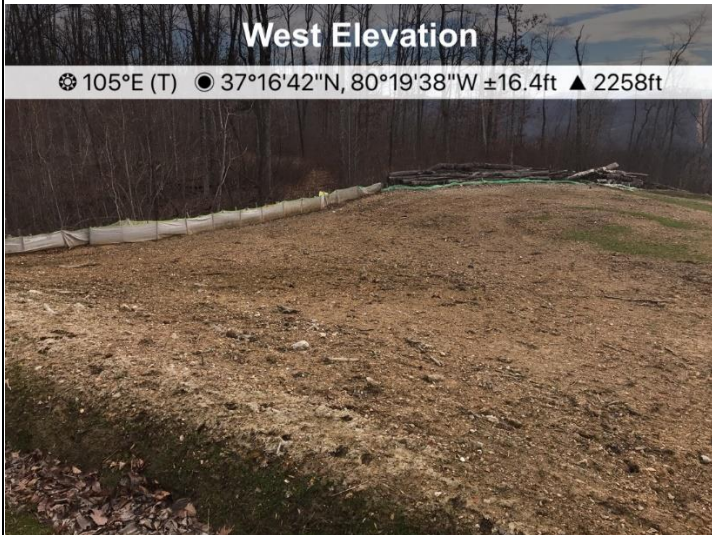
- Between St11930 and St11975 areas are showing signs of rill erosion and inadequate stabilization.
- Karsts signs have been damaged and are no longer in place

- Fig. 1 Near St#11939+13 area lacks inadequate stabilization

Recommended Corrective Action: Maintain all controls per the approved plan.

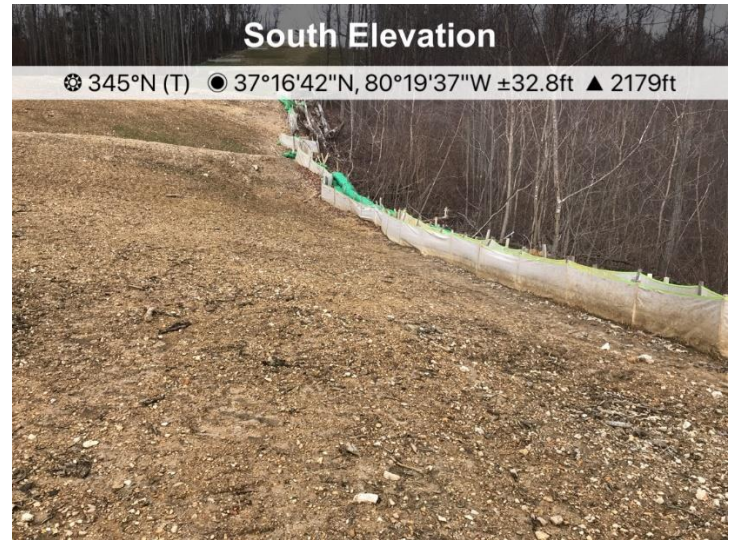
- Fig. 2 Near St#11942 area lacks adequate stabilization

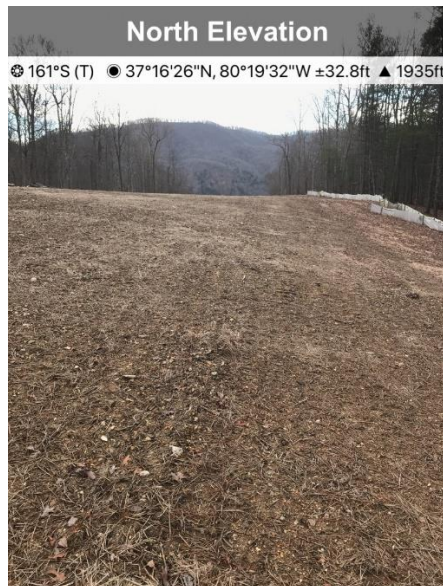
- Fig. 3 Near St#11961 area lacks adequate stabilization

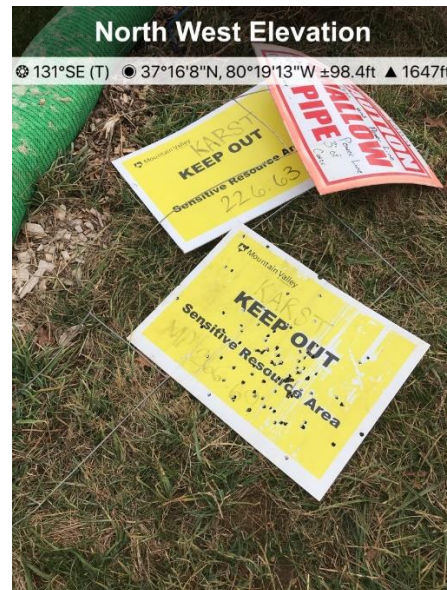
- Fig. 4 Karst signs have been damage
