COMPLAINT INVESTIGATION REPORT

Project Name:	Mountain Valley Pipeline	Inspector:	Marshall Willis
Inspection Date:	Friday, March 5, 2021	Project Contact:	Brian Clauto, Cory Chalmers
Spread I: Pittsylvania County	STA 15852+90 – 15947+64 MVP-PI-340	Weather:	Dry

FIELD INSPECTION PHOTO LOG

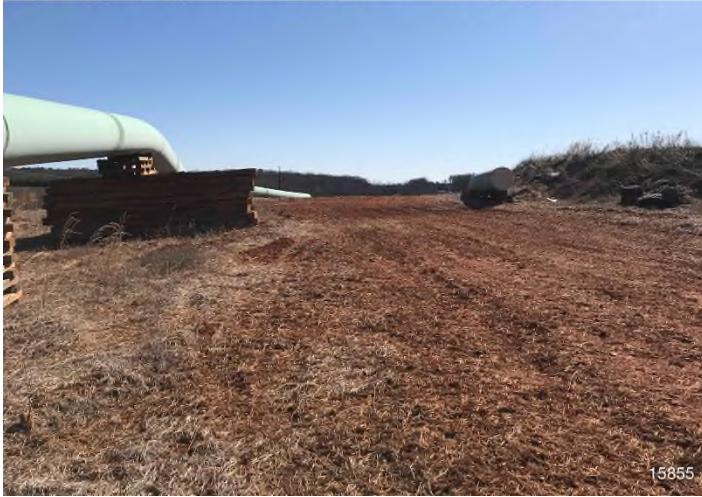
15855

Figure 1: STA 15855+00 – Controls in place and functioning properly. Area stabilized with straw. No erosion evident.

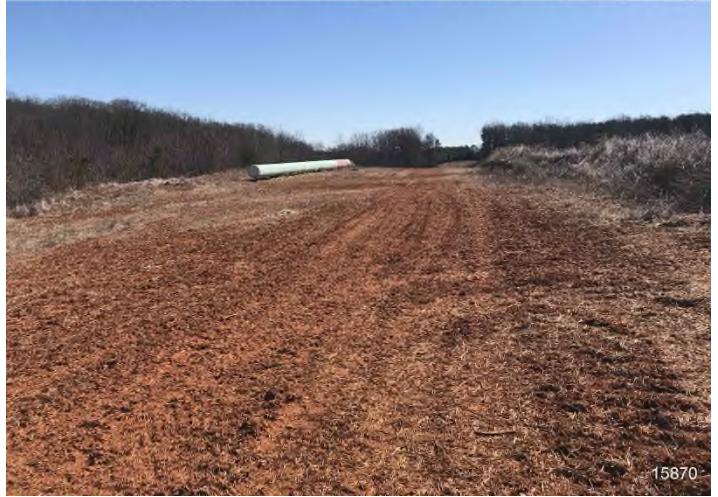
15870

Figure 2: STA 15870+00 – Controls in place and functioning properly. Area stabilized with straw. No erosion evident.

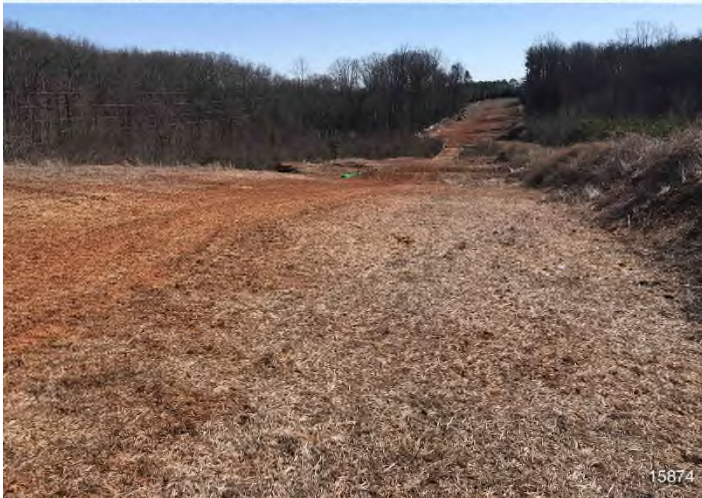
15874

Figure 3: STA 15874+00 – Controls in place and functioning properly. Area stabilized with straw. No erosion evident.

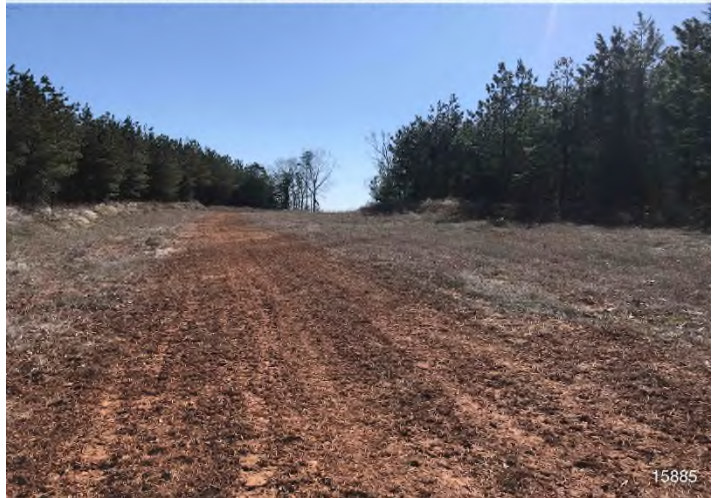
15885

Figure 4: STA 15885+00 – Controls in place and functioning properly. Area stabilized with straw. No erosion evident.

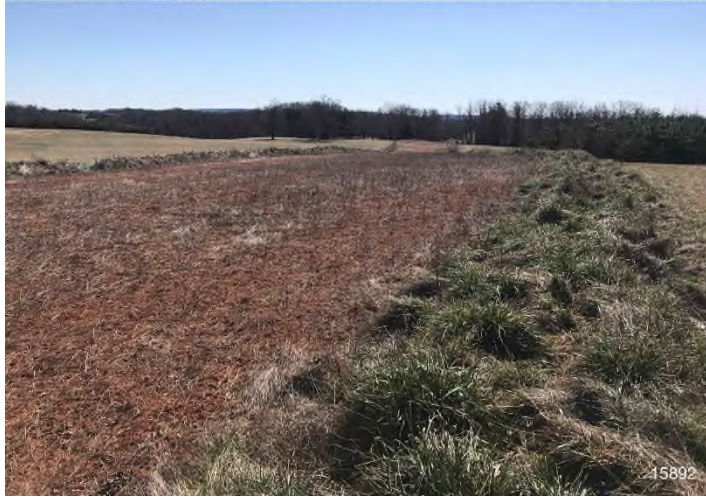
Figure 5: STA 15892+00 – Controls in place and functioning properly. Area stabilized with straw. No erosion evident.
BRG: 126°SE (T) **LAT:** 36.847981 **LON:** -79.373584 ±16ft **ALT:** 720ft

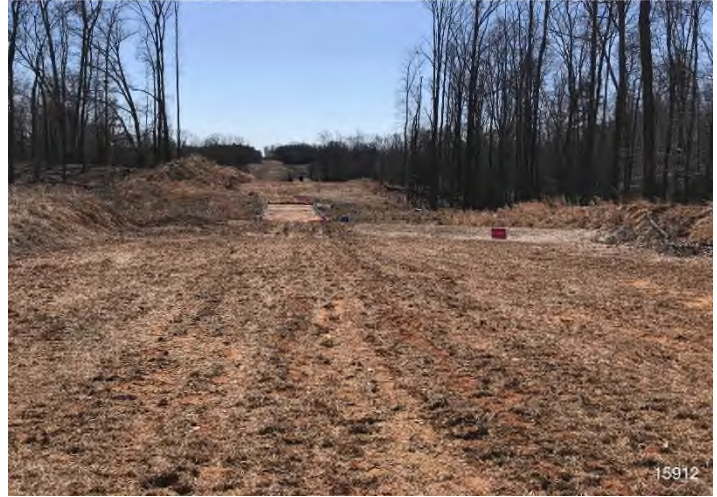
Figure 6: STA 15912+00 – Controls in place and functioning properly. Area stabilized with straw. No erosion evident.
BRG: 152°SE (T) **LAT:** 36.843917 **LON:** -79.369526 ±16ft **ALT:** 658ft

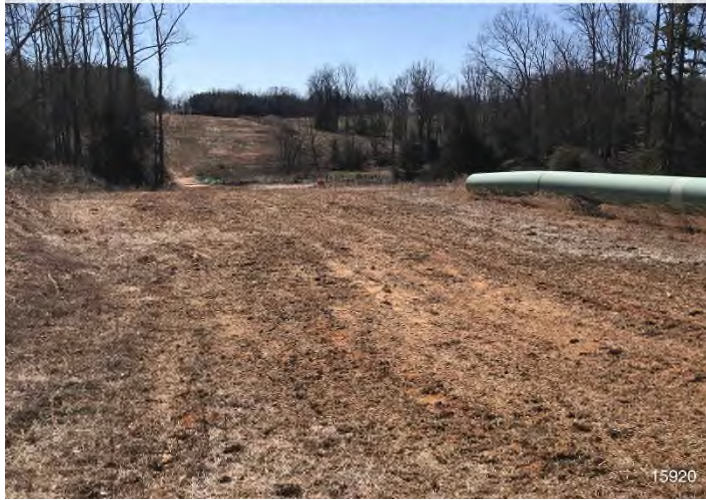
Figure 7: STA 15920+00 – Controls in place and functioning properly. Area stabilized with straw. No erosion evident.
BRG: 158°S (T) **LAT:** 36.841984 **LON:** -79.367466 ±16ft **ALT:** 639ft

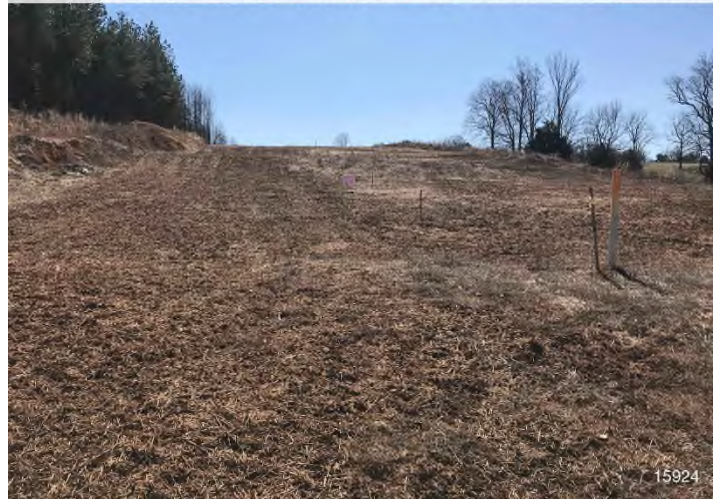
Figure 8: STA 15924+00 – Controls in place and functioning properly. Area stabilized with straw. No erosion evident.
BRG: 152°SE (T) **LAT:** 36.840938 **LON:** -79.366688 ±16ft **ALT:** 620ft
