COMPLAINT INVESTIGATION REPORT

Project Name:	Mountain Valley Pipeline	Inspector:	Marshall Willis
Inspection Date:	Thursday, March 4, 2021	Project Contact:	Brian Clauto, Cory Chalmers
Spread I: Pittsylvania County	STA 15370+62 – 15480+67	Weather:	Dry

FIELD INSPECTION PHOTO LOG

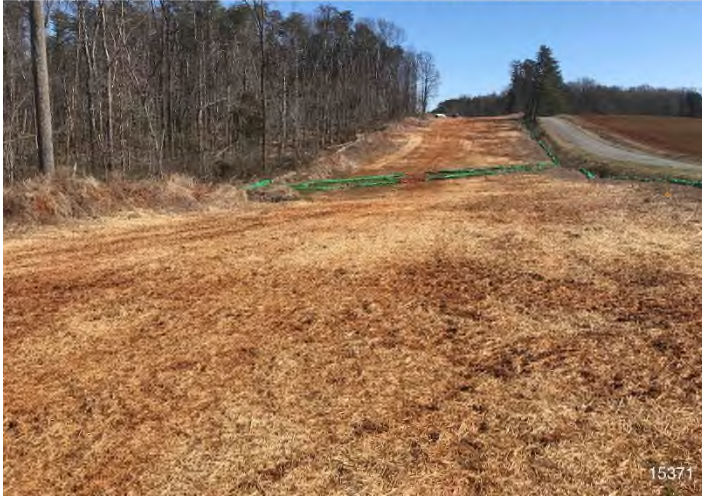
15371

Figure 1: STA 15371+00 – Controls in place and functioning properly. Area stabilized with straw. No erosion evident.

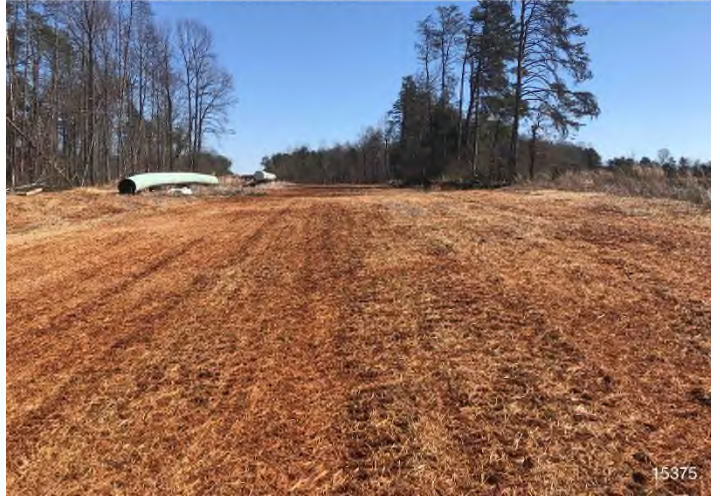
15375

Figure 2: STA 15375+00 – Controls in place and functioning properly. Area stabilized with straw. No erosion evident.

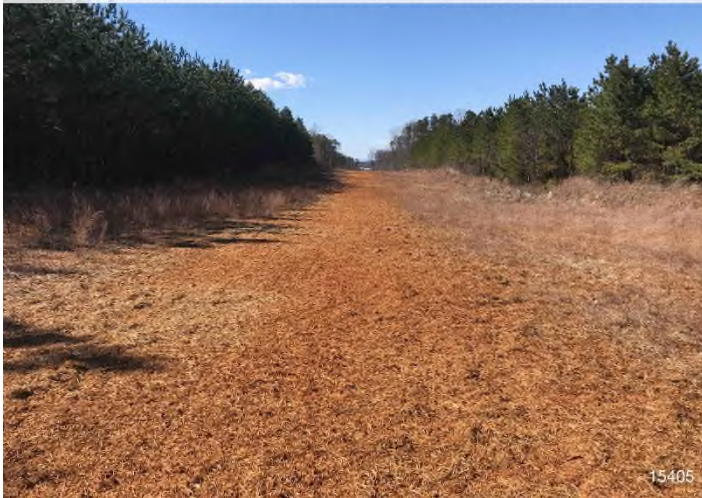
15405

Figure 3: STA 15405+00 – Controls in place and functioning properly. Area stabilized with straw. No erosion evident.

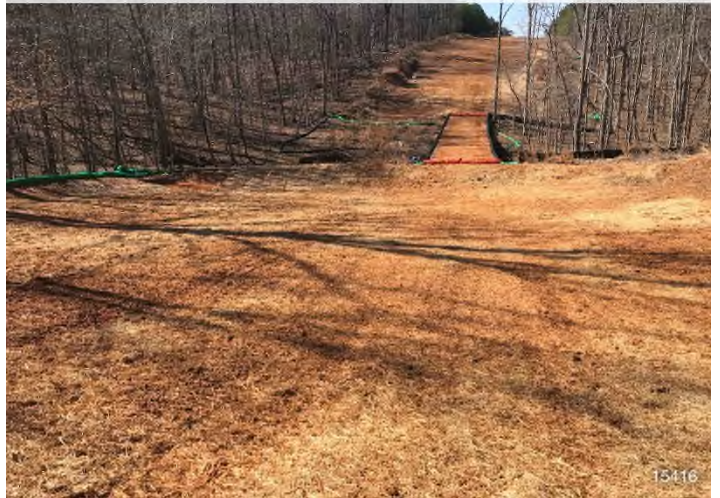
15416

Figure 4: STA 15416+00 – Controls in place and functioning properly. Area stabilized with straw. No erosion evident.

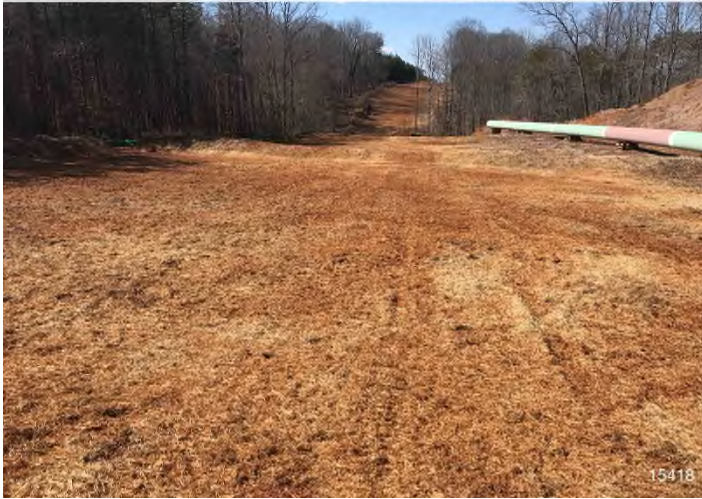
15418

Figure 5: STA 15418+00 – Controls in place and functioning properly. Area stabilized with straw. No erosion evident.

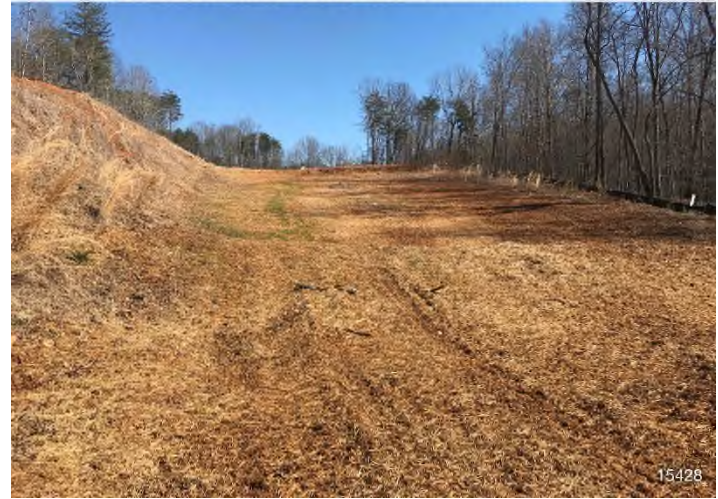
15428

Figure 6: STA 15428+00 – Controls in place and functioning properly. Area stabilized with straw. No erosion evident.

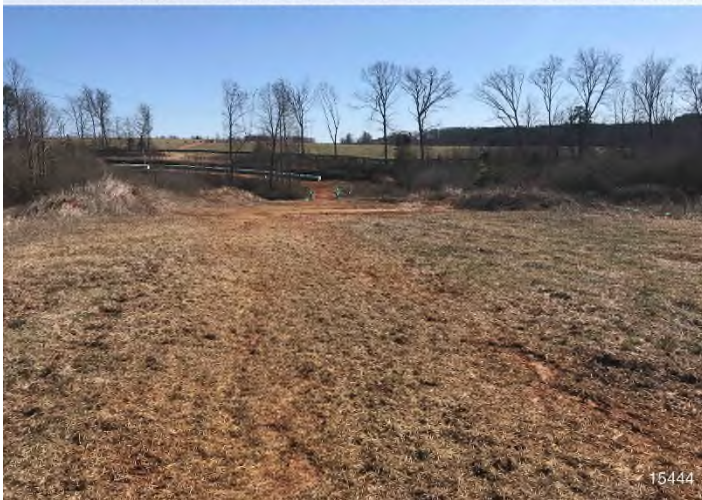
15444

Figure 7: STA 15444+00 – Controls in place and functioning properly. Area stabilized with straw. No erosion evident.

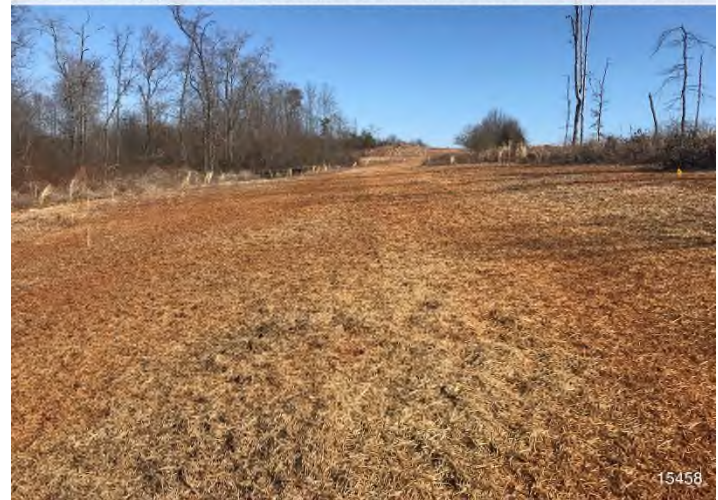
15458

Figure 8: STA 15458+00 – Controls in place and functioning properly. Area stabilized with straw. No erosion evident.
