## FIELD INSPECTION REPORT

<b>Project Name:</b>	Mountain Valley Pipeline	<b>Inspector:</b>	Marshall Willis
<b>Inspection Date:</b>	Tuesday, March 2, 2021	<b>Project Contact:</b>	Brian Clauto, Cory Chalmers
<b>Spread G: Giles County</b>	STA 11184+85 – 11227+59 MVP-GI-249.02 MVP-MLV-AR-25	<b>Weather:</b>	Wet

## FIELD INSPECTION PHOTO LOG

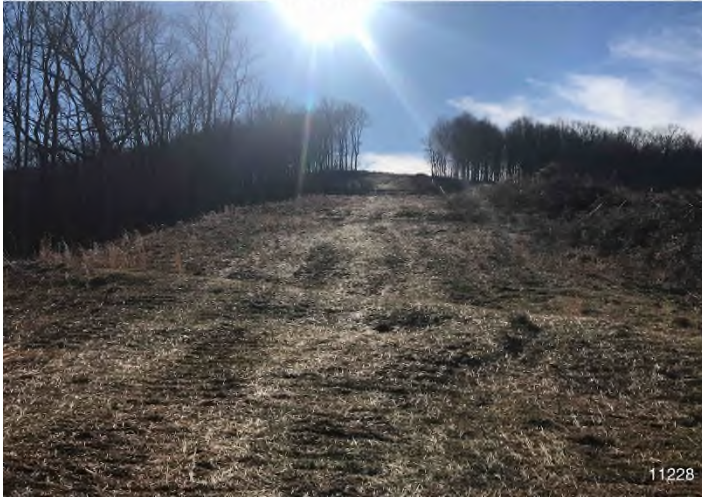
11228

**Figure 1: STA 11228+00** – Controls in place and functioning properly. Area stabilized with straw.

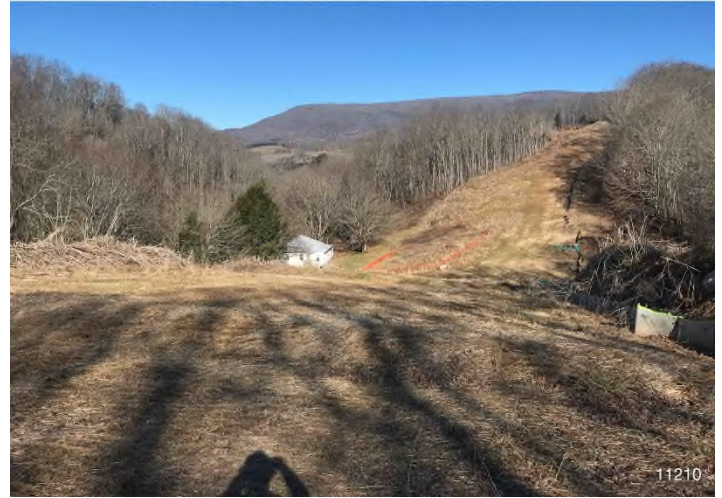
11210

**Figure 2: STA 11210+00** – Controls in place and functioning properly. Area stabilized with straw.

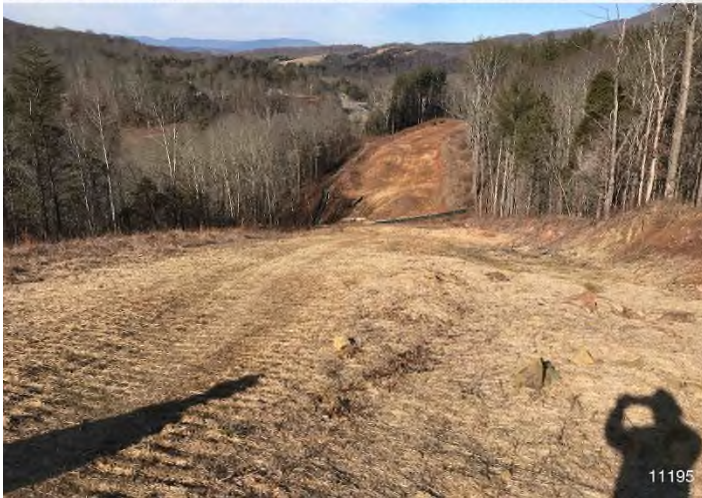
11195

**Figure 3: STA 11195+00** – Controls in place and functioning properly. Area stabilized with straw.

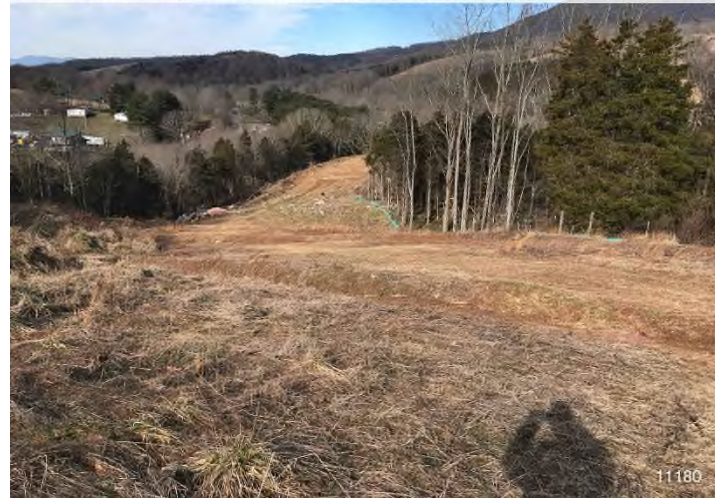
11180

**Figure 4: STA 11180+00** – Controls in place and functioning properly. Area stabilized with straw.
