FIELD INSPECTION REPORT

Project Name:	Mountain Valley Pipeline	Inspector:	Matthew Grant
Inspection Date:	Wednesday, March 24, 2021	Project Contact:	Brian Clauto
Spread G: Giles	ST11230-11254+66 AR-MLV25 ATWS 1347	Weather:	Wet

FIELD INSPECTION PHOTO LOG

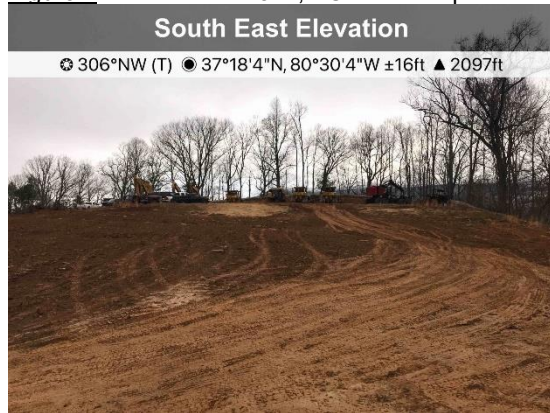
Figure 1: Near ATWS 1347, ECD's are in place.

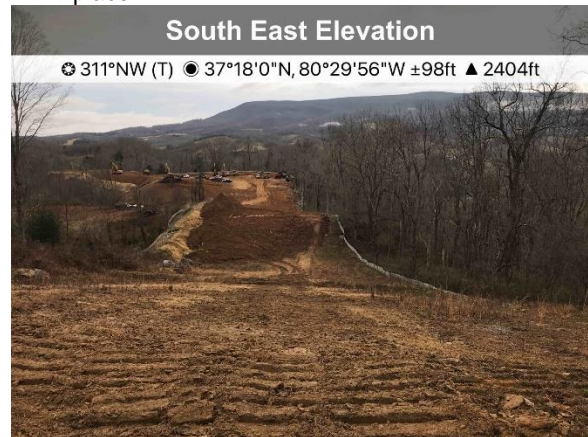
Figure 2: Above St11230+00 ECD's and stockpile stabilization in place.

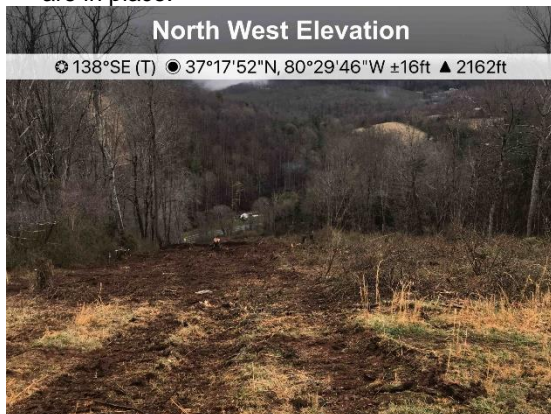
Figure 3: Near St11248+00 area is planned for grubbing, ECD's are in place.

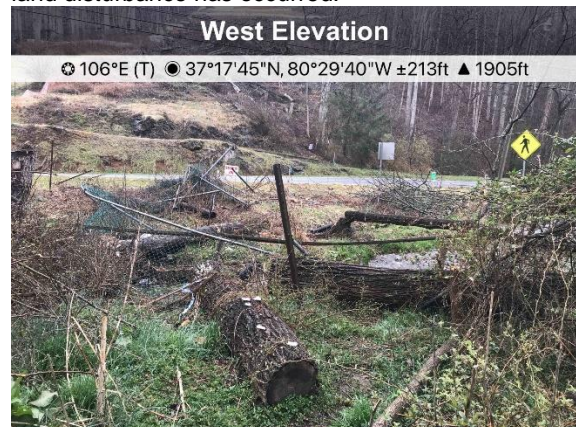
Figure 4: Near designated crossings S-RR2 and W-RR18, no land disturbance has occurred.
