## FIELD INSPECTION REPORT

<b>Project Name:</b>	Mountain Valley Pipeline	<b>Inspector:</b>	Marshall Willis
<b>Inspection Date:</b>	Tuesday, March 23, 2021	<b>Project Contact:</b>	Brian Clauto, Cory Chalmers
<b>Spread G: Giles County</b>	STA 11165+00 – 11230+00	<b>Weather:</b>	Dry

## FIELD INSPECTION PHOTO LOG

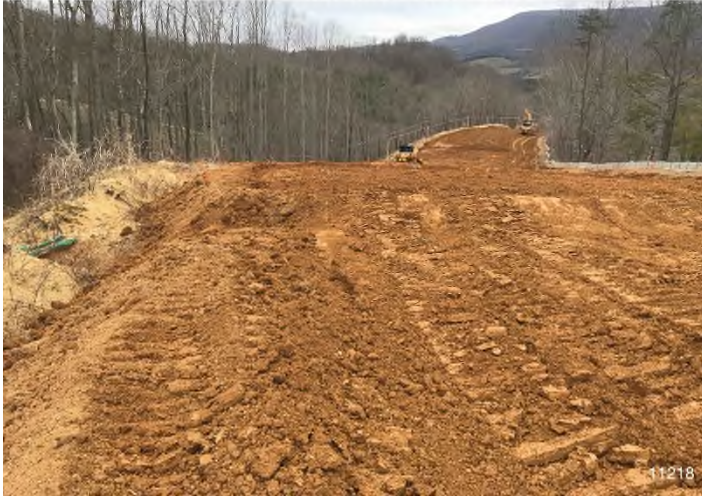
**Figure 1: STA 11218+00** – Controls in place and functioning properly.  
 BRG: 300°NW (T) LAT: 37.301381 LON: -80.503930 ±16ft ALT: 2080ft

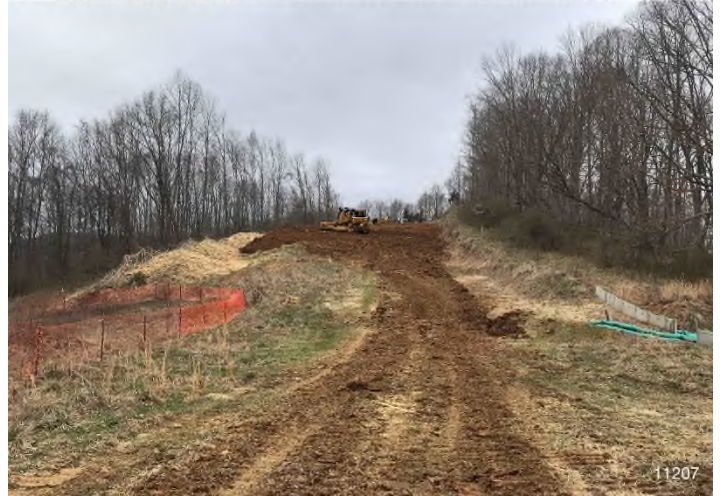
**Figure 2: STA 11207+00** – Controls in place and functioning properly.  
 BRG: 333°NW (T) LAT: 37.303751 LON: -80.506530 ±16ft ALT: 1957ft

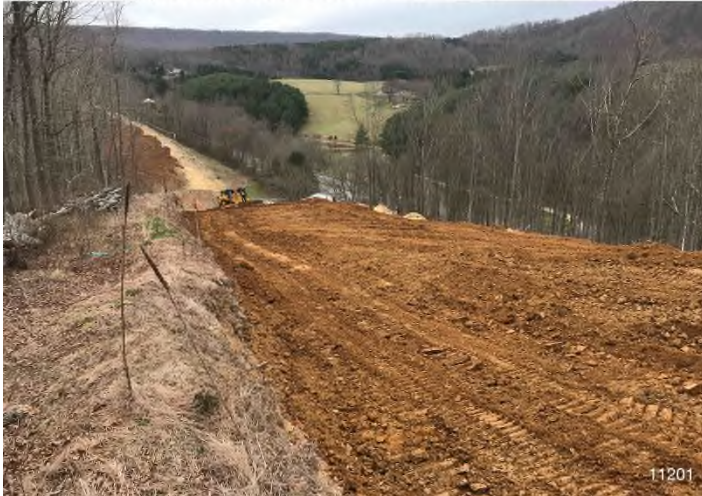
**Figure 3: STA 11201+00** – Controls in place and functioning properly.  
 BRG: 184°S (T) LAT: 37.305400 LON: -80.507007 ±32ft ALT: 2000ft

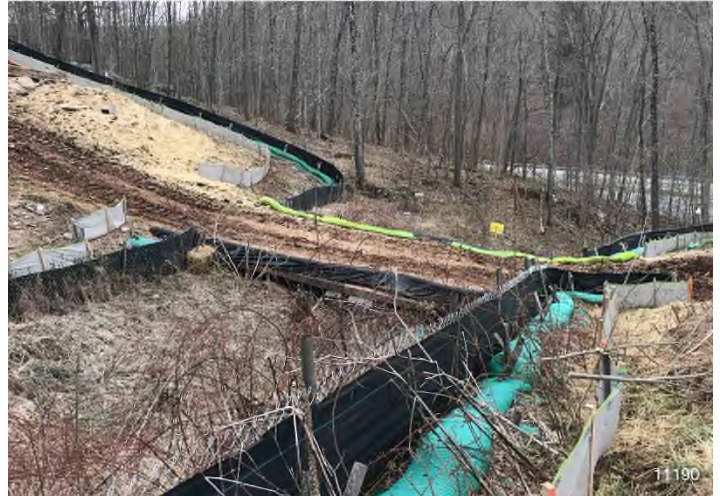
**Figure 4: STA 11190+00** – Controls in place and functioning properly.  
 BRG: 169°S (T) LAT: 37.306290 LON: -80.509893 ±32ft ALT: 1947ft
