Project Name:	Mountain Valley Pipeline	Inspector:	Matthew Grant
Inspection Date:	Tuesday, March 23, 2021	Project Contact:	Brian Clauto
Spread G: Giles	ST11185-11192, ST11300- 11254+66 AR-GI 249.02, GI-253.02	Weather:	Dry

## FIELD INSPECTION PHOTO LOG

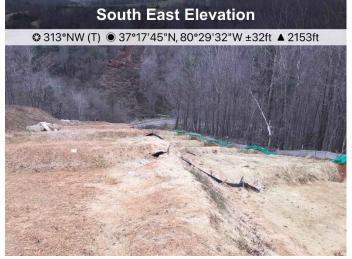
Figure 3: Near St11280 has recently been re stabilized.

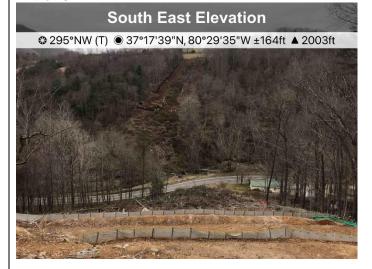
Figure 4: Near ST 11258+00 ECD's are in place at the end of the LOD.
