FIELD INSPECTION REPORT

Project Name:	Mountain Valley Pipeline	Inspector:	Marshall Willis
Inspection Date:	Thursday, March 18, 2021	Project Contact:	Brian Clauto, Cory Chalmers
Spread G: Montgomery County	STA 11596+94 – 11618+91 STA 11765+00 – 11792+18 MVP-MN-258.05/.04 MVP-MLV-AR-26	Weather:	Rainy

FIELD INSPECTION PHOTO LOG

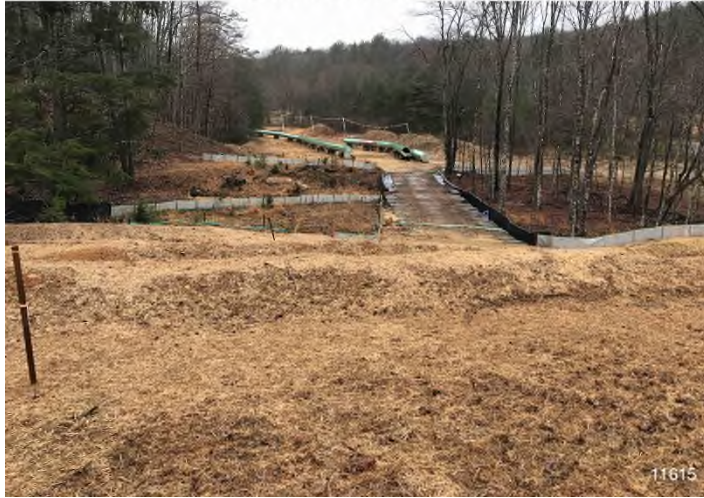
Figure 1: STA 11615+00 – Controls in place and functioning properly.

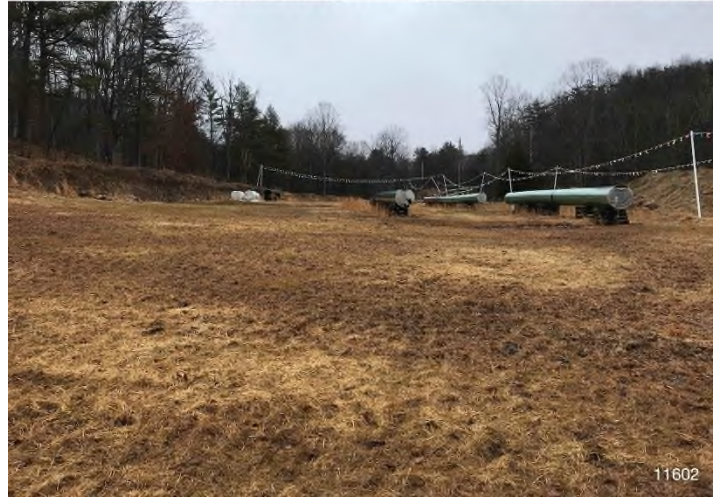
Figure 2: STA 11602+00 – Controls in place and functioning properly.

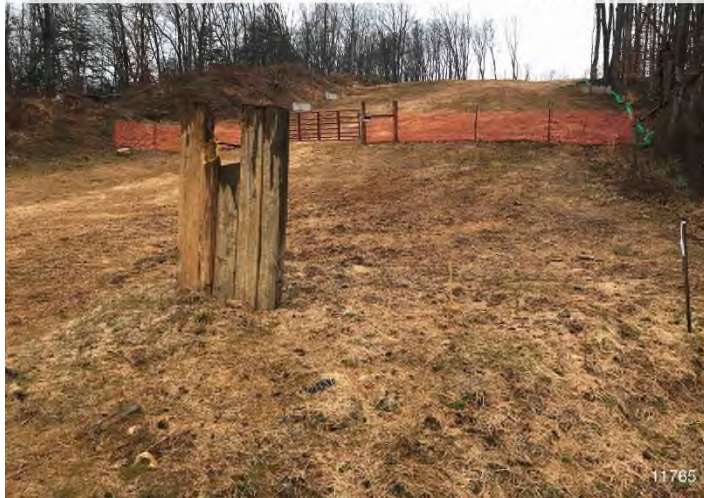
Figure 3: STA 11765+00 – Controls in place and functioning properly.

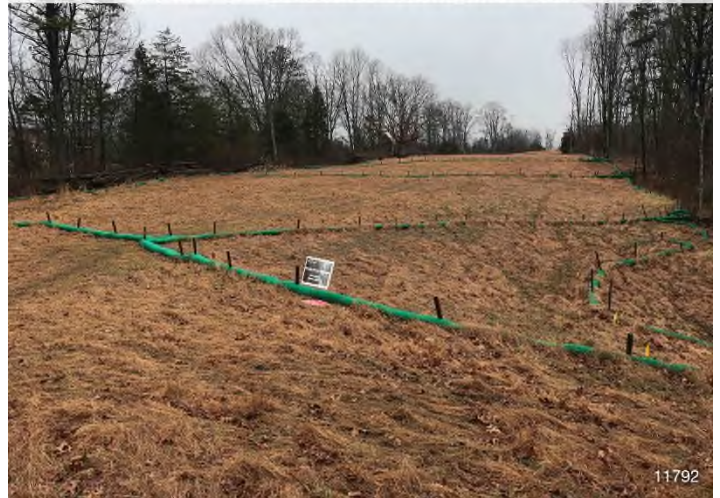
Figure 4: STA 11792+00 – Controls in place and functioning properly.
