FIELD INSPECTION REPORT

Project Name:	Mountain Valley Pipeline	Inspector:	Marshall Willis
Inspection Date:	Thursday, March 11, 2021	Project Contact:	Brian Clauto, Cory Chalmers
Spread G: Giles County	STA 11011+87 – 11065+00 MVP-GI-243.01 MVP-GI-245.01	Weather:	Dry

FIELD INSPECTION PHOTO LOG

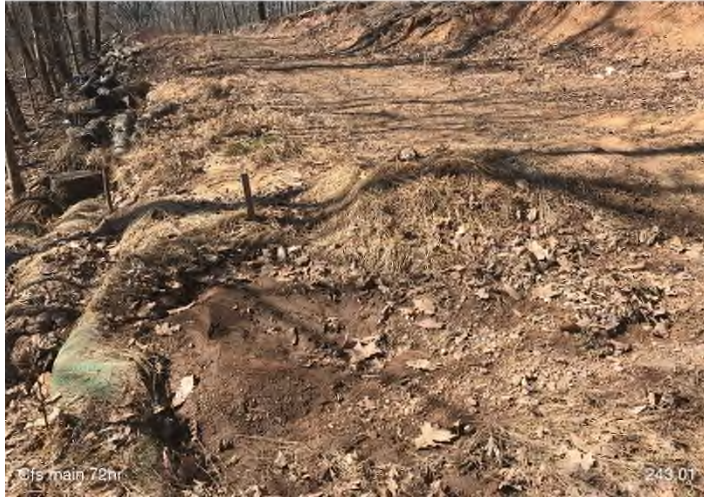
Routine Maintenance: (72-Hour Deadline from Notification)
 - MVP-GI-243.01: CFS maintenance needed.

Figure 1: MVP-GI-243.01 – CFS maintenance needed.

Recommended Corrective Action: Maintain and install all controls per the approved PSS&S.

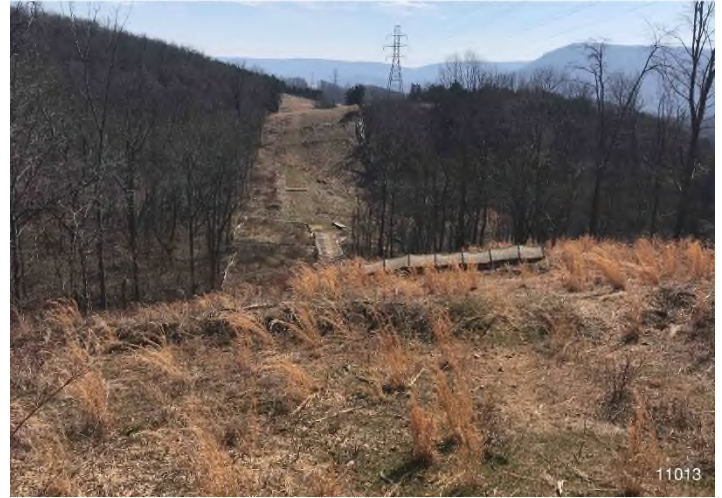
Figure 2: STA 11013+00 – Controls in place and functioning properly.

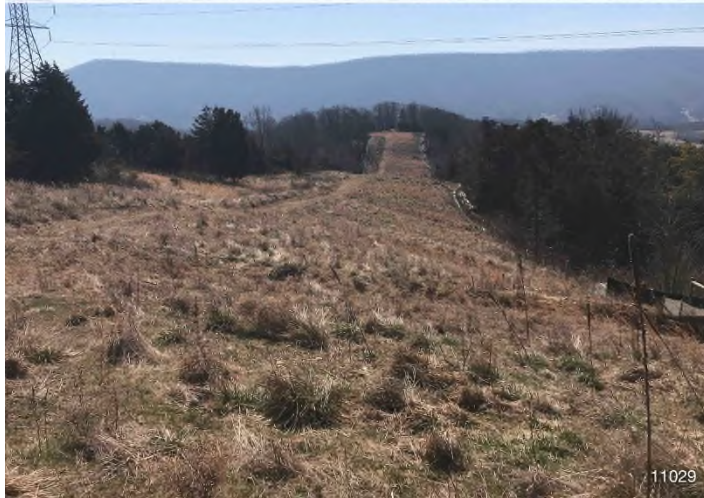
Figure 3: STA 11029+00 – Controls in place and functioning properly.

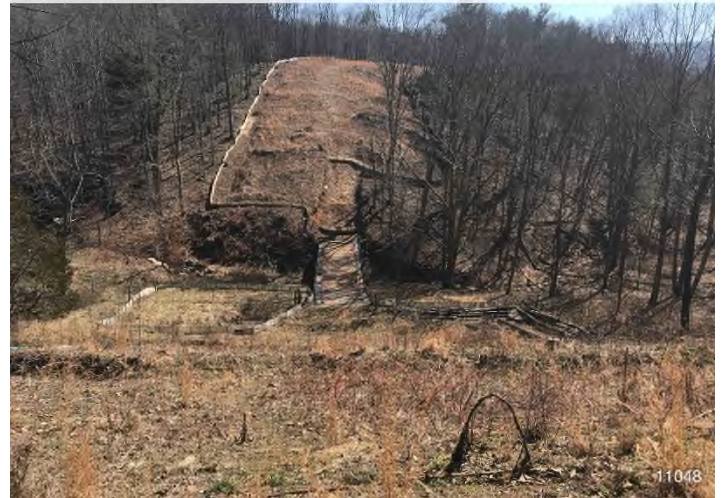
Figure 4: STA 11048+00 – Controls in place and functioning properly.
