Virginia Department of Environmental Quality's investigation into the Mountain Valley Watch report titled "Mountain Valley Pipeline Stabilization, Pittsylvania County, VA"

March 17, 2020

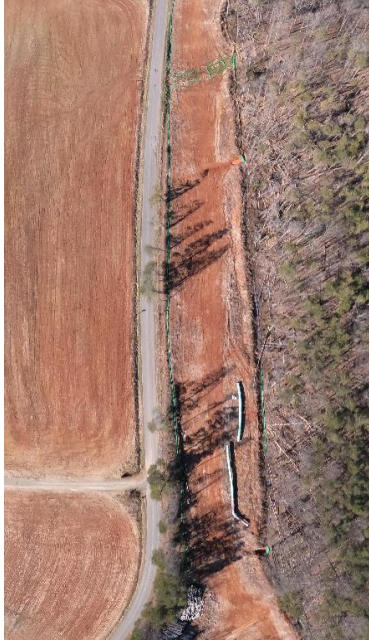
Inspected areas that were permanently stabilized had acceptable vegetative cover, being uniform, mature enough to survive and inhibiting erosion as required by Minimum Standard 1. (See Photo 6.) Areas that were temporarily stabilized had some vegetation in varying stages vigor and effectiveness in soil stabilization. Where temporary vegetation was observed to be in poor condition, soil stabilization was provided by straw mulch, blankets and matting, hydromulch or stabilization pellets. (See Photos 2., 4. & 8.) Inspectors observed that some of the temporary vegetation (annual grasses or grains) were in a mature or dormant condition and that straw in some areas had become stained by the underlying soil. This may be a reason why areas that were observed on the ground to be stabilized during the inspections appeared to have no cover in the aerial photographs in the MVW report. (See Photos 1. & 2.)

Photo 1.  
MVW Photo Jan. 14, 2021 at MP 291 showing alleged inadequate vegetative stabilization.

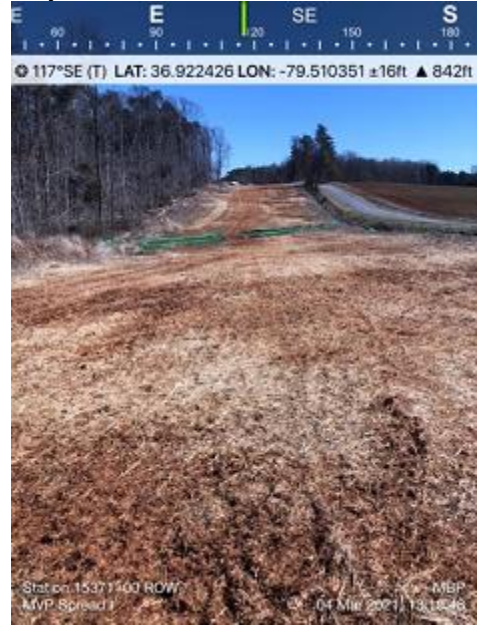
Photo 2.  
MBP Photo Mar. 4, 2021 near MP 291 showing temporary stabilization with straw. Note straw is stained by red soil.

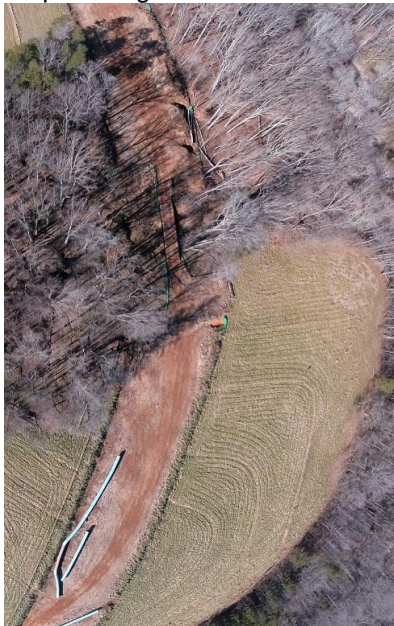
Photo 3.  
MVW Photo Jan. 14, 2021 at MP 302.1 showing alleged inadequate vegetative stabilization.

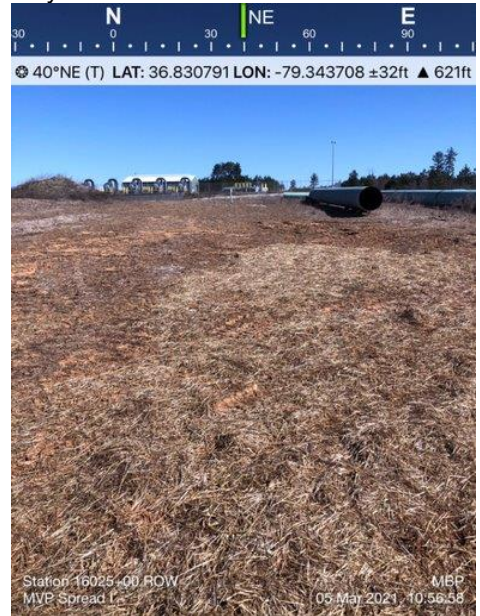
Photo 4.  
MBP Photo Mar. 5, 2021 at MP 302.1 showing poor vegetative cover with additional straw providing temporary stabilization.

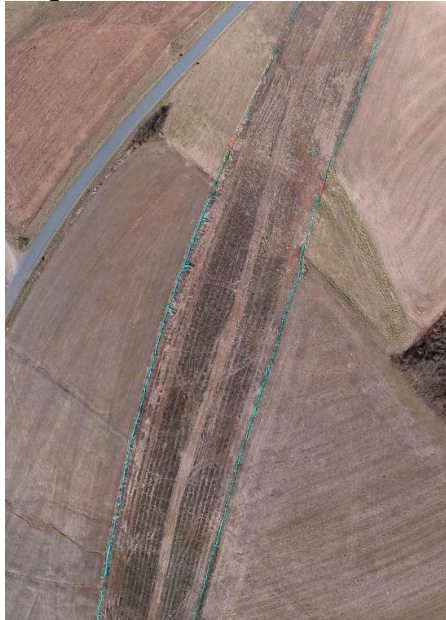
Most of the photographs were taken on January 14, 2021. The photographs "identify areas of inadequate soil cover" to support the report's allegation that "seeding of disturbed areas in the MVP right-of-way has not met minimum cover requirements". Captions included with each photograph identify various locations along the right-of-way, noting that vegetative cover is sparse. (See Photos 1. & 3. below.) Some captions include requests for inspection and reseeded. In contrast to the many photos showing sparse vegetation, three photographs show parts of the project that are acceptably vegetated. (See Photo 5.)

Photo 5.  
MVW Photo Jan.14, 2021 of MP 293.1 showing adequate vegetative stabilization.

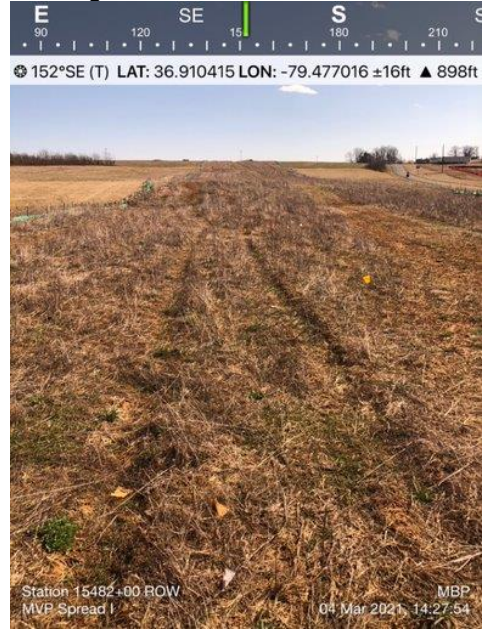
Photo 6.  
MBP Photo Mar.4, 2021 near MP 293.1 showing adequate vegetative stabilization.

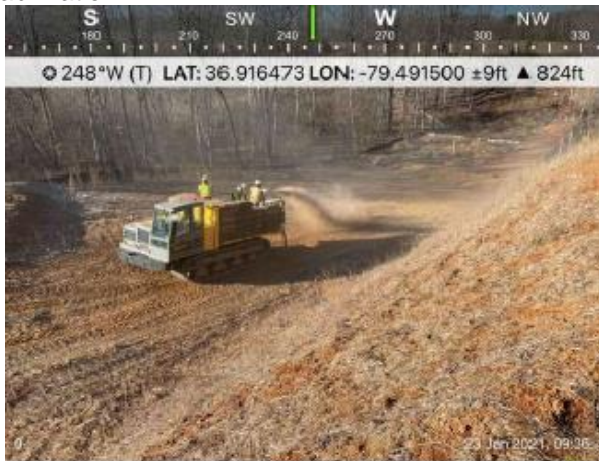
Photo 7.  
MV Photo Jan. 23, 2021 showing application of straw mulch over seeded area to maintain temporary stabilization.

Even though the MVW report did not include observations of sediment being discharged from the right-of-way, DEQ treated it as a complaint and assigned an incident response number in its PReP database. This was done to investigate MVW's allegations of non-compliance and document the findings in this report. Upon DEQ's request, MVP produced records of its recent stabilization activities on spread I that show temporary seeding was applied in various areas in Pittsylvania from May 2020 through March 2021. On this project, temporary seeding is always applied with an additional soil stabilizing material, which may include straw mulch, erosion control blankets and matting, hydraulically applied bonded fiber matrix or biotic soil media and aerial or hand-applied stabilization pellets. (See Photo 7.)

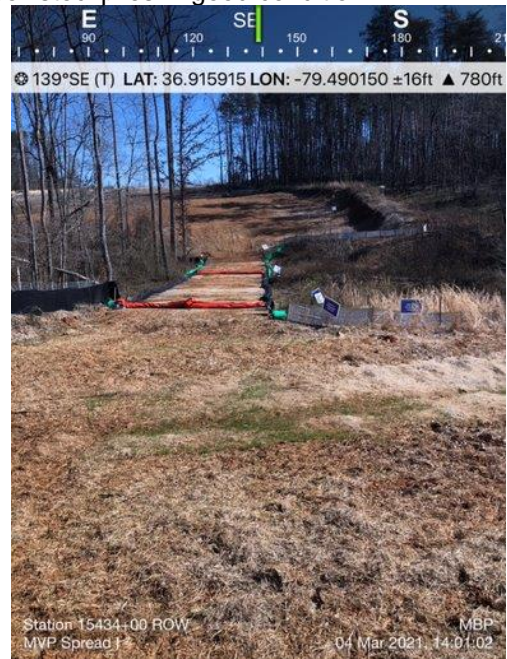
for sediment leaving the right-of way. Over those five days of inspection, one control measure was detected in need of routine maintenance. Soil stockpiles and stream buffers were observed to be well vegetated and in good condition. (See Photo 8.) No areas were found to be unstabilized, showing soil movement, rill erosion or significant deposition of sediment in the sediment-trapping controls. There were no observations of sediment deposited off the project limits. Additionally, during these March inspections, MVP was observed actively applying seed and stabilization materials from the ground and from the air using two helicopters. (See Photos 7. & 9.)

Photo 8.  
MBP Photo Mar. 4, 2021 showing E&S controls at stream crossing, stream buffer and stabilized topsoil stockpiles in good condition.

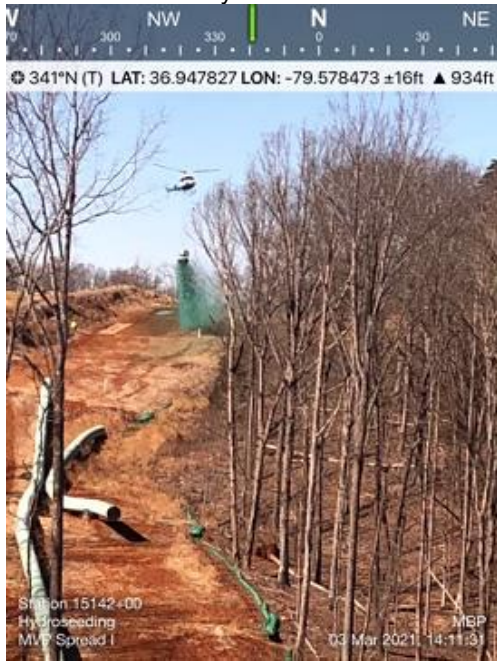
Photo 9.

MBP Photo Mar. 3, 2021 showing maintenance of temporary stabilization by aerial application of seed and hydromulch.

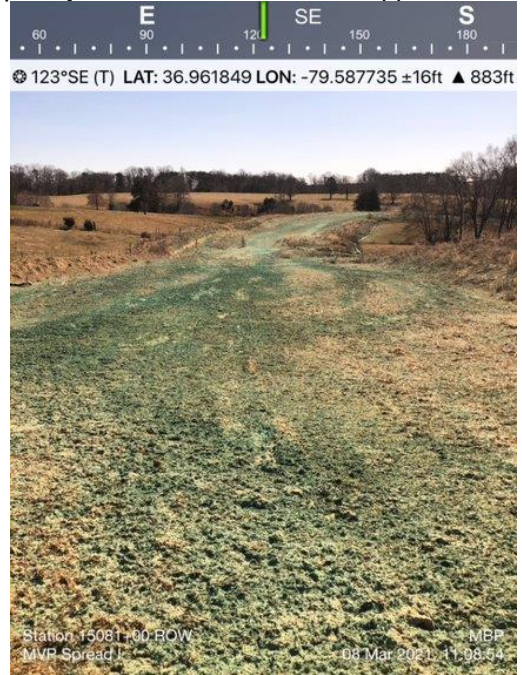
Photo 10.

MBP Photo Mar 8, 2021 near MP 286 showing temporary stabilization after aerial application.

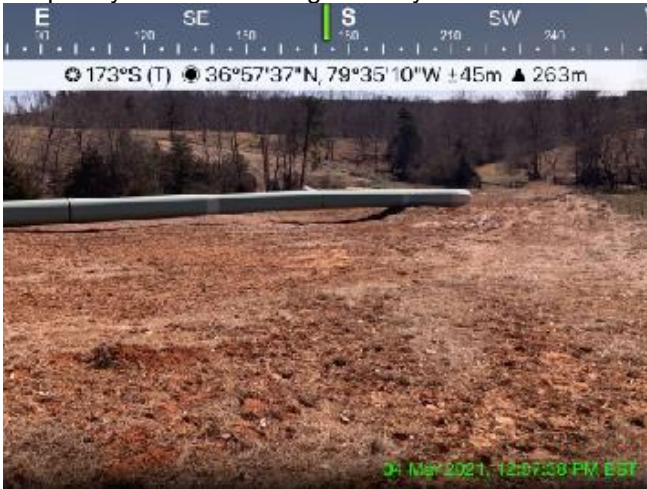
Photo 11.

In conclusion, based on observations made as a result of the investigation conducted by DEQ in response to the MVW report, the MVP project in Pittsylvania County appears to be in compliance with the requirements for soil cover. Temporary and permanent stabilization has been applied in accordance with the *VESCH* and MVP Standards and Specifications. Temporary stabilization in accordance with the requirements of Minimum Standard 1 is provided in by a combination of vegetation and other soil stabilization materials. Permanent stabilization is provided by vegetation that is in accordance with the requirements of Minimum Standard 3. Presently, MVP is appropriately accelerating its activities to maintain stabilization measures that have undergone the typical degradation brought on by the winter season. (See Photos 7., 9., 10., 11. & 12.)

MBP Photo Mar. 2, 2021 of MP 285.6 showing temporary stabilization degraded by winter weather.

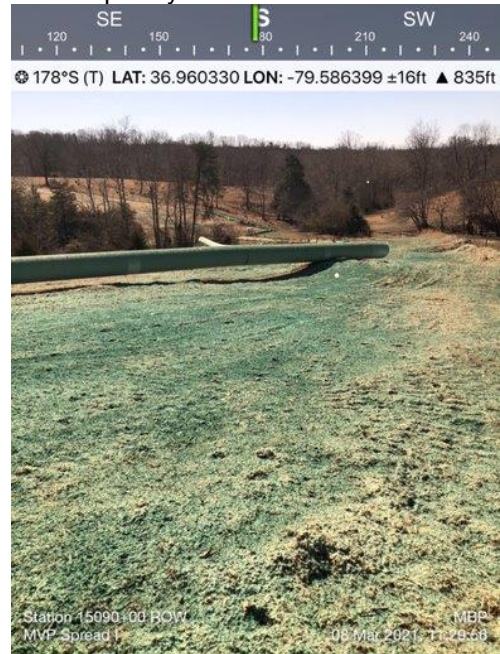
Photo 12.

MBP Photo Mar 8, 2021 of MP 285.6 showing new application of seed, hydromulch and straw to maintain temporary stabilization.
