Virginia Department of Environmental Quality's investigation into the Mountain Valley Watch report titled "Mountain Valley Pipeline Stabilization, Franklin County, VA"

April 15, 2021

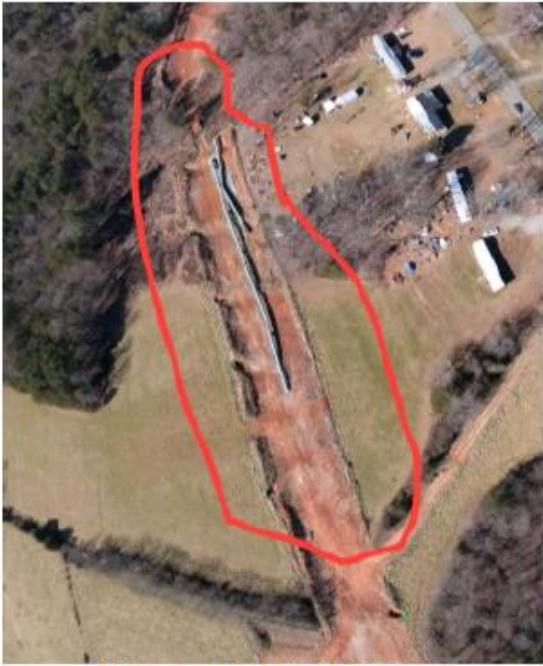
Photo 1.
MVW aerial photo and caption.

No exception is taken to MVW's observations that many areas are sparsely vegetated and the temporary stabilization needs maintenance. The aerial photographs were taken by MVW in January, when much of the vegetation stabilizing the right-of-way (ROW) is at the end of its effective life. The MVW report incorrectly stated that Minimum Standard 1, requires "the use of vegetation to stabilize soil and prevent erosion during and after land-disturbing activities". This implies that because the MVP ROW is not stabilized with vegetation, the project is not in compliance with the ESC Regulation. As the MVW report correctly notes, Minimum Standard 1 of the ESC regulation addresses soil stabilization. It does not specify that stabilization must be provided by vegetation. Because establishing and maintaining vegetation is not always possible on construction sites due to staging or seasonal constraints, other methods of stabilization may be applied. MVP has several approved alternative methods of soil stabilization, which it employs when vegetative stabilization is not successful or feasible. Although not always evident in the aerial photographs, soil stabilization has been maintained by MVP throughout the course of the project, per the requirements of Minimum Standard 1 and verified by DEQ field inspectors, through the application of straw, blankets and matting or soil stabilization pellets as exhibited in

Milepost 271.4 [G0020328](#)
Inspection requested for sparsely
vegetated area. Reseeding needed.

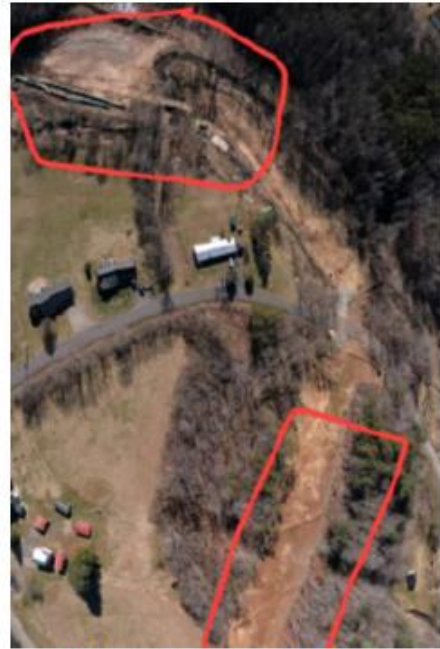
Photo 2.
MVW aerial photo and caption.

Milepost 260.2 [G0020665](#)
Inspection requested for sparsely vegetated
areas.

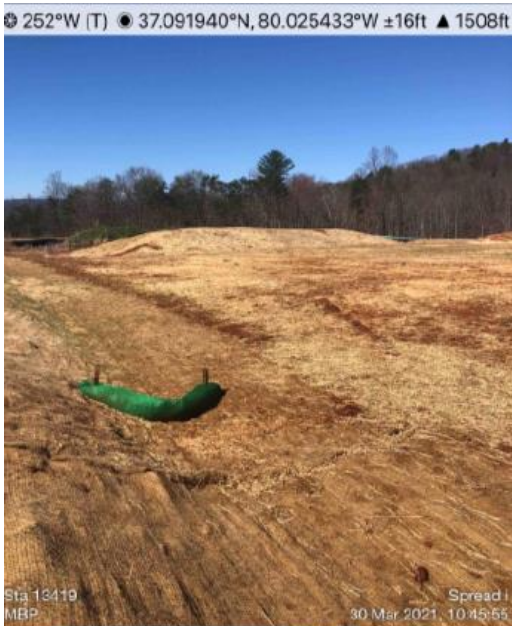
Photos 3 & 4 of this report. When alternative methods of stabilization are used, and there may not be a highly visible ground cover, close inspection of the soil is necessary to verify that rill erosion and sediment transport is not occurring.

Photo 3. MBP photo showing straw providing
temporary soil stabilization.

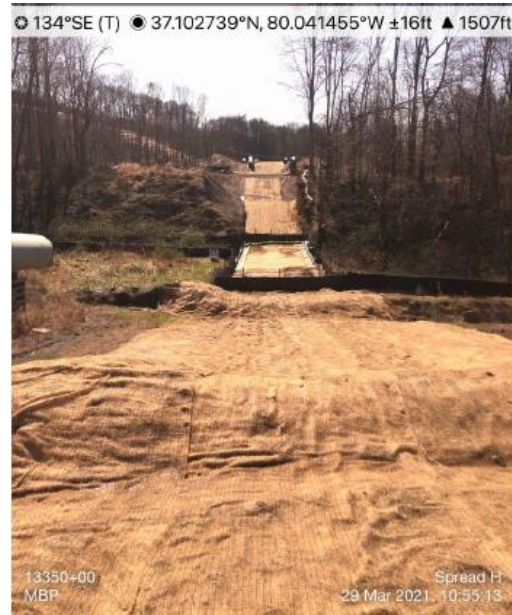
Photo 4. MBP photo showing blankets and matting providing
temporary soil stabilization.

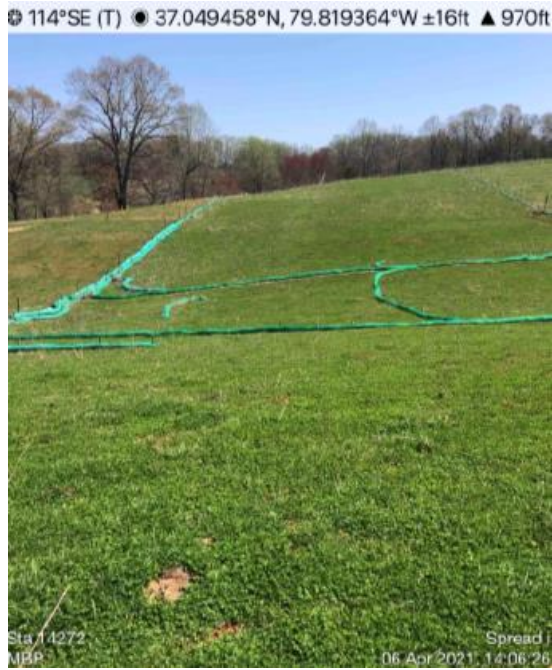
The report also alleges that Minimum Standard 3 requires the ROW to have been permanently stabilized, since it has been dormant for one year. The MVP project has experienced long delays to construction and its schedule for completion has remained unclear. There has been no schedule for completion that specified the project would be maintained at temporary grade but dormant for over one year. At this time, a relatively few areas in Franklin County have been taken to the stage of construction where the ROW is returned to finish grade, topsoil spread and prepared for final seeding. However, throughout the duration of the project, soil stabilization has been required and MVP has maintained temporary stabilization on the unfinished areas of the ROW. In the areas where the ROW has been restored and seeded with its permanent seed mixture, there is an excellent stand of permanent perineal vegetation as required by the Regulations. (Photo 5.)

Photo 5. MBP photo showing permanent vegetation.

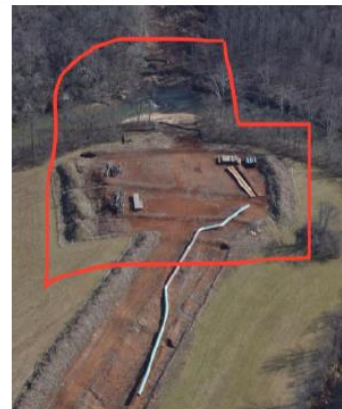
Photos at MPs 269.7, 269.4, 269.3 show sediment deposits in the Blackwater River and implies that sediment from the project has been deposited in the channel. (Photo 8.) Inspectors on the ground at this location have observed that there is no evidence of sediment leaving the ROW and the sediment pictured is from natural stream channel deposition. (Photo 9.) Likewise, the sediment pictured in the channel at MP 272.1 is from natural stream deposition. The light colored areas in the aerial picture are rocks and sand from stream deposition, and curlex erosion control blanket material that has been applied to the stream bank.

Photo 8. MVW photo alleging sediment deposition into stream channel.

Milepost 269.4 [DSC_0162](#)
Inspection requested for apparent evidence of sediment runoff into stream and sparsely vegetated areas.

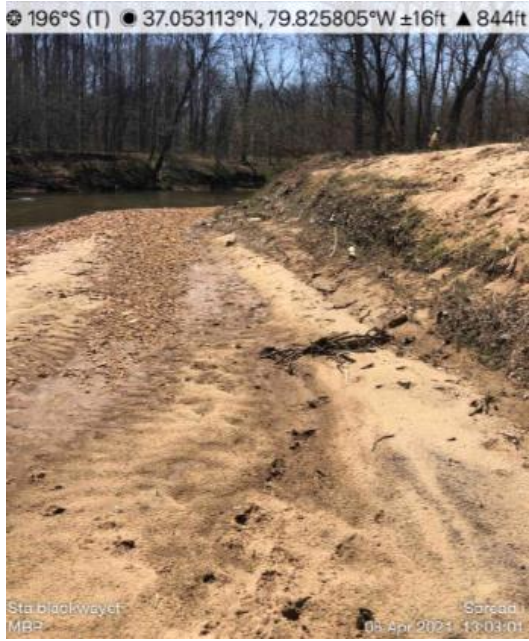
Photo 9. MBP photo showing natural stream sediment deposition.

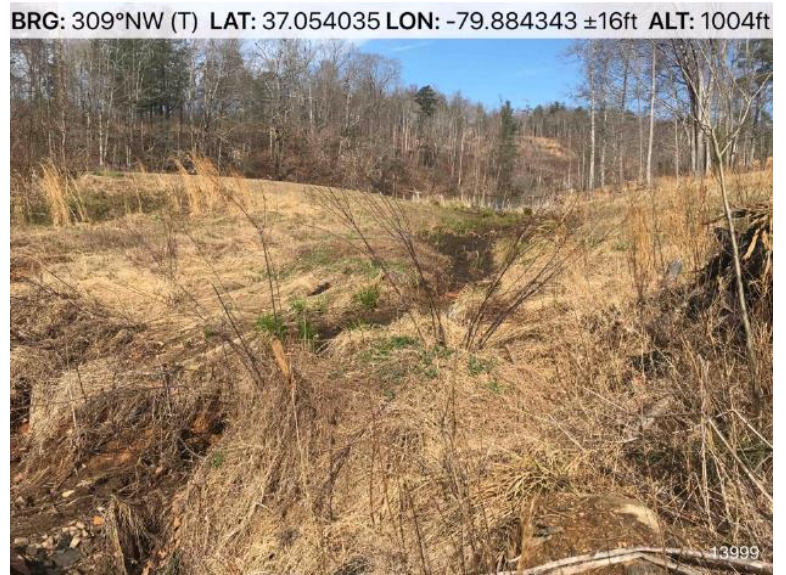
The photo from MP 265 shows an offsite pond discharging its emergency spillway onto the ROW and causing erosion. This known issue has been an ongoing concern for DEQ and MVP has been working with the owner of the offsite pond for a resolution. Rather than armoring the emergency spillway and constructing a stabilized channel for the pond to continue to overflow through, the owner has recently repaired the pond's principal spillway and it is functioning properly now. The pond no longer overflows constantly across the emergency spillway. (Photo 10.) The discharge is now through the principal spillway, into a channel that is off the MVP ROW. As conditions allow, the eroded channel on the ROW will be backfilled and stabilized.

Photo 10. DEQ photo showing pond emergency spillway no longer discharging from the surface of the pond. .

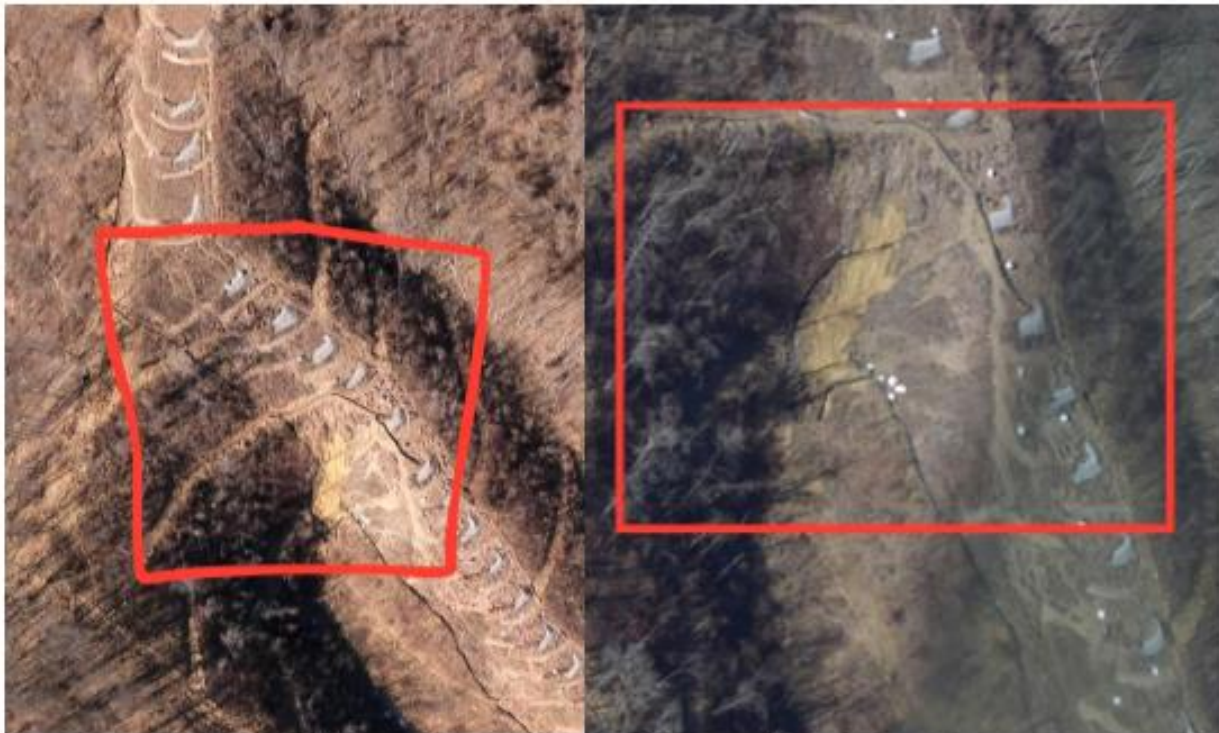
Milepost 250.8 [G0020905](#) and [DSC_0468](#)

The MVW aerial photos show a slip at MP 250.8 where a fissure has formed at the top of a layer of soil on a steep slope. (Photo 11.) MVP inspectors first observed this slip immediately after Tropical Storm Eta on November 12, 2020. The slip has been stabilized and presently an engineering plan is being designed by MVP to repair and permanently remedy the instability here. In addition to the engineering plan, MVP must submit a revised erosion and sediment control plans to DEQ for approval and prepare a request for a variance from the Federal Energy Regulatory Commission (FERC), since the repair will involve work off of the approved ROW.

Photo 11. MVW photo soil slip. MVP has stabilized this area and is currently working on a plan to remedy the slip.

Large slip is visible on the left side of ROW. Inspection requested for visible slip.

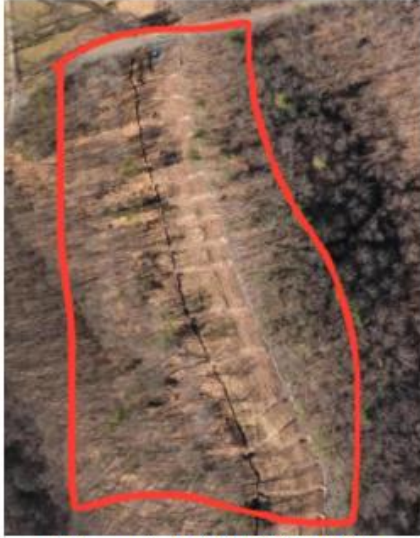
The MVW photo taken at MP 249.9 (Photo 12.) shows a length of the ROW where it alleges sediment is being discharged from the ROW. During a recent inspection, it was observed that this area outside of the ROW was recently logged and there has been extensive land-disturbance from both the logging and from non-project related 4-wheel drive activities. (Photo 13)

Photo 12. MVW alleging sediment is being discharged from the ROW.

Milepost 249.9 [G0020965](#)
Inspection requested for evidence of sediment off the left side of ROW.

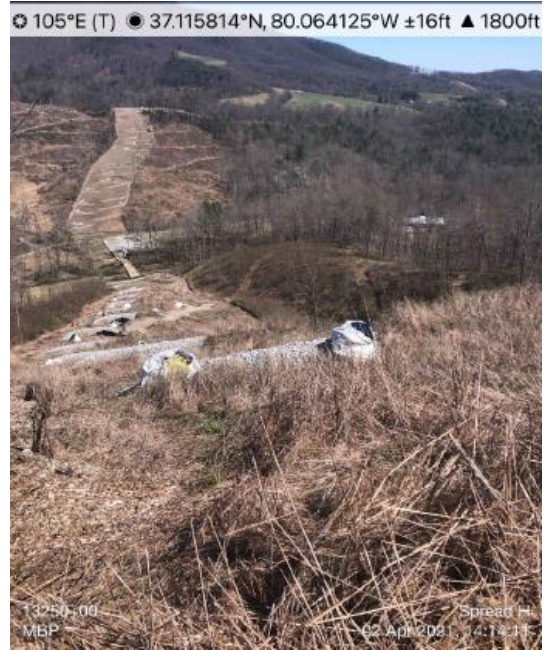
Photo 13. MBP photo from April 2, 2021 showing land-disturbance outside the ROW from logging and 4-wheel drive activities.
