## FIELD INSPECTION REPORT

<b>Project Name:</b>	Mountain Valley Pipeline	<b>Inspector:</b>	Marshall Willis
<b>Inspection Date:</b>	Monday, April 5, 2021	<b>Project Contact:</b>	Brian Clauto, Cory Chalmers
<b>Spread G: Giles County</b>	STA 11158+50 – 11170+00 MVP-GI-256.02 MVP-GI-249.01	<b>Weather:</b>	Dry

## FIELD INSPECTION PHOTO LOG

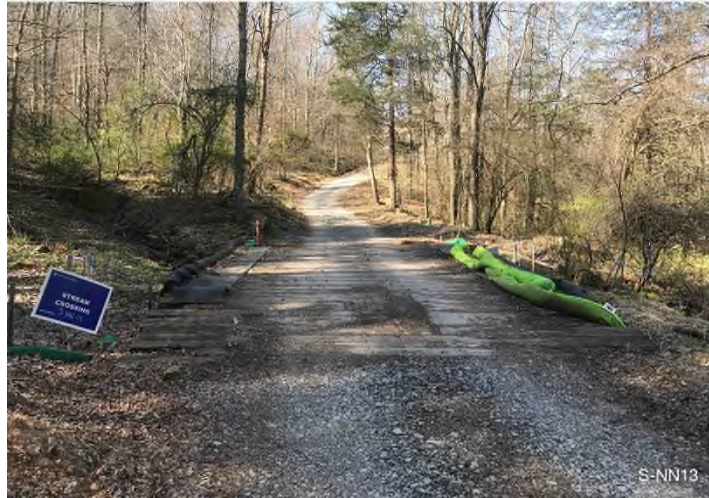
**Figure 1: MVP-GI-256.02** – Controls in place and functioning properly.  
 BRG: 226°SW (T) LAT: 37.304000 LON: -80.471603 ±5443ft ALT: 2088ft

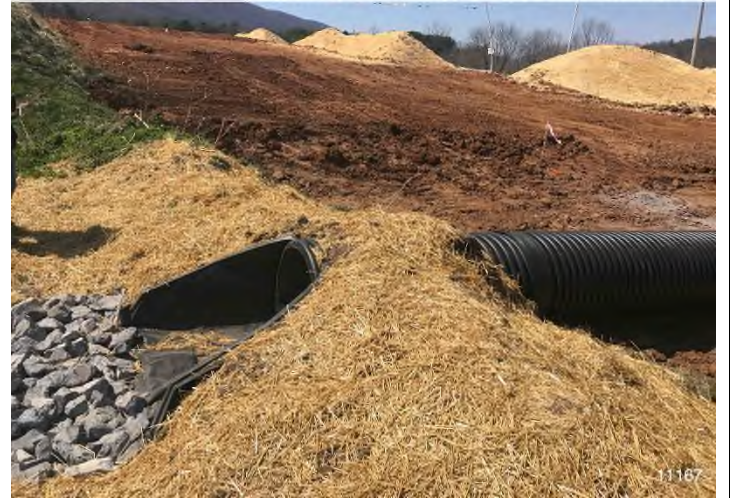
**Figure 2: STA 11167+00** – PPL actively installing CWD and level spreader outlet.  
 BRG: 240°SW (T) LAT: 37.310146 LON: -80.514244 ±32ft ALT: 1868ft

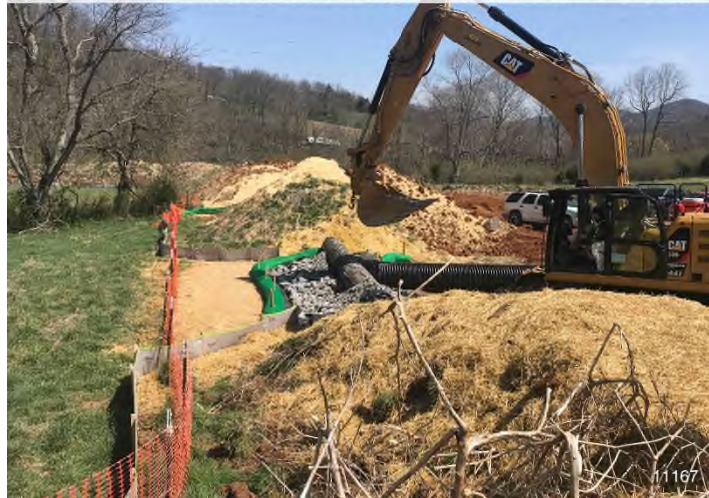
**Figure 3: STA 11167+00** – PPL actively installing CWD and level spreader outlet.  
 BRG: 48°NE (T) LAT: 37.310492 LON: -80.514443 ±16ft ALT: 1840ft

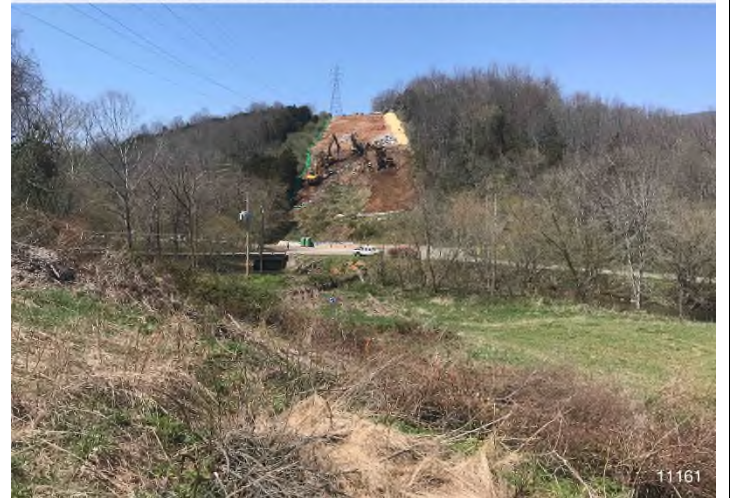
**Figure 4: STA 11161+00** – Controls in place and functioning properly.  
 BRG: 299°NW (T) LAT: 37.310801 LON: -80.515844 ±541ft ALT: 1832ft
