FIELD INSPECTION REPORT

Project Name:	Mountain Valley Pipeline	Inspector:	Marshall Willis
Inspection Date:	Tuesday, March 30, 2021	Project Contact:	Brian Clauto, Cory Chalmers
Spread G: Giles County	STA 11064+28 – 11151+27 MVP-GI-249 MCP-GI-245.01	Weather:	Dry

FIELD INSPECTION PHOTO LOG

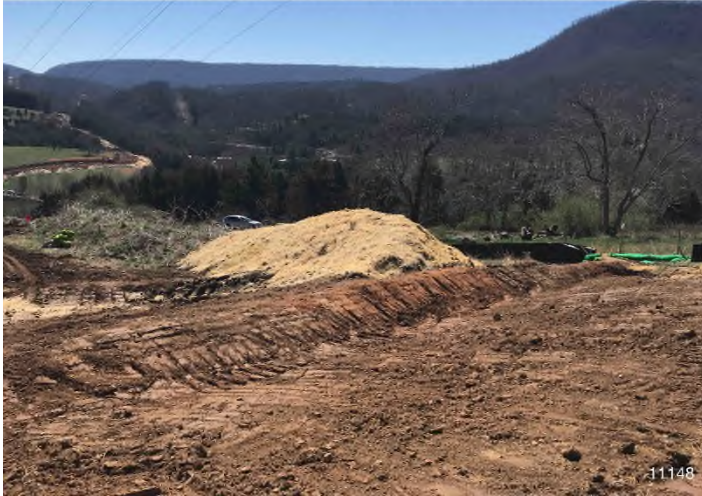
Figure 1: STA 11148+00 – Controls in place and functioning properly.
 BRG: 153°SE (T) LAT: 37.306572 LON: -80.509770 ±11398ft ALT: 1865ft

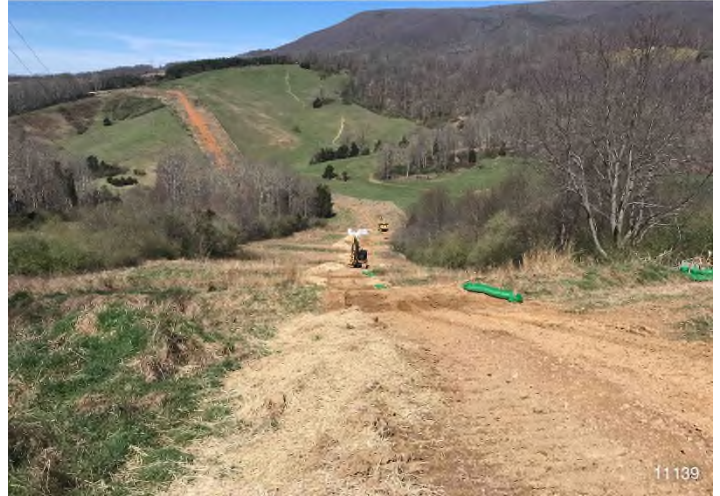
Figure 2: STA 11139+00 – Controls in place and functioning properly.
 BRG: 305°NW (T) LAT: 37.313599 LON: -80.522308 ±16ft ALT: 2149ft

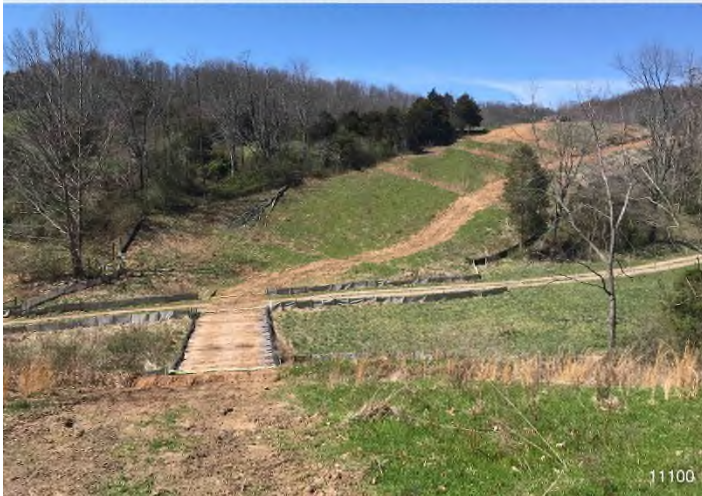
Figure 3: STA 11100+00 – Controls in place and functioning properly.
 BRG: 273°W (T) LAT: 37.313195 LON: -80.533283 ±32ft ALT: 1984ft

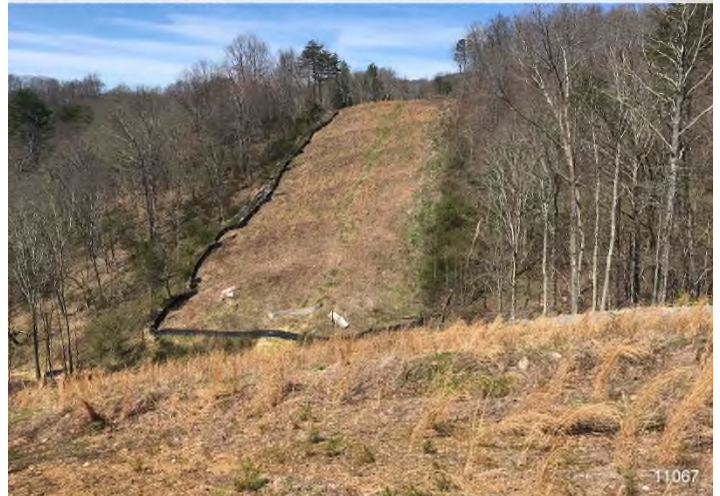
Figure 4: STA 11067+00 – Controls in place and functioning properly.
 BRG: 92°E (T) LAT: 37.306213 LON: -80.508641 ±13639ft ALT: 2168ft
