FIELD INSPECTION REPORT

Project Name:	Mountain Valley Pipeline	Inspector:	Marshall Willis
Inspection Date:	Wednesday, April 28, 2021	Project Contact:	Brian Clauto, Cory Chalmers
Spread G: Giles County	STA 10819+00 – 10859+34 MVP-GI-241.03	Weather:	Dry

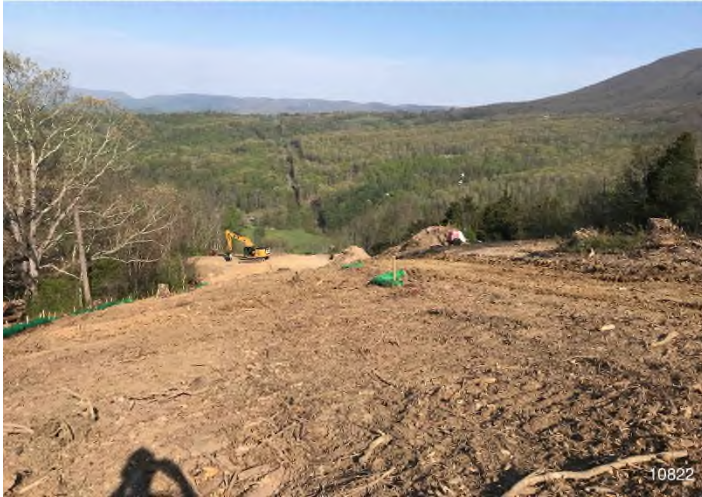
10822

Figure 1: STA 10822+00 – Controls in place and functioning properly.

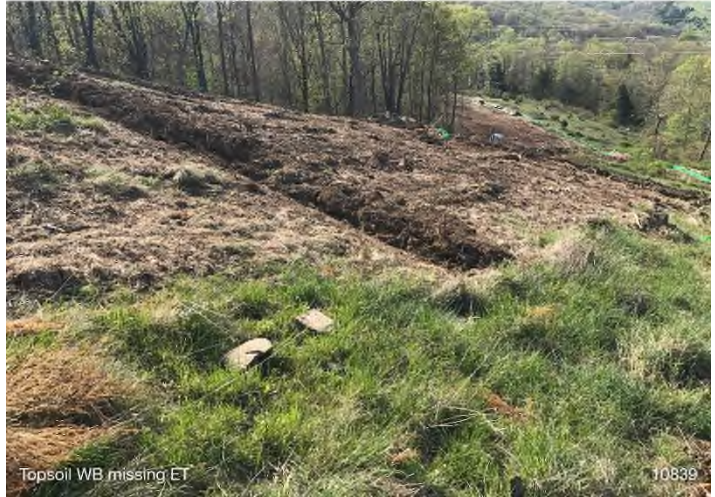
10839

- STA 10839+00: Temp. topsoil waterbar does not have end-treatment.
- STA 10840+70: Temp. topsoil waterbar does not have end-treatment.

Figure 2: STA 10839+00 – Temp. topsoil WB does not have end-treatment.

Topsoil WB missing ET

Recommended Corrective Action: Maintain and install all controls per the approved PSS&S.

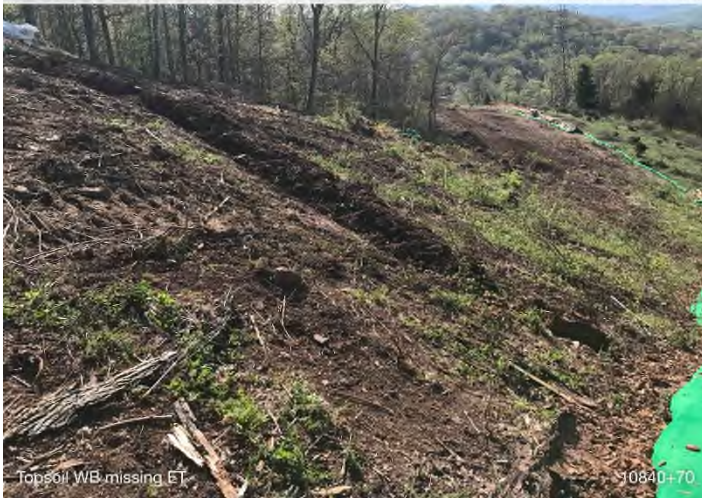
Figure 3: STA 10840+70 – Temp. topsoil WB does not have end-treatment.

Topsoil WB missing ET

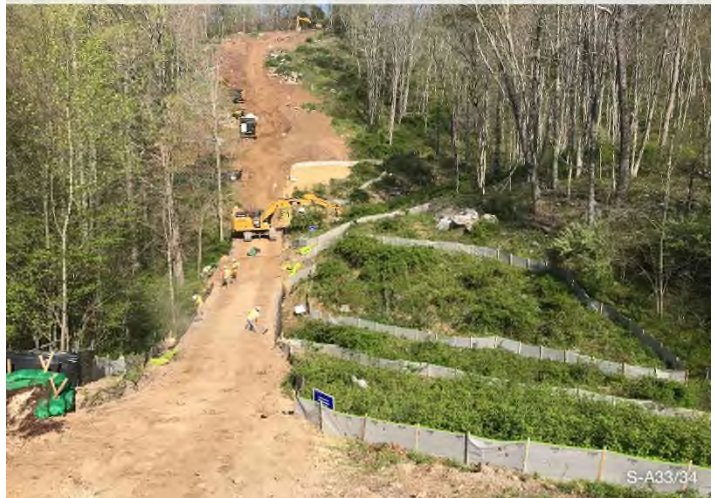
S-A33/34

Figure 4: Streams S-A33 and S-A34 – Controls in place and functioning properly.
