FIELD INSPECTION REPORT

Project Name:	Mountain Valley Pipeline	Inspector:	Marshall Willis
Inspection Date:	Tuesday, April 27, 2021	Project Contact:	Brian Clauto, Cory Chalmers
Spread G: Giles County	STA 10971+74 – 11098+43 MVP-GI-242.01 MVP-GI-245.01	Weather:	Dry

FIELD INSPECTION PHOTO LOG

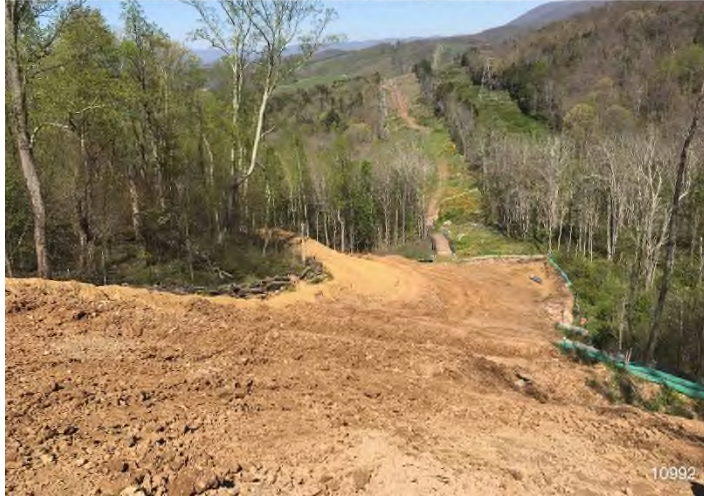
Figure 1: STA 10992+00 – Controls in place and functioning properly.
BRG: 286°W (T) **LAT:** 37.325000 **LON:** -80.563064 ±16ft **ALT:** 2530ft

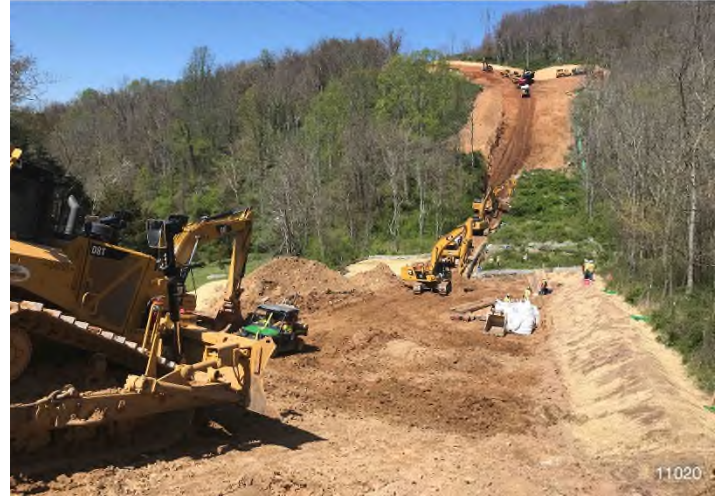
Figure 2: STA 11020+00 – Controls in place and functioning properly.
BRG: 266°W (T) **LAT:** 37.323524 **LON:** -80.554245 ±16ft **ALT:** 2459ft

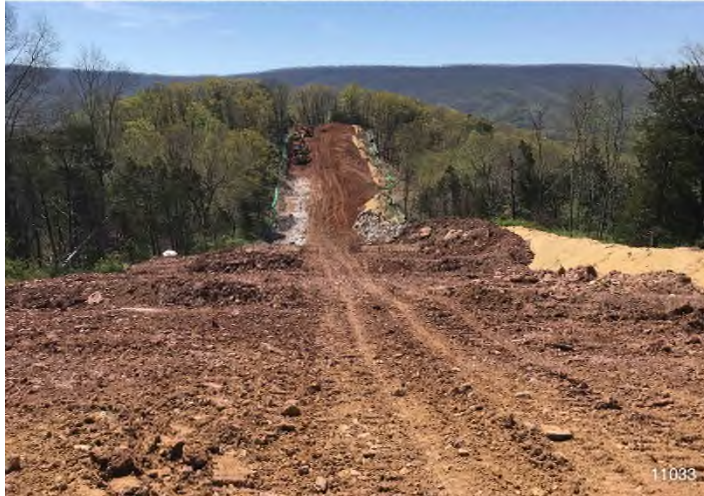
Figure 3: STA 11033+00 – Controls in place and functioning properly.
BRG: 148°SE (T) **LAT:** 37.321152 **LON:** -80.550845 ±16ft **ALT:** 2386ft

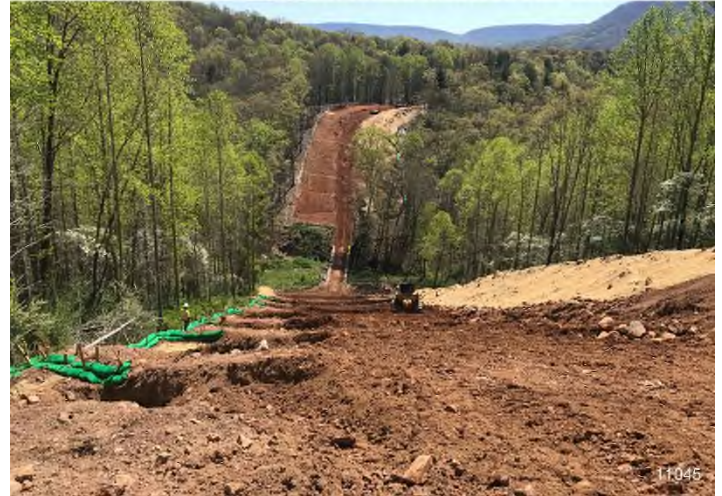
Figure 4: STA 11045+00 – Controls in place and functioning properly.
BRG: 112°E (T) **LAT:** 37.326534 **LON:** -80.550608 ±9564ft **ALT:** 2346ft
