FIELD INSPECTION REPORT

Project Name:	Mountain Valley Pipeline	Inspector:	Marshall Willis
Inspection Date:	Monday, April 26, 2021	Project Contact:	Brian Clauto, Cory Chalmers
Spread G: Giles County	STA 11158+12 – 11250+00 MVP-MLV-AR-25 MVP-GI-249.01	Weather:	Dry

FIELD INSPECTION PHOTO LOG

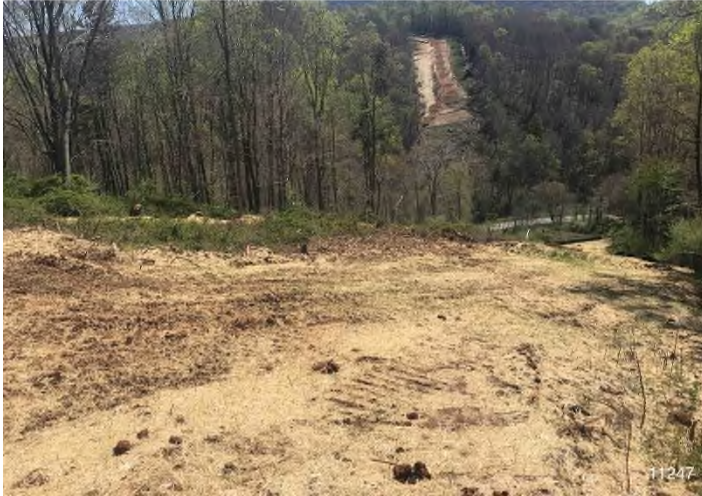
Figure 1: STA 11247+00 – Controls in place and functioning properly.
 BRG: 106°E (T) LAT: 37.302043 LON: -80.505112 ±12986ft ALT: 2229ft

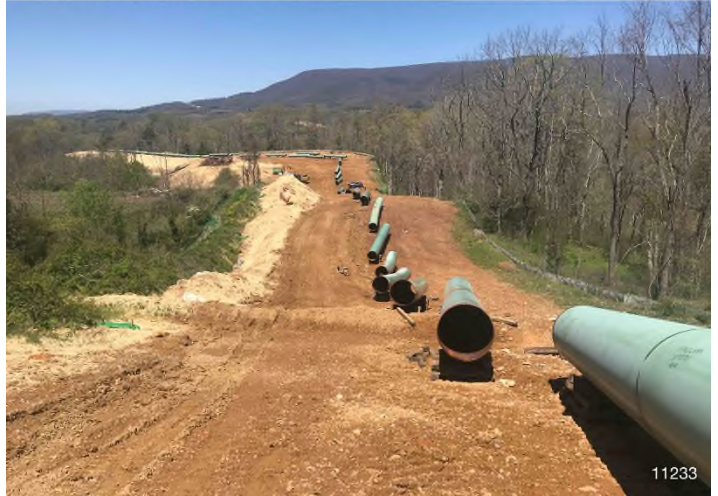
Figure 2: STA 11233+00 – Controls in place and functioning properly.
 BRG: 347°N (T) LAT: 37.303642 LON: -80.505547 ±13714ft ALT: 2126ft

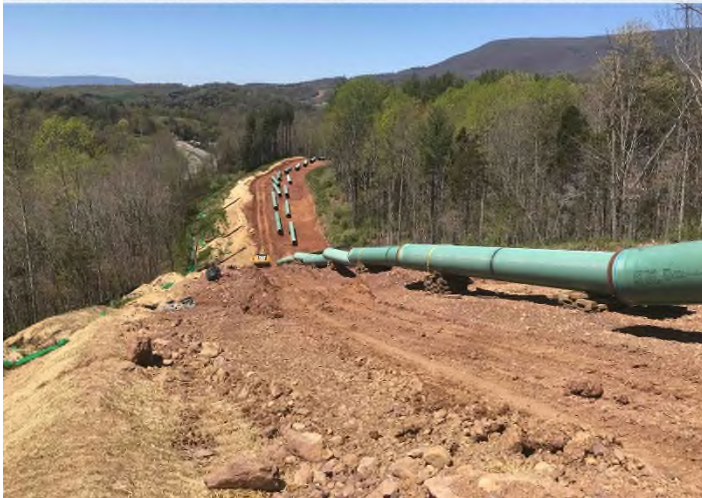
Figure 3: STA 11198+00 – Controls in place and functioning properly.
 BRG: 296°NW (T) LAT: 37.303724 LON: -80.505674 ±13714ft ALT: 2161ft

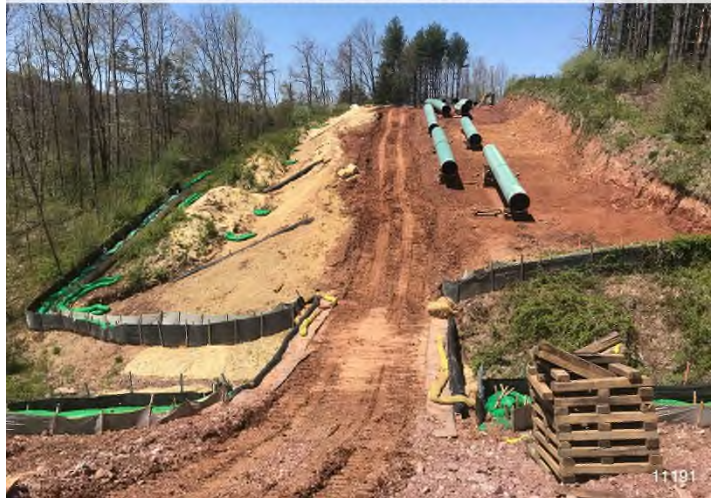
Figure 4: STA 11191+00 – Controls in place and functioning properly.
 BRG: 319°NW (T) LAT: 37.306628 LON: -80.509749 ±32ft ALT: 2023ft
